**FLOODS
ON
FRENCH BROAD
AND
SWANNANOA
RIVERS**

**VICINITY
OF
ASHEVILLE
NORTH
CAROLINA**

**TENNESSEE
VALLEY
AUTHORITY**

REPORT NO. 0-5975

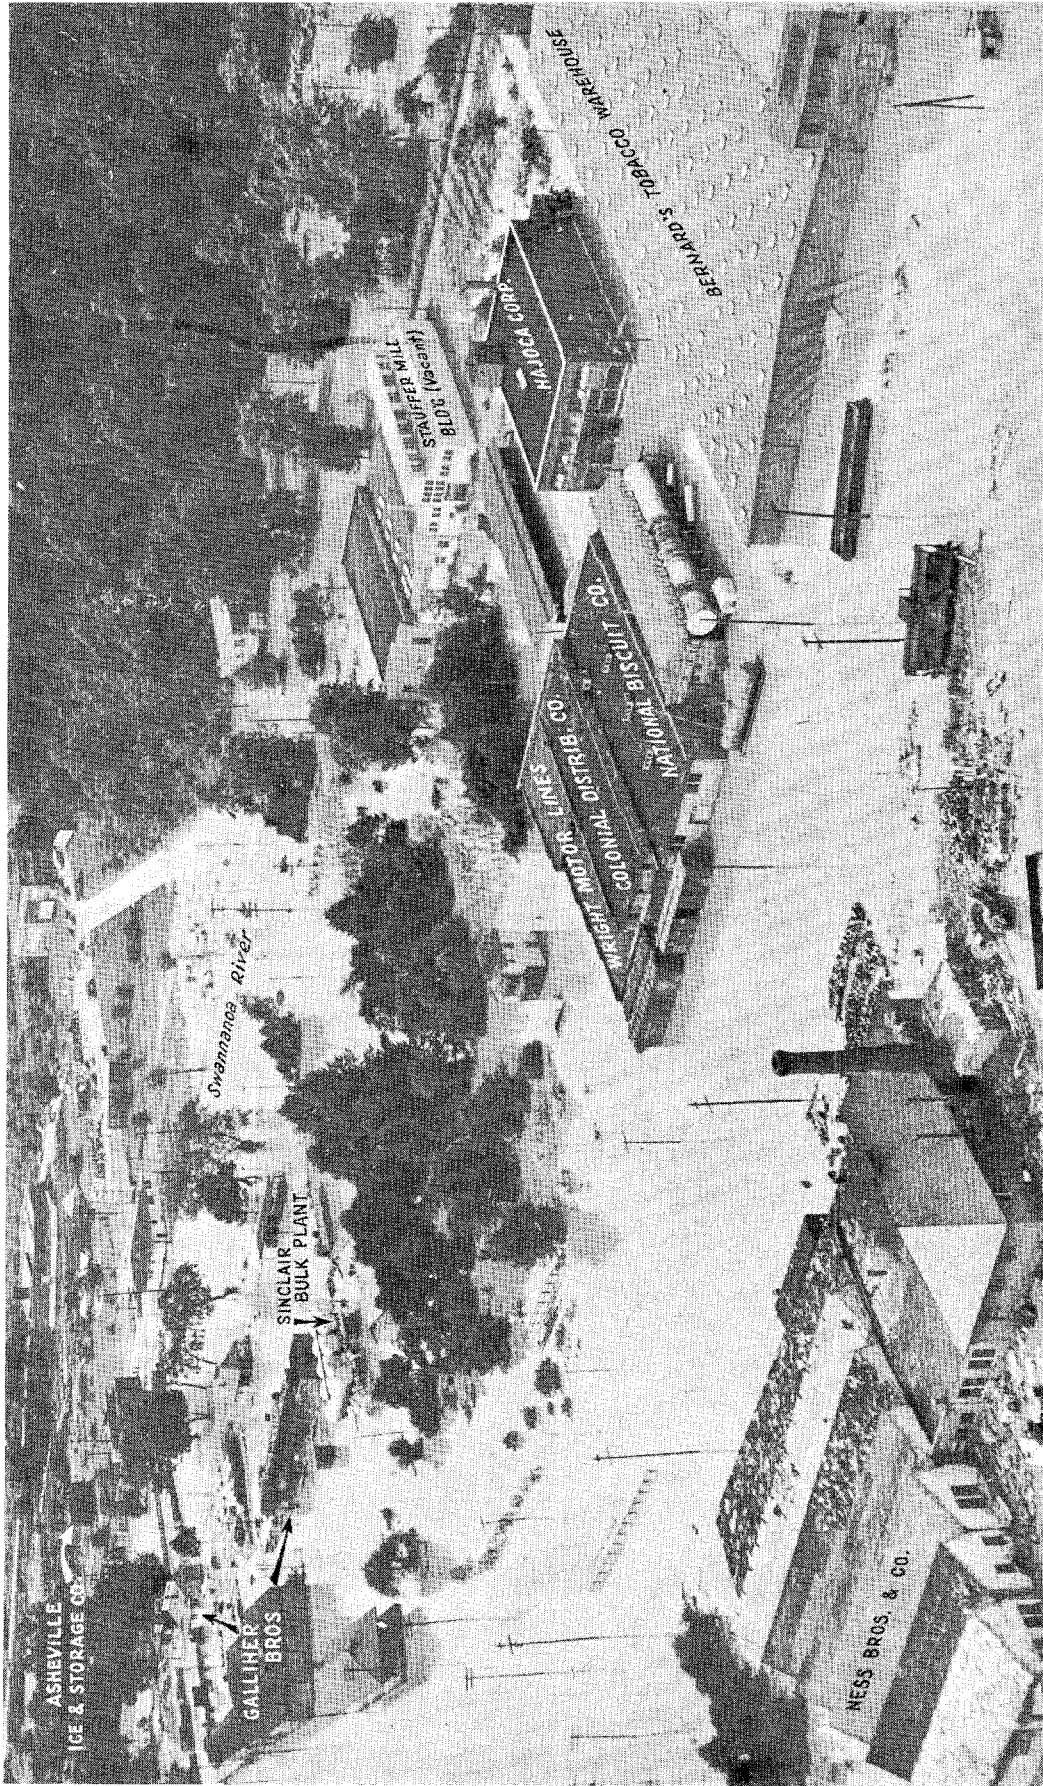
Figure 1. -- AUGUST 30, 1940, FLOOD AT BILTMORE

The Swannanoa River's normal channel is from right to left along the rows of telephone poles in the middle background. The Southern Railway right-of-way is in the foreground. The mid-August 1940 flood crest was 3 feet higher than the overflow shown in this view.

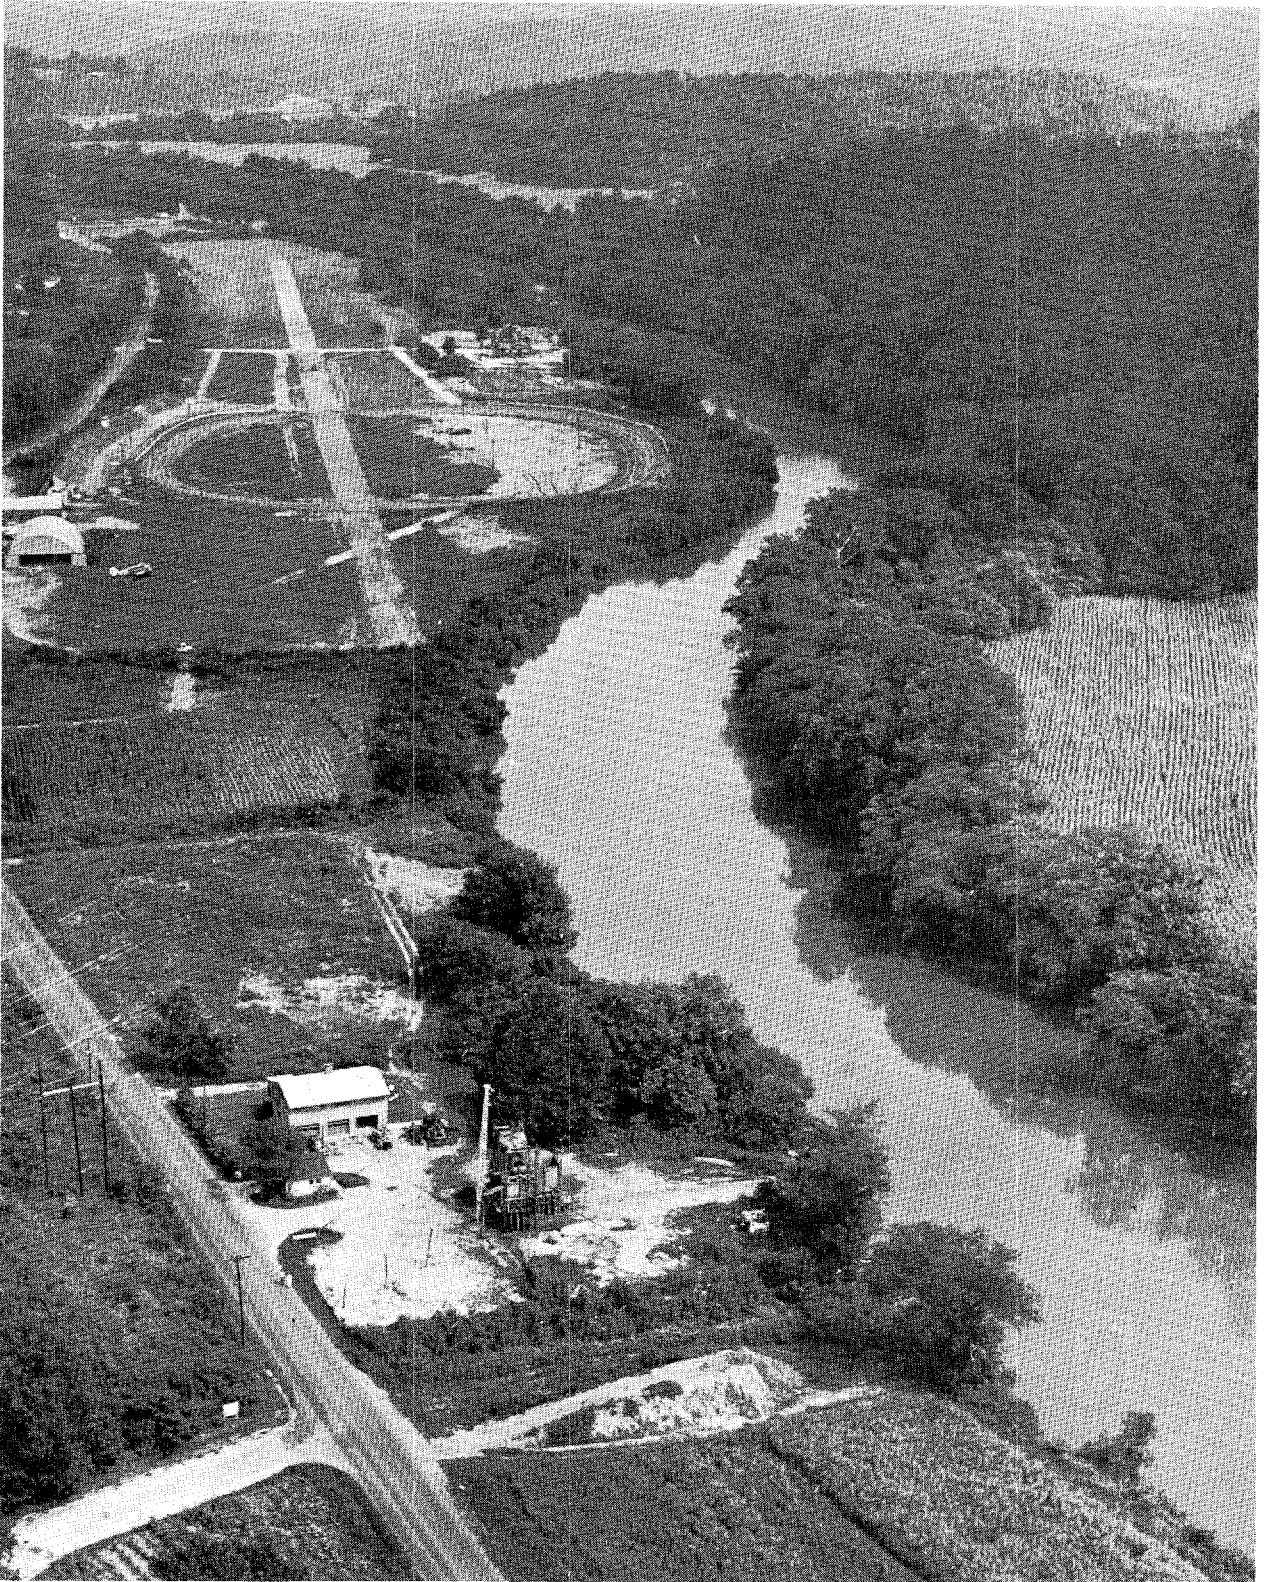
Figure 2. --FLOOD PLAINS ABOVE CARRIER BRIDGE

Aerial view of French Broad River and flood plains, looking downstream from about Mile 150.6. Bell Sand Company is in the left foreground. Owen's Airfield and an auto racetrack are near the center of the picture.

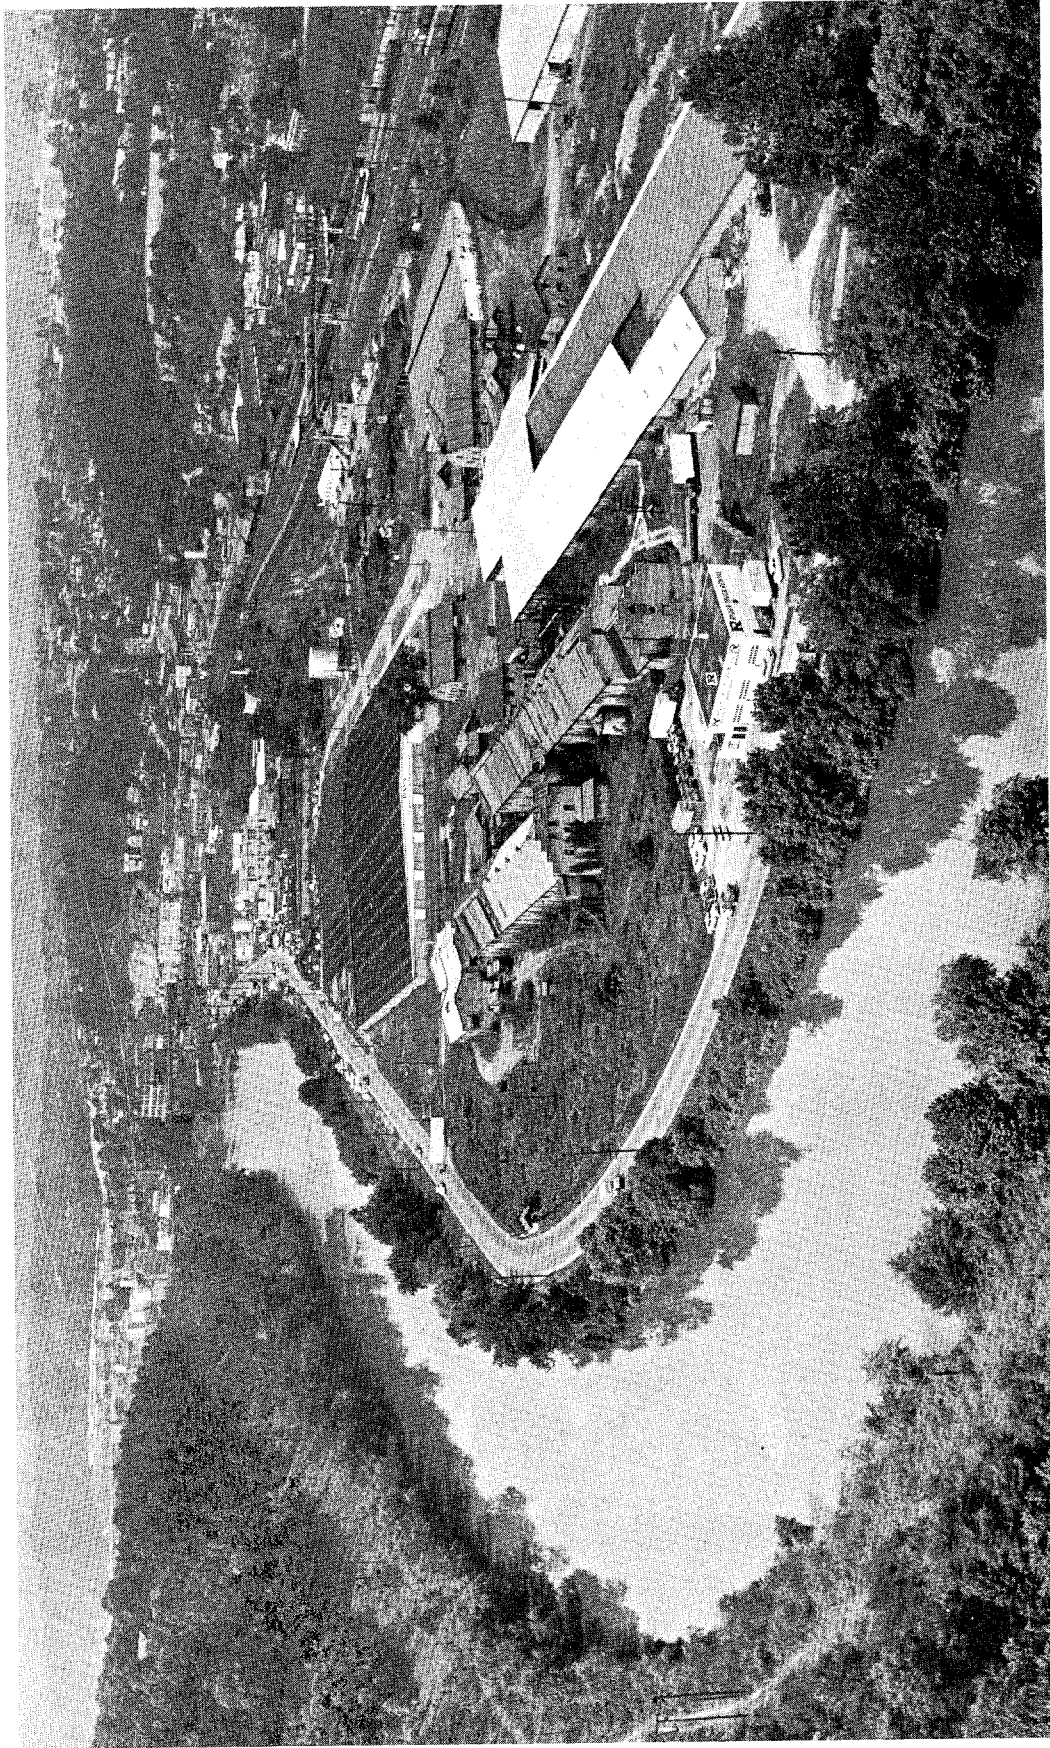
Figure 3. --DEVELOPMENTS JUST BELOW CARRIER BRIDGE

This view, looking down the French Broad River from about Mile 148.7, shows the upper end of the heavy flood plain development along the right side of the river. Ness Brothers occupies the old Hans Rees Tannery buildings. Day's large tobacco warehouse is new since 1940.

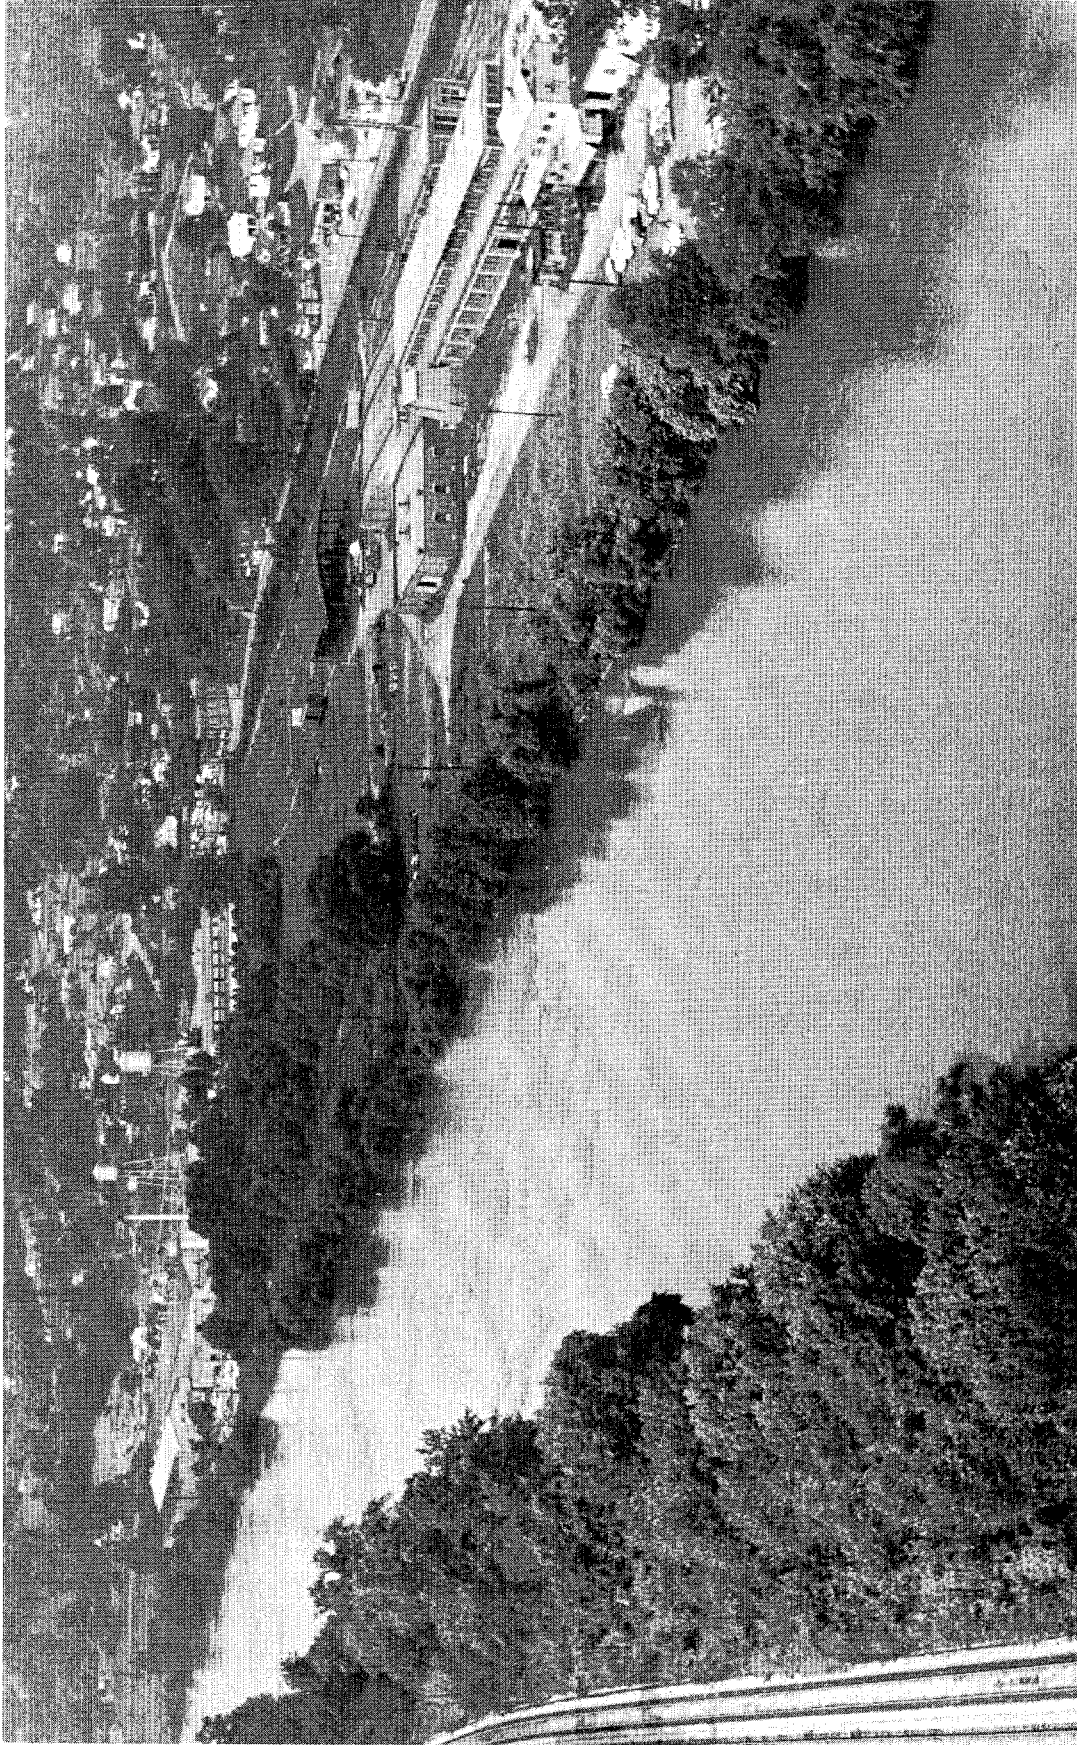
Figure 4. --WOODFIN MANUFACTURING DISTRICT

This view is downstream from about Mile 145. 3. The Hicks Corporation plant at the lower right was formerly the National Casket Company. (Photo by H. Malcolm Gamble, Asheville Citizen-Times)

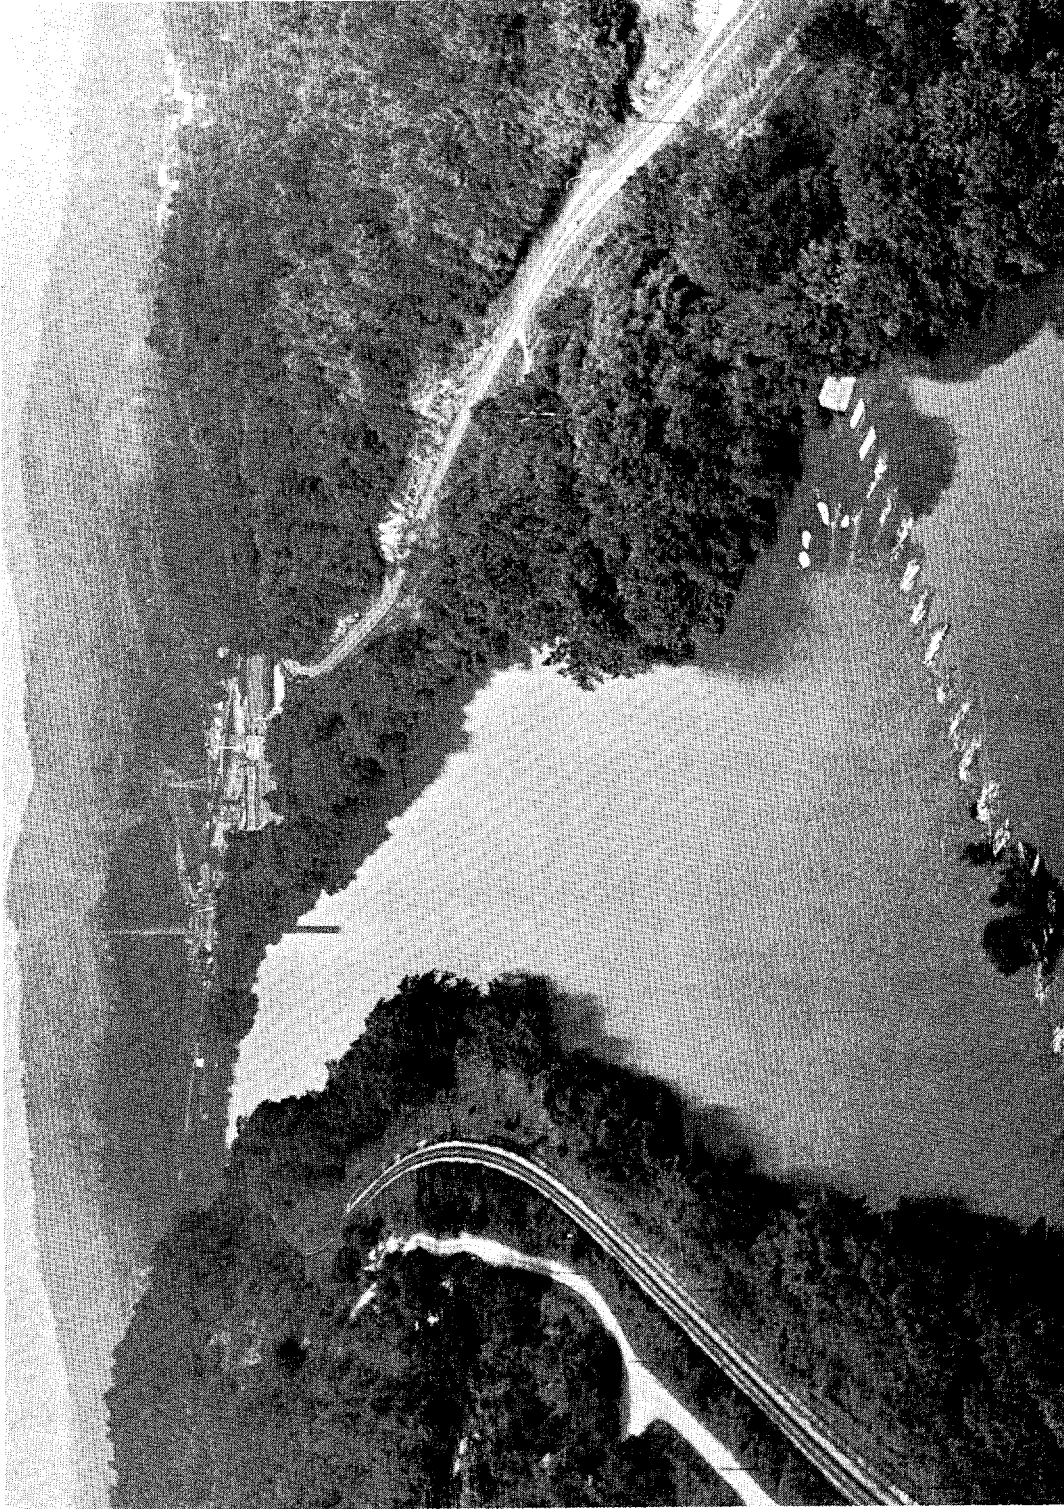
Figure 5. --FLOOD PLAIN BELOW CRAGGY BRIDGE

The river in this view is in backwater from Craggy Dam. The remains of the old Southern Railway bridge at Mile 143.0 are in the foreground.

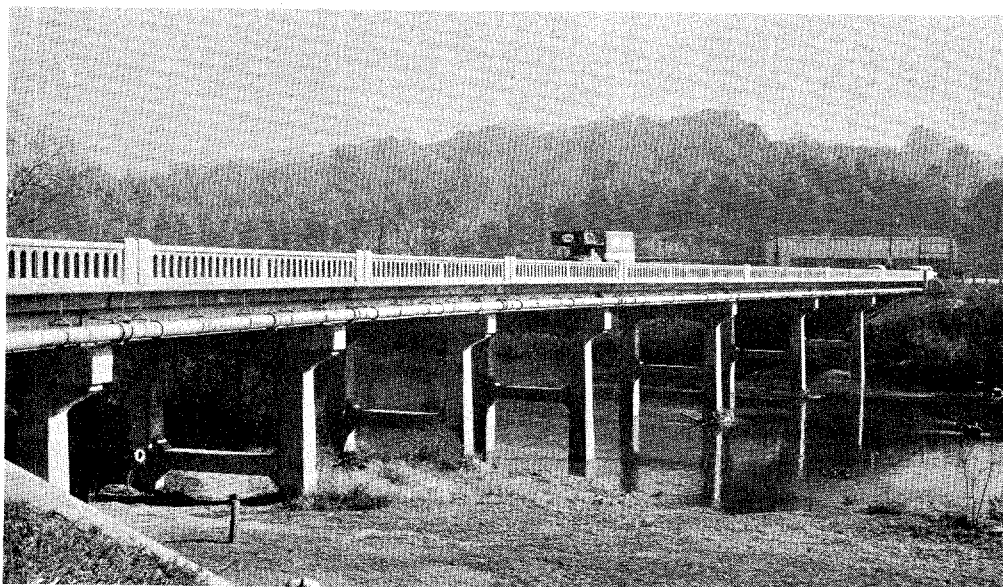
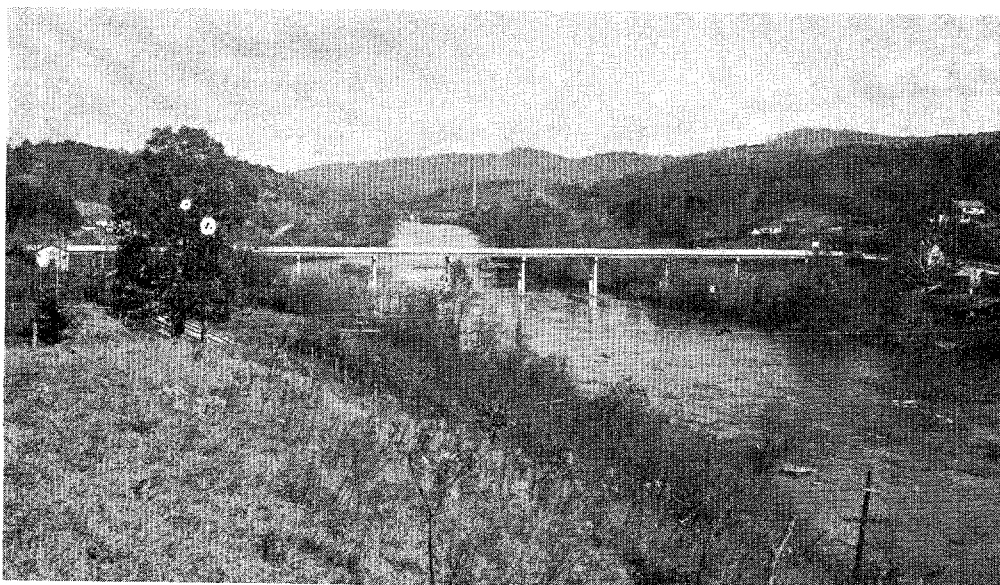
Figure 6. --CARRIER AND CRAGGY BRIDGES ACROSS
FRENCH BROAD RIVER

Carrier Bridge, Mile 148.98, looking downstream. This structure, built in 1951, replaces a steel truss bridge. An earlier bridge was destroyed by the July 1916 flood. A recurrence of the 1916 flood would overtop the floor of the present bridge.

Craggy Bridge, Mile 143.08, looking downstream. Rebuilt in 1954, the underclearance is 19 feet above the level of the 1916 flood which washed out an earlier bridge.

Carrier Bridge, Figure 6, which crosses the French Broad River just below the mouth of Swannanoa River, is a concrete and steel structure completed in 1951. It replaced a steel truss bridge which in turn was built to replace the one destroyed there by the flood of July 1916. The floor of the present bridge is just above the elevation reached by the actual 1916 flood, but it would be overtopped in a recurrence of that flood since there is now somewhat less opening under the bridge

Also a high bridge is the one at Craggy, Mile 143.08, shown in Figure 6. The bridge washed out by the 1916 flood was replaced by a high level concrete arch

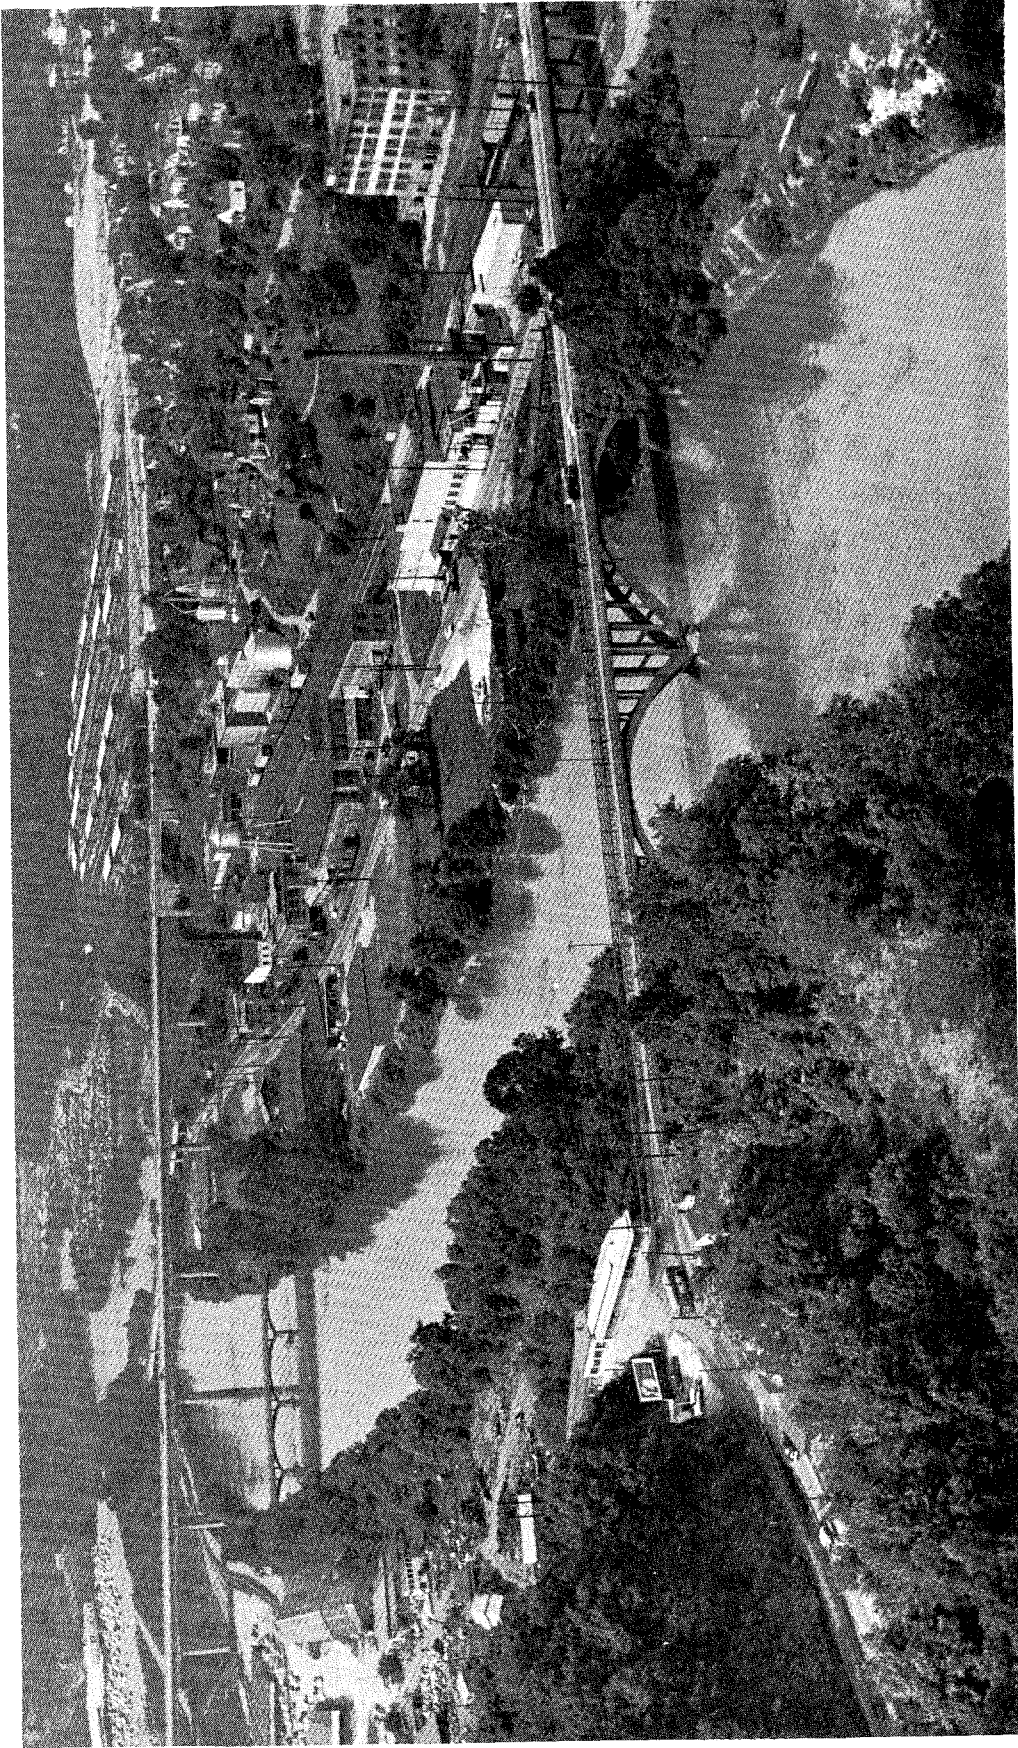
Figure 7. --WEST ASHEVILLE VIADUCT AND FLOOD PLAIN DEVELOPMENT

The viaduct, in the foreground, is at Mile 147.66. It was the only street bridge left at Asheville after the 1916 flood. A recurrence of the 1916 flood would be 24 feet under the bridge floor, but it would flood all of the buildings downstream from the bridge on the right bank riverward from the Earl Chesterfield Mills.

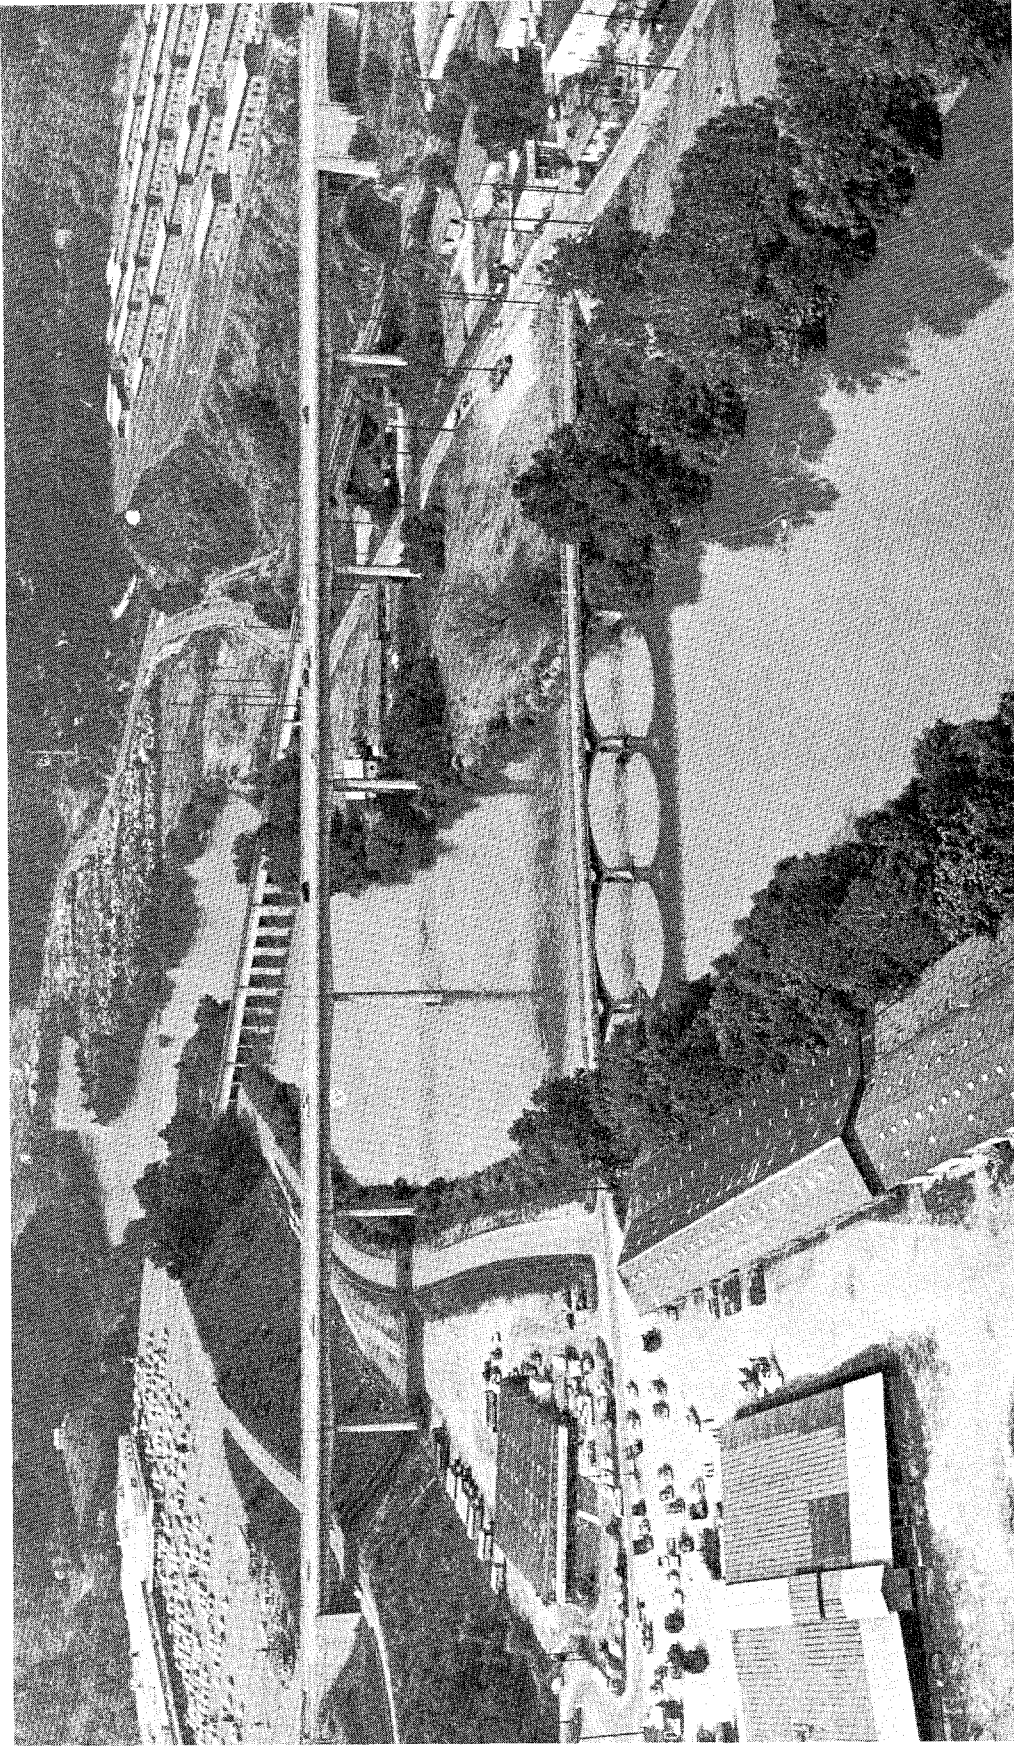
Figure 8. --SMITH, SMOKY PARK, AND SOUTHERN RAILWAY BRIDGES

Smith Bridge, Mile 147.33, was built after the 1916 flood to replace a washed-out steel bridge. It would be overtopped by a recurrence of the flood. Downstream at Mile 147.23, Smoky Park Bridge is new and is well above flood danger. The Southern Railway bridge, Mile 147.08, caught heavy drift during the 1916 flood but was not damaged.

The Southern Railway bridge, Figure 8, is of heavy concrete construction with 22 openings each 30 feet wide. It is built at an angle of about 45 degrees to the flow line of the stream with the left end farthest downstream. In the 1916 flood, debris piled high against the upstream side of the bridge but it withstood the flood without damage. Flood waters headed up about 2.4 feet at the bridge but lacked about 6 feet of reaching track level.

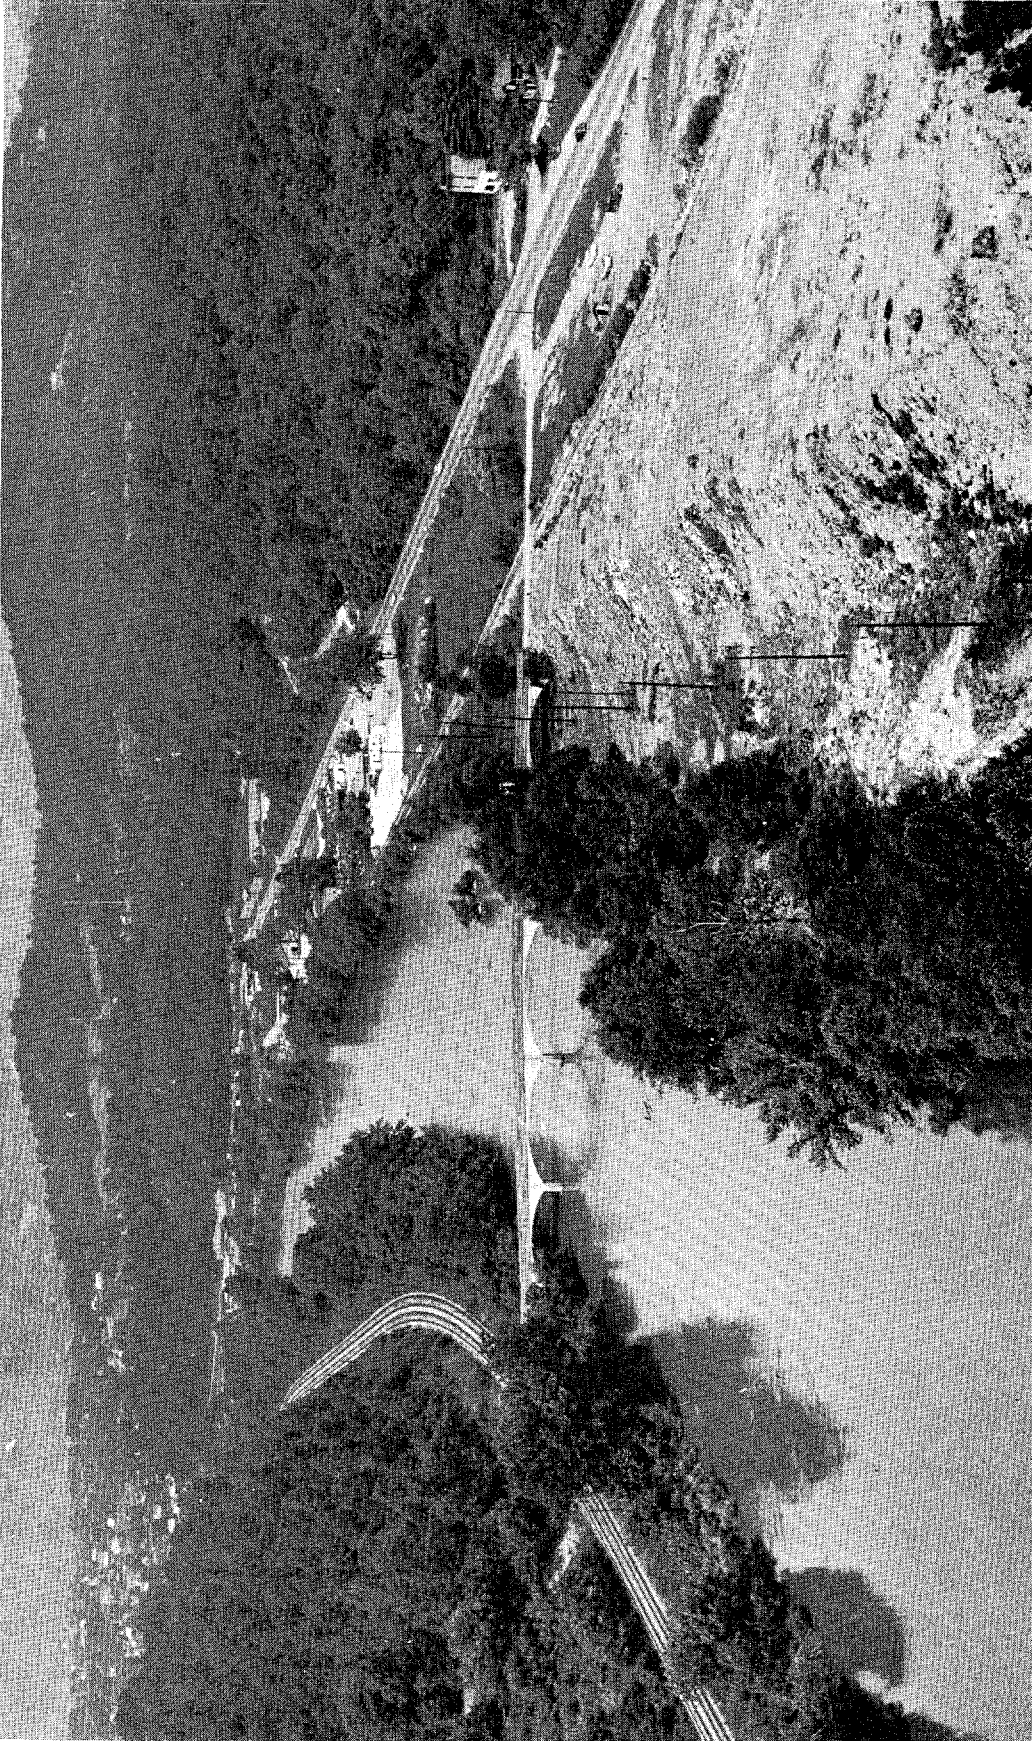
Figure 9. --PEARSON BRIDGE AND LAND FILL

This bridge at Mile 145.75 is another which was built in 1916 to replace a washed-out steel bridge. Because of the high sanitary fill on the right bank just upstream from the bridge, a recurrence of the 1916 flood would be 3 to 4 feet higher in the foreground than the actual flood.

Pearson Bridge, Figure 9, is a concrete arch bridge of five spans built after the 1916 flood to replace the steel truss bridge which was washed out at the time. Like Smith Bridge, the floor of this structure is five feet higher at the center than at the ends. The 1916 flood crest was two feet higher than the roadway at the ends of the bridge and considerably higher than the right bank approach to the bridge. However, because of the land fill on the right bank upstream, a recurrence of the 1916 flood would be 3.7 feet higher than the actual flood just above the bridge.

Since 1944 Asheville has used the land-fill method for disposal of its garbage, the area for disposal until 1960 being the right bank flood plain of French Broad River between the Southern Railway bridge and Pearson Bridge, Figures 9 and 10. This method has materially reduced the cost of garbage disposal for the city, and some 40 acres of land which was formerly idle because of the danger of frequent flooding has been made available for lease and development by commercial enterprises. The operation has altered conditions on the right bank from a point just above the railroad bridge to Pearson Bridge. On the left bank, grading for the Westgate Shopping Center and for a road between Smith Bridge and the railroad bridge, Figure 8, has reduced the overbank area and encroached on the river channel. Improvements to the truck route by-pass on the right bank of the river have resulted in considerable filling between Carrier bridge and Town Branch.

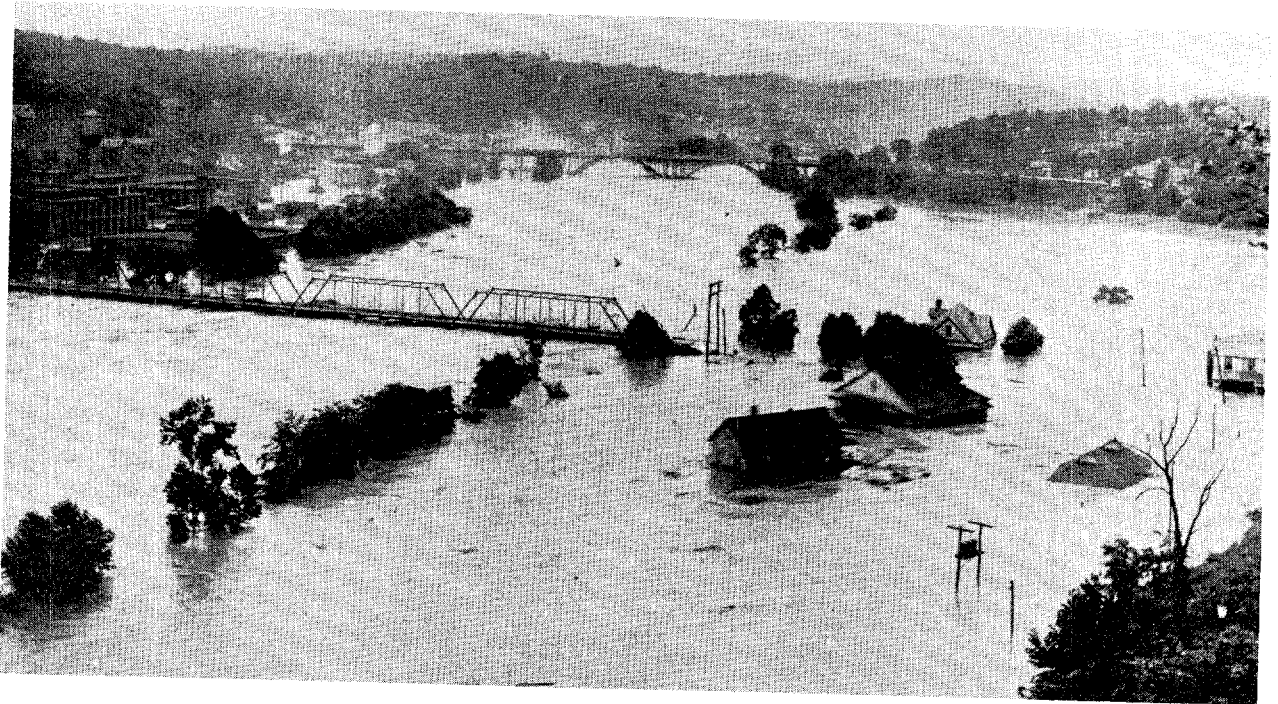
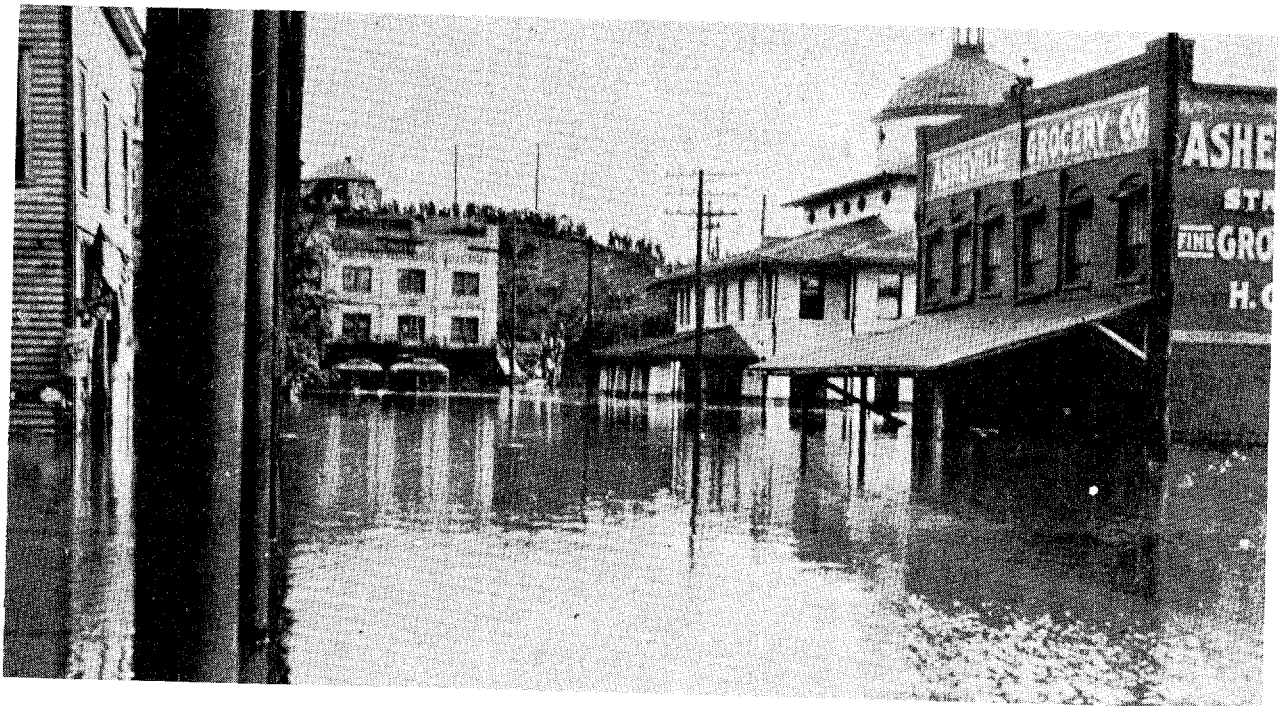
Figure 12. --JULY 1916 FLOOD AT ASHEVILLE

The upper view shows the French Broad River between Smith Bridge, in the foreground, and West Asheville Viaduct. Smith Bridge was washed out later during the flood. The flooded area on the right is now occupied by a Buncombe County garage, tobacco warehouse, livestock market, auto parts firm, and a supply company. The lower view is on Depot Street. The white building on the right is the Southern Railway station.

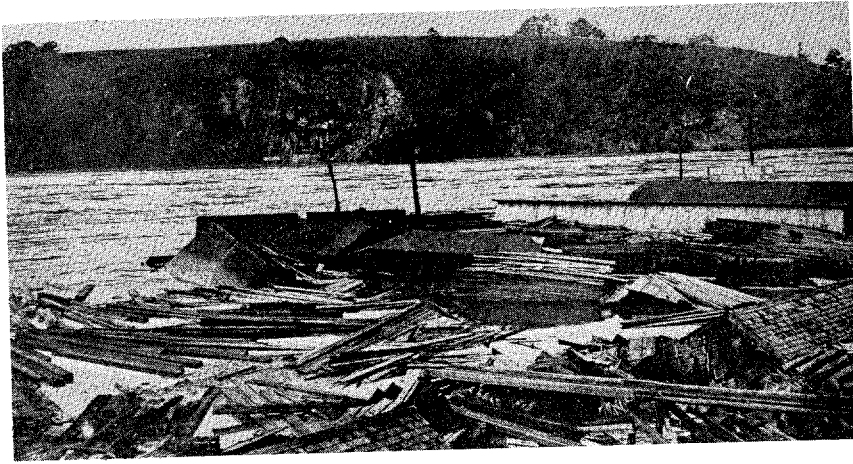
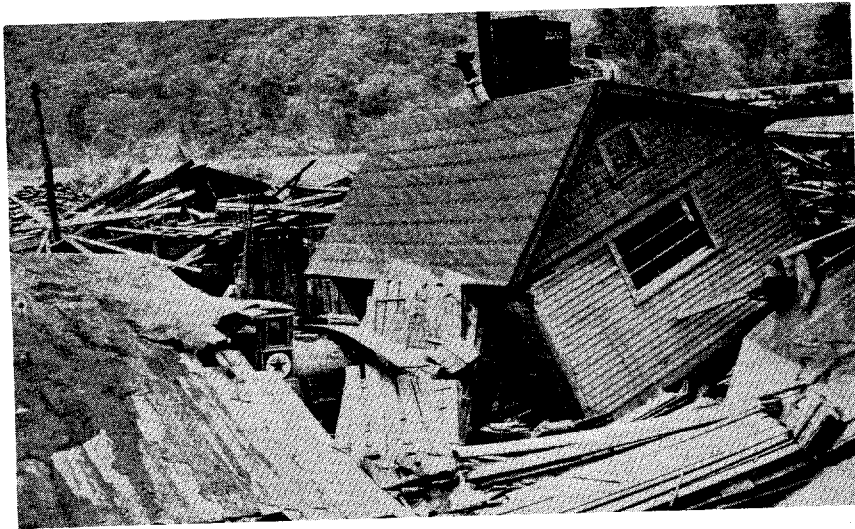
Figure 13. --MANY ASHEVILLE BUILDINGS CARRIED AWAY BY 1916 FLOOD

These three views show the debris of many frame buildings washed away and smashed by the flood. The upper view is at the Southern Coal Company yards; the middle picture is at the Texaco oil yard; the lower view is at the Southern Railway bridge, Mile 147.08.

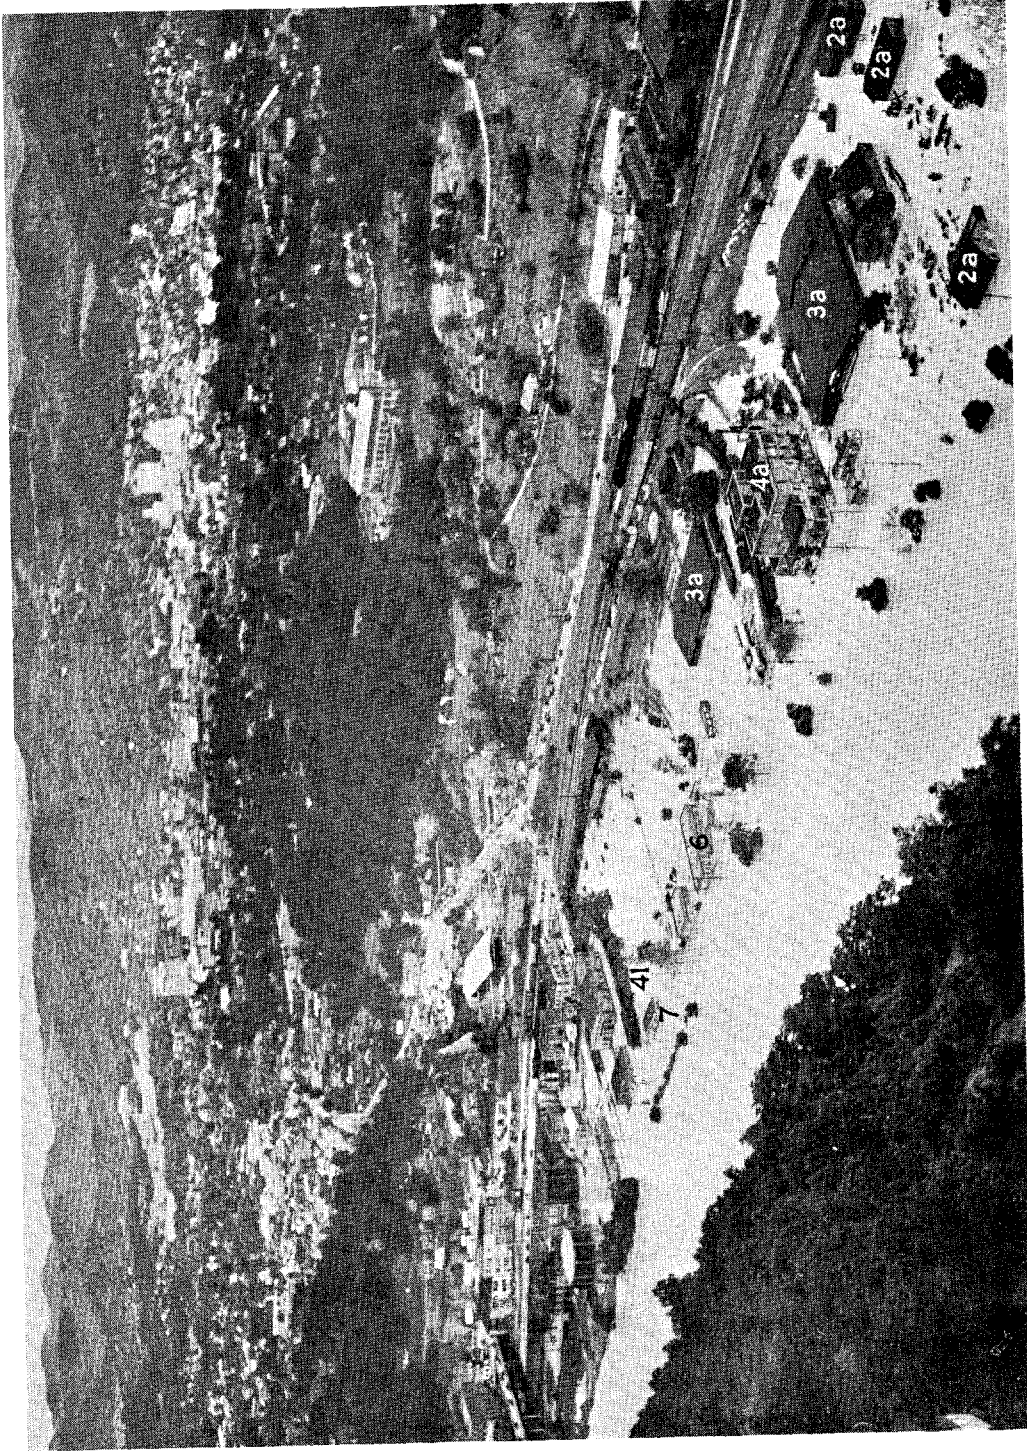
Figure 15. --ASHEVILLE WATERFRONT ON AUGUST 30, 1940

This view is downstream from about Mile 148 toward the West Asheville Viaduct. Buildings shown are: No. 2a, Hildebrand Machine Company; No. 3a, Asheville Livestock Yards; No. 4a, S. Sternberg Company, now the Kahn Company; No. 6, the Texas Company; No. 7, Post Machinery Company; No. 41, the Carolina Coal and Ice Company.

On the French Broad River the crest stage was 0.5 foot higher than on August 14 and damage was essentially a repetition of that in the earlier flood. Figure 15 shows the Asheville waterfront during the flood. Swannanoa River was 3.7 feet lower at Biltmore than in the August 13 flood and damage was moderate, amounting in most cases to reflooding of goods which were already damaged from the first flood. The frontispiece, Figure 1, shows the overflow at Biltmore.

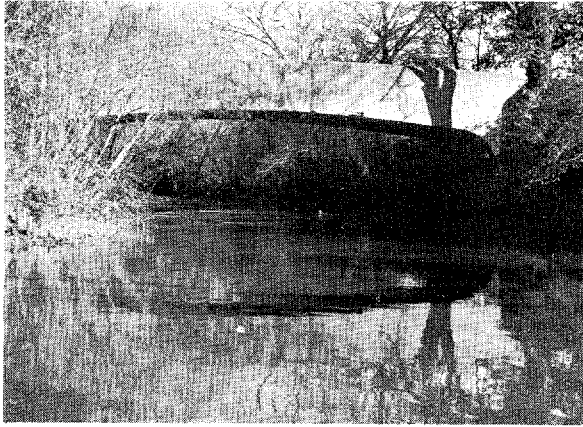
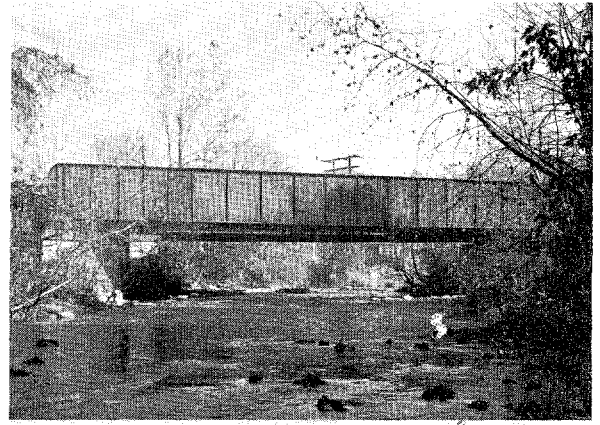
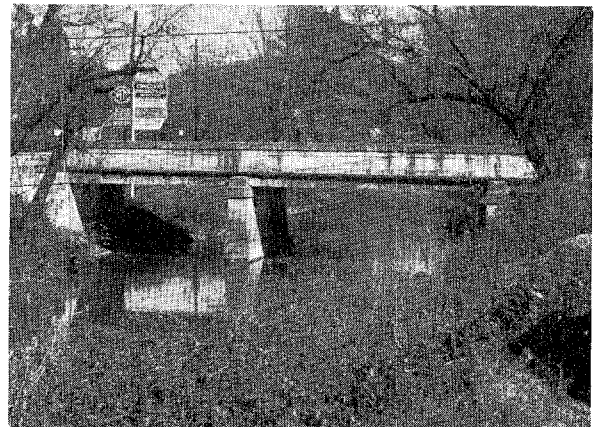
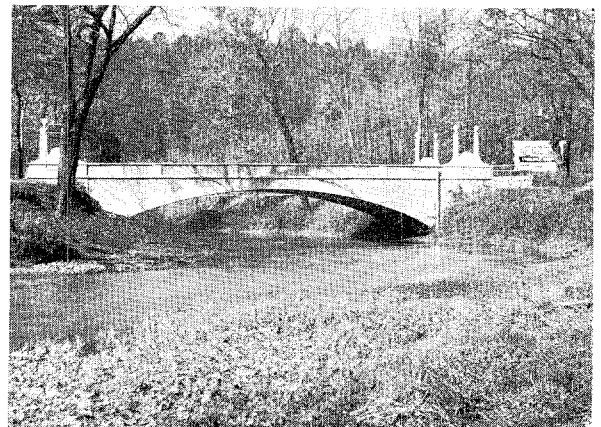
Biltmore Estate bridge, Mile 0.68,
downstream side

Southern Railway bridges, Mile 1.51,
downstream side

Glendale Avenue bridge, Mile 2.66,
downstream side

Sayles Bridge, Mile 3.53,
upstream side

All six of these bridges would be overtopped by a recurrence of the July 1916 flood. The high McDowell Street Viaduct, Mile 1.47, is shown in Figure 21.
