**FLOODS
ON
FRENCH BROAD
AND
SWANNANOA
RIVERS**

**VICINITY
OF
ASHEVILLE
NORTH
CAROLINA**

**TENNESSEE
VALLEY
AUTHORITY**

REPORT NO. 0-5975

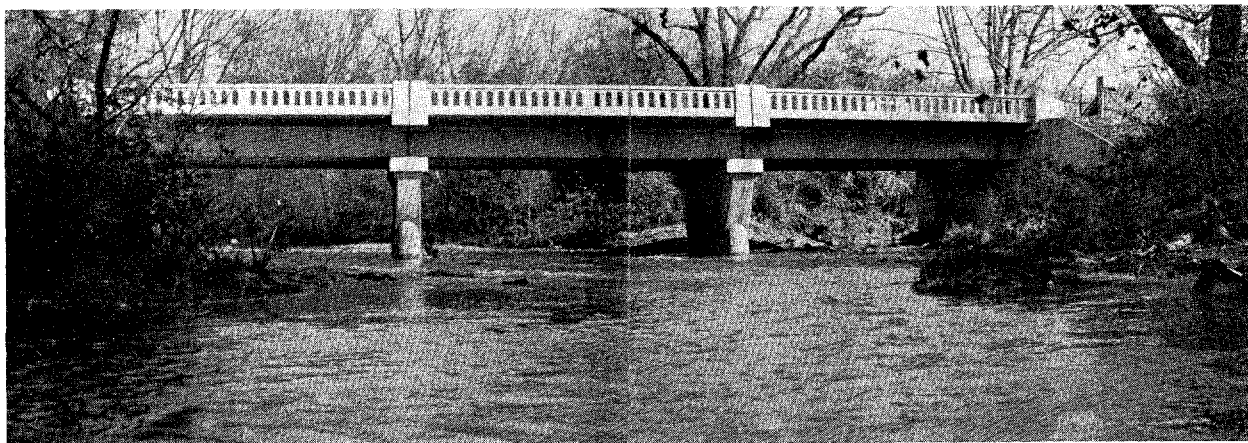
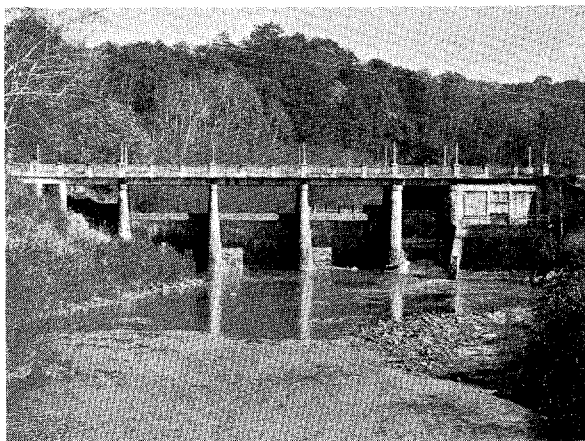
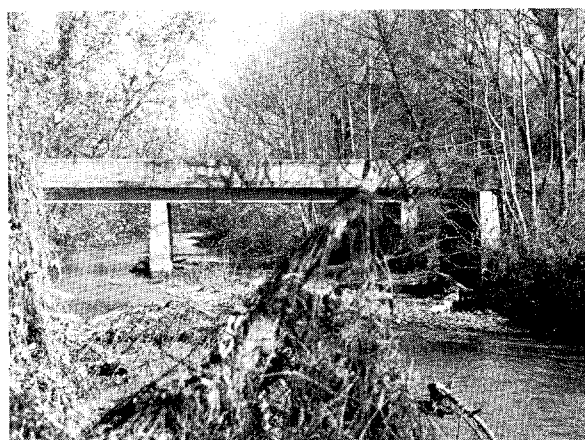
U. S. Highway 74 bridge, Mile 4.35, upstream side

Asheville Recreation Park dam and bridge, Mile 5.12

Azalea Bridge, Mile 6.97, downstream side

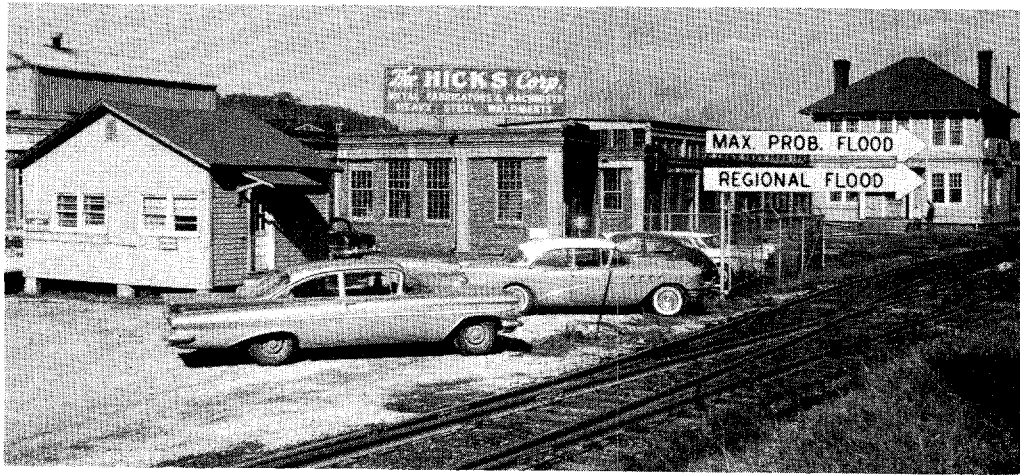
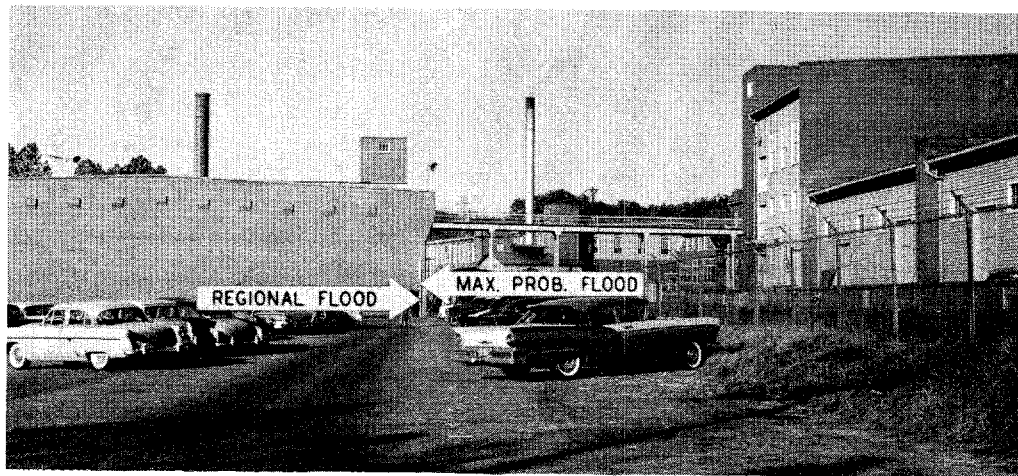
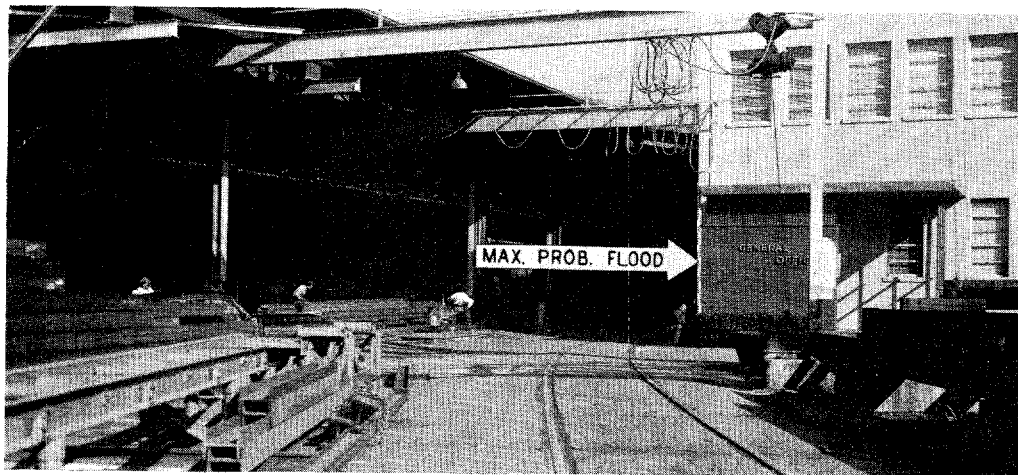
Figure 24. --ASHEVILLE INDUSTRIES ON FRENCH BROAD RIVER FLOOD PLAIN

The upper view is the Hicks Corporation plant on the right bank of the French Broad River at Mile 145. The middle view shows the Burlington Mills plant 2.5 miles farther downstream. The lower view shows the Dave Steel Company at Mile 147.78. This is Building No. 256 shown on Plate 11. Arrows show the heights of the Regional and Maximum Probable Floods at each location.

The profiles of the Regional Floods on the French Broad River and the Swannanoa River are shown on Plate 12. Figures 24 to 26 show the heights that would be reached by the Regional and Maximum Probable Floods at various locations along the French Broad River. Figures 27 to 29 show similar views along the Swannanoa River.

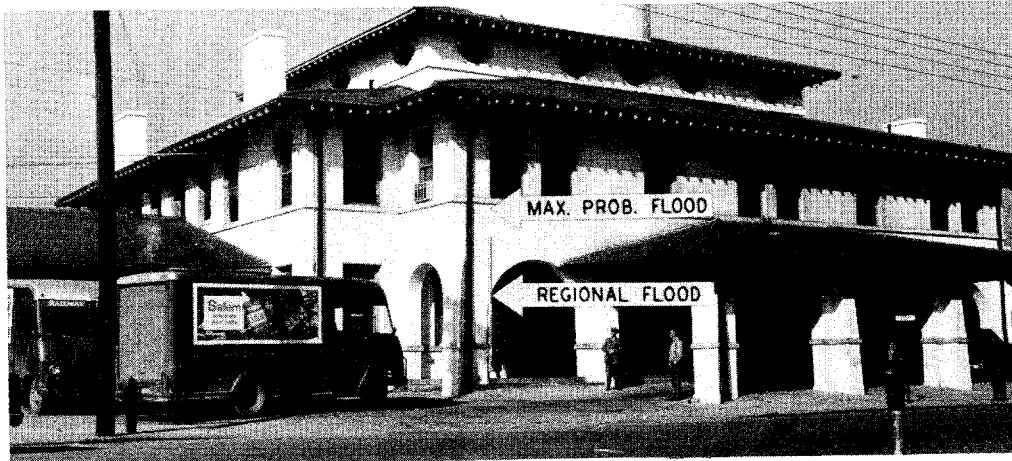
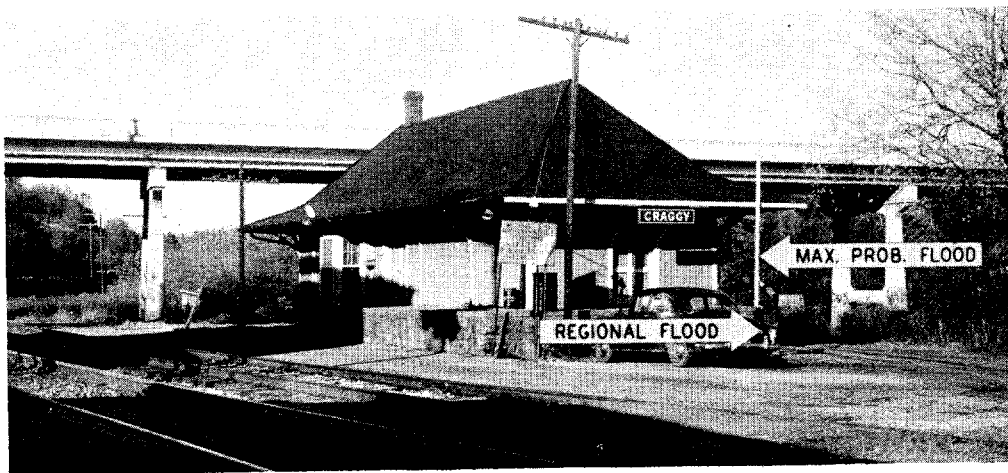
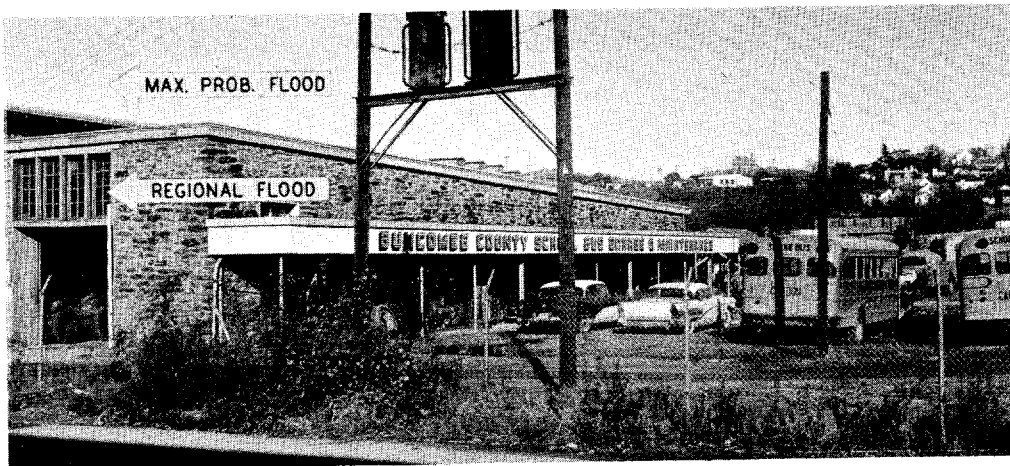
Figure 25. --SOUTHERN RAILWAY DEPOTS
AND SCHOOL BUS GARAGE

The upper view shows the Asheville station of the Southern Railway at Mile 148.08, Building No. 180 on Plate 11. The Craggy depot in the middle view is on the left bank 5 miles downstream, just above the Craggy Bridge. The lower view shows the Buncombe County school bus garage, Building No. 286, on the left bank at Mile 147.28. Arrows show the heights of the Regional and Maximum Probable Floods at these places.

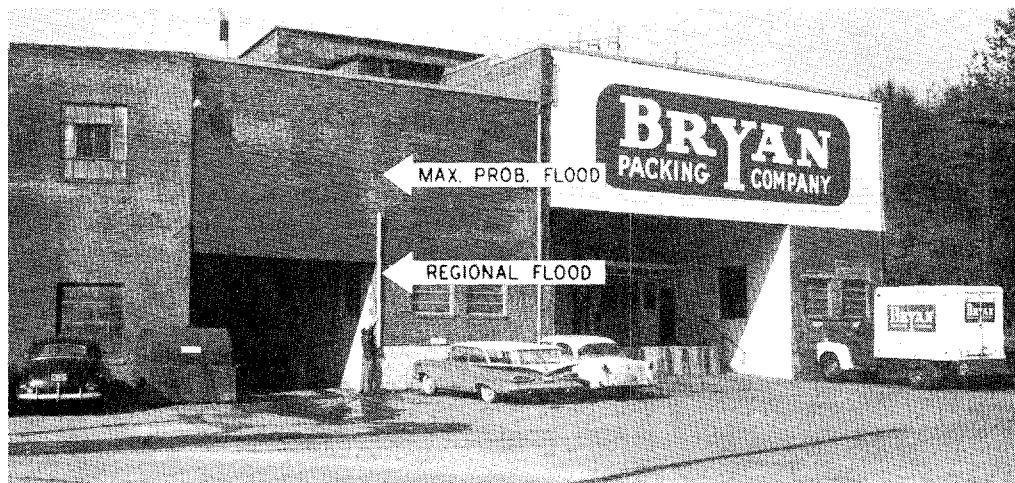
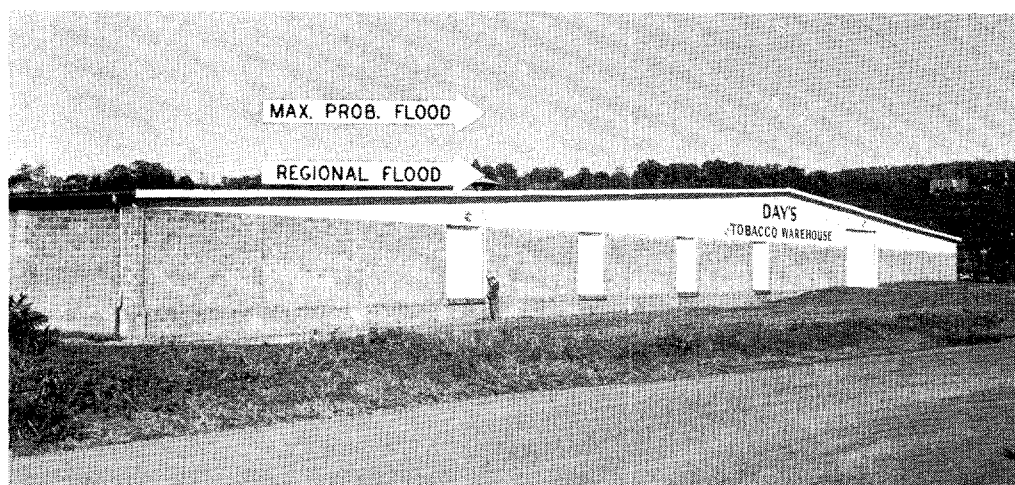
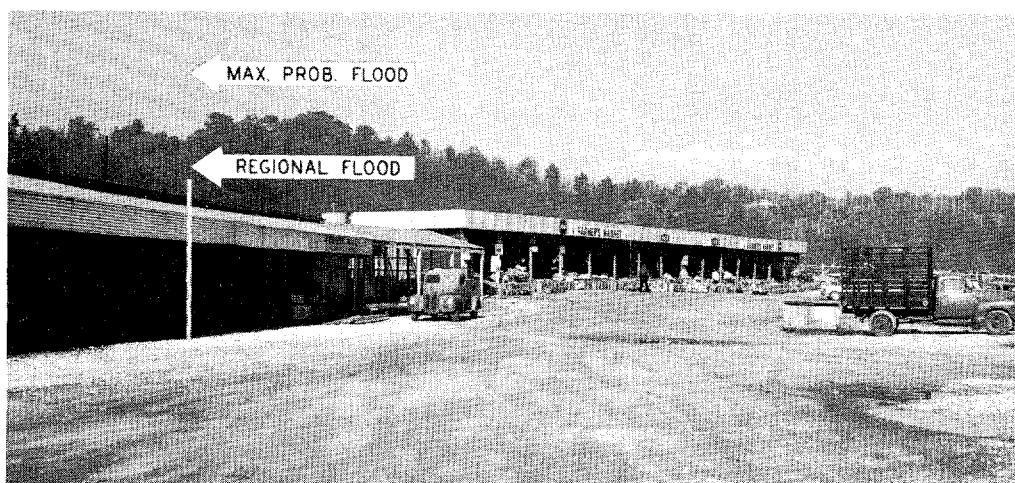
Figure 26. --ASHEVILLE FLOOD PLAIN DEVELOPMENTS

The Bryan Packing Company in the upper view is Building No. 285 at Mile 147.31. Day's Tobacco Warehouse, Mile 148.22, is shown as Building No. 177 on Plate 11. The lower view shows Farmer's Market, located on the new land fill on the right bank at Mile 146.23. Arrows show the heights of the Regional and Maximum Probable Floods at the three locations.

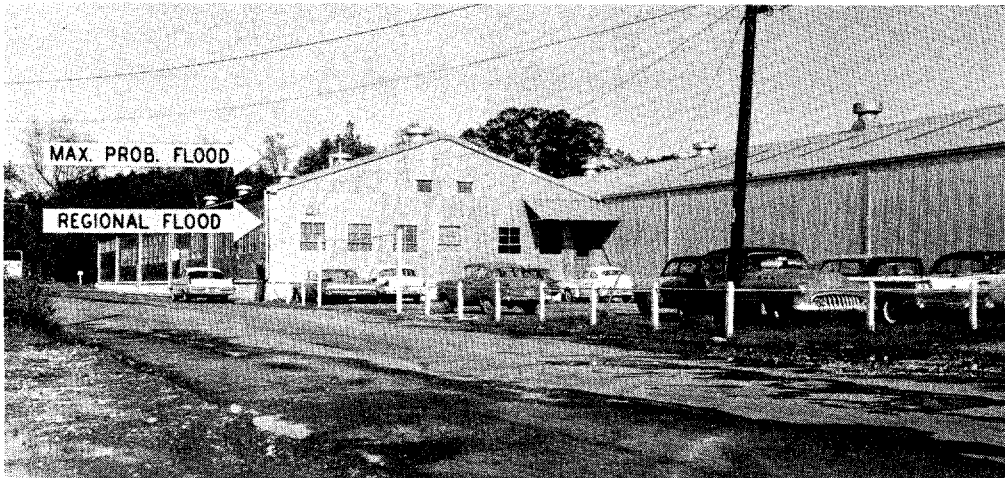
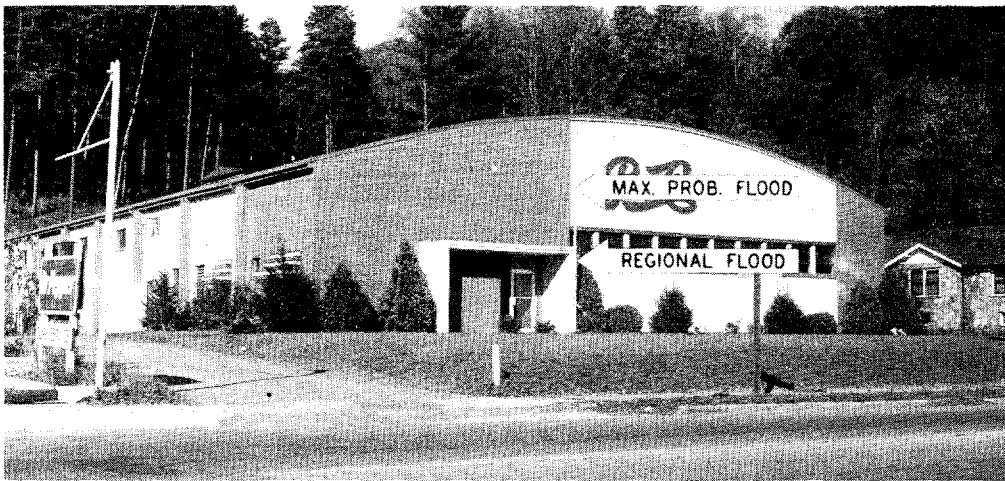
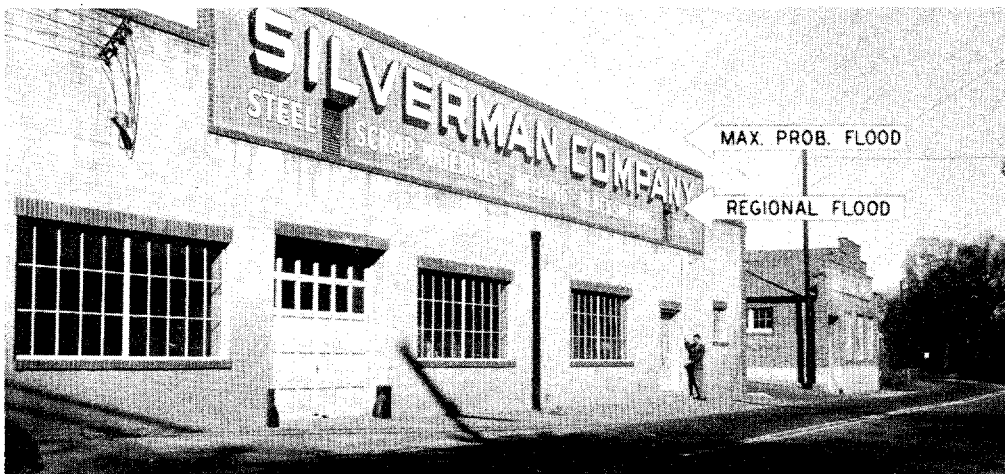
Figure 27. --INDUSTRIES ON SWANNANOA RIVER FLOOD PLAIN

Three Mountaineers, Inc., in the upper view is in the Koon Development, Building No. 4 on Plate 15. The middle view is the Pepsi-Cola Bottling Company at Mile 3.30 on the right side of the river. Silverman Company in the lower view is on the right side of the river, Mile 1.80, Building No. 63 on Plate 15. Arrows show the heights of the Regional and Maximum Probable Floods.

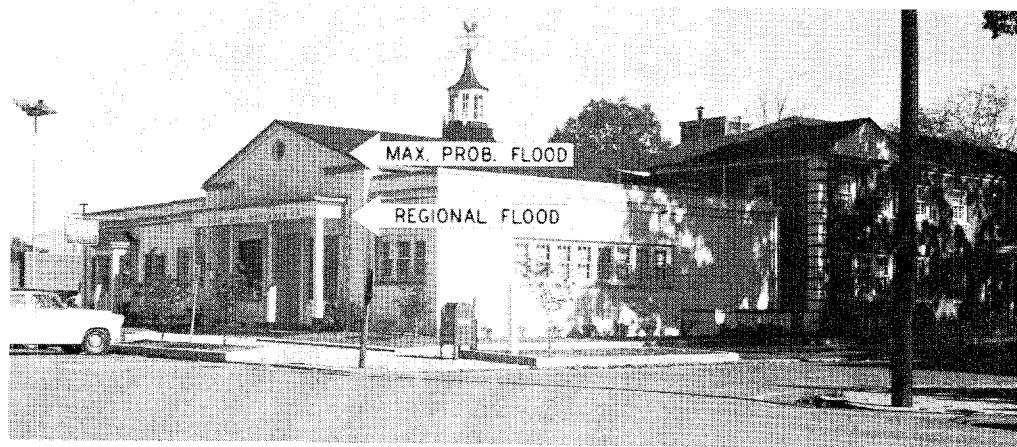
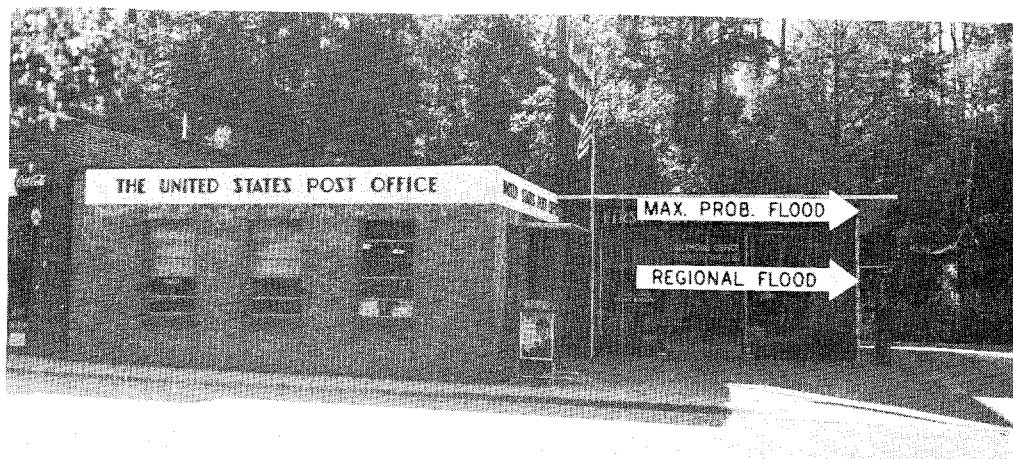
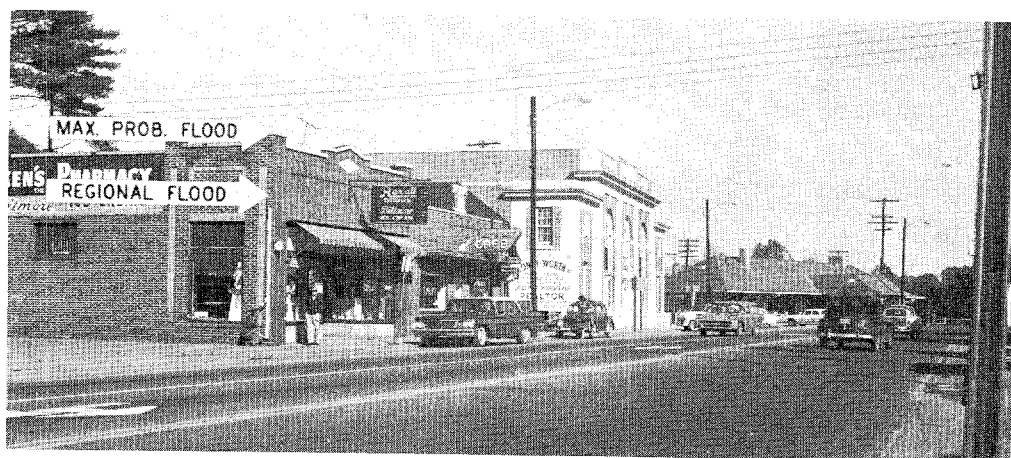
Figure 28. --OFFICE BUILDING, POST OFFICE, AND STORES
IN BILTMORE

Building No. 102, in the upper view, is the Pilot Life Insurance Company office building on Biltmore Plaza. In the middle view is the Biltmore Branch of the Asheville Post Office and the Biltmore office of the First Union National Bank, Buildings Nos. 143 and 142, respectively, on Plate 15. The lower view, east along Brook Street, shows Buildings Nos. 115, 114, 108, and the Biltmore railway depot in the background. Arrows show the heights of the Regional and Maximum Probable Floods at each location.

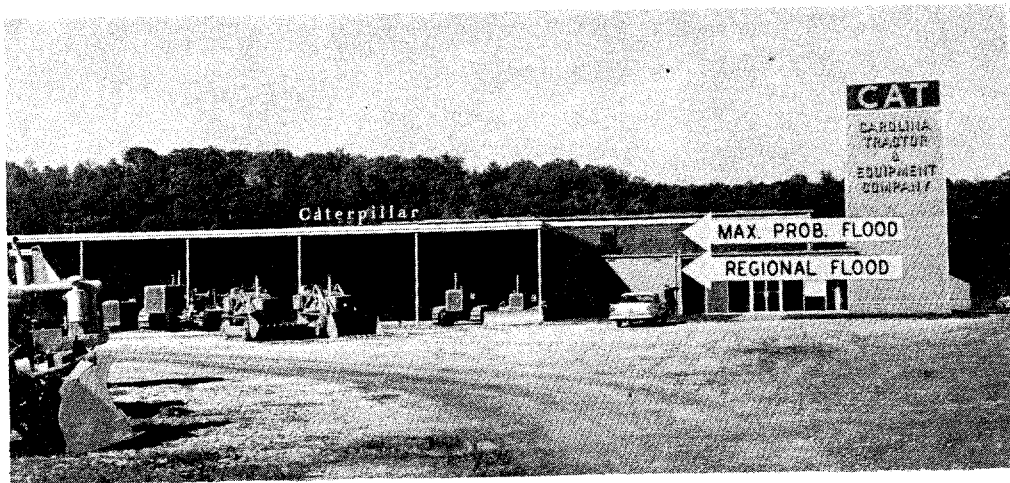
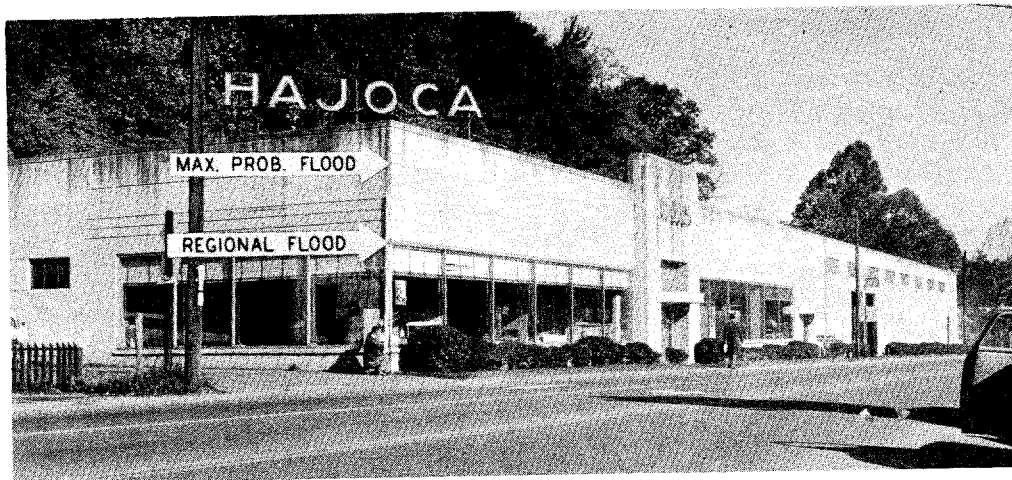
Figure 29. --BUILDERS' SUPPLY FIRMS ALONG SWANNANOA RIVER

Building No. 61, Carolina Tractor and Equipment Company at Biltmore, is in the upper view. The Hajoca Corporation, distributors of plumbing supplies, is Building No. 91 on Plate 15 and is located just above Biltmore Avenue on the right side of the river. The lower view shows part of the Asheville Concrete Materials Company plant, Building No. 159, on the right-bank flood plain near Mile 1.0. Arrows show the heights of the Regional and Maximum Probable Floods.

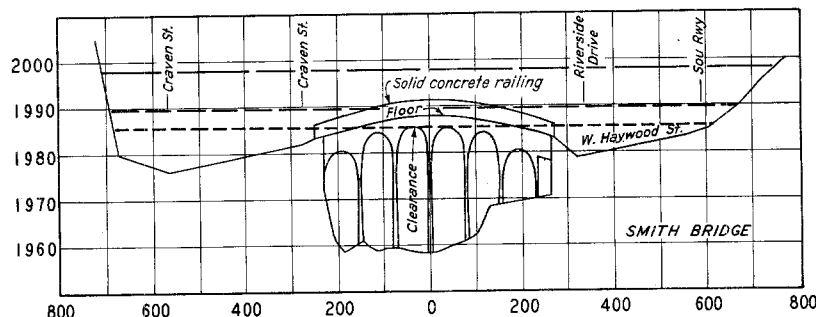
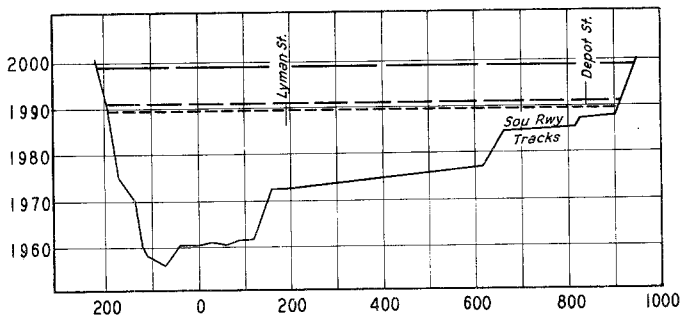
VALLEY CROSS SECTIONS
FRENCH BROAD RIVER
VICINITY OF
ASHEVILLE, NORTH CAROLINA
DECEMBER 1960

SECTION 14 - MILE 146.76

SECTION 18 - MILE 147.33

SECTION 20 - MILE 147.88

Plate 13 shows typical cross sections of the French Broad River valley in the Asheville vicinity. The location of the cross sections is shown on the map and profile, Plates 10 and 12. Each cross section shows the elevation and extent of overflow of the actual flood of 1916 and of the Regional and Maximum Probable Floods. The Regional Flood elevation is the same as the 1916 flood would be under present conditions. A number of cross sections, the locations of which are shown on the map and profiles, are not reproduced but are available from the Hydraulic Data Branch of TVA to anyone who has need for them.
