TENNESSEE VALLEY
AUTHORITY

FLOODS ON PIGEON RIVER
IN VICINITY OF
CANTON & CLYDE, NORTH CAROLINA

REPORT NO. 0-5866

FEBRUARY 1959

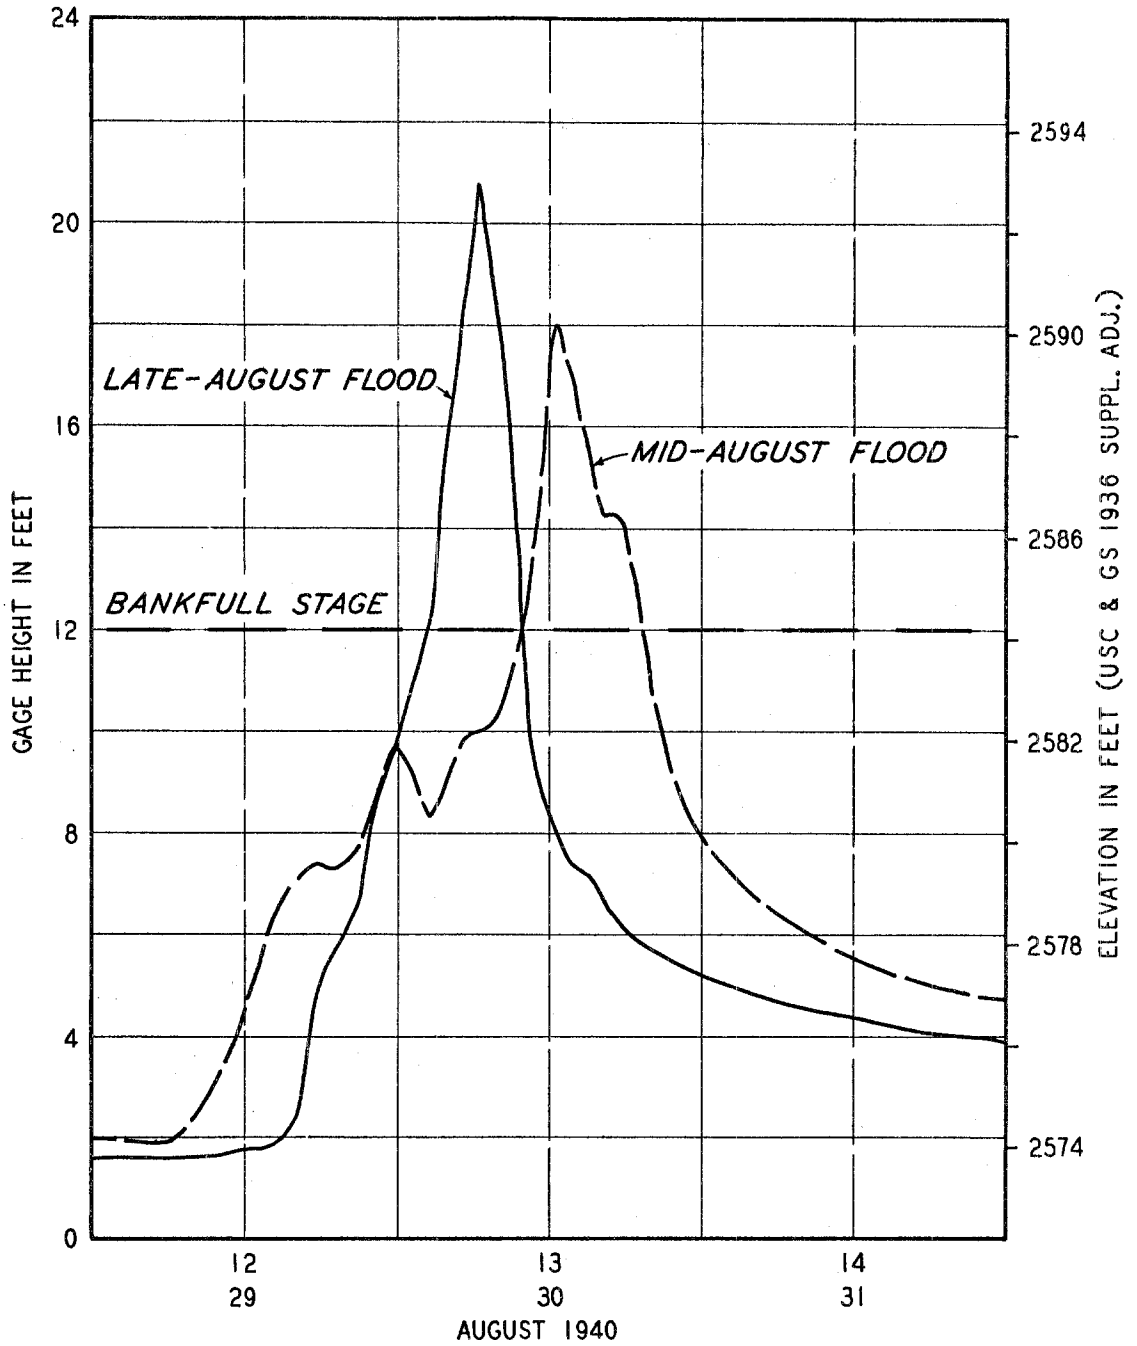
STAGE HYDROGRAPHS
PIGEON RIVER
AT CANTON, NORTH CAROLINA

(a) Staff gage record

(b) Recording gage record

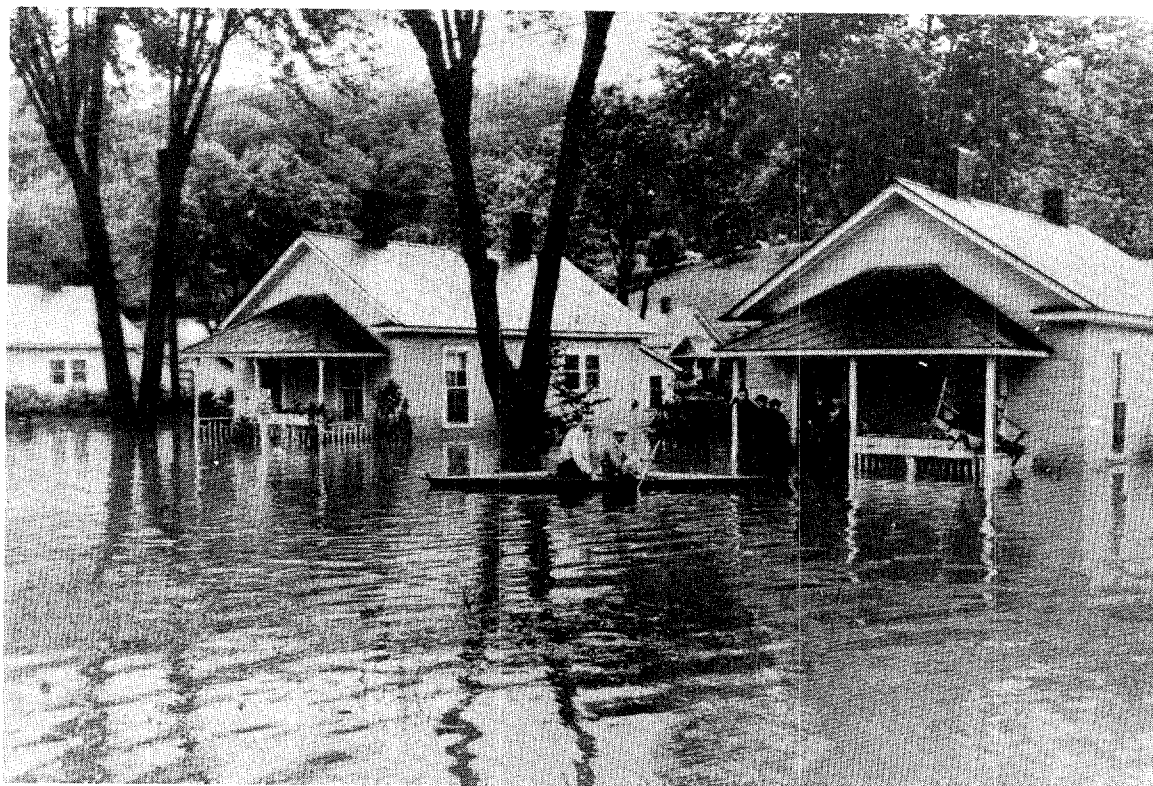
Figure 5.--HIGH WATER IN CANTON, JUNE 1949

Homes in the Fibreville section of Canton were overflowed on the afternoon of June 16. The crest of the flood is indicated by the dark stains on the houses. The 1940 flood reached nearly to the eaves of these houses.

At Fibreville 6 houses were flooded and a suspension type foot-bridge was washed out. Figure 5 shows flooded houses in this area. The local National Guard Company had been organized in the emergency and assisted in the evacuation of 15 families in advance of the flood.

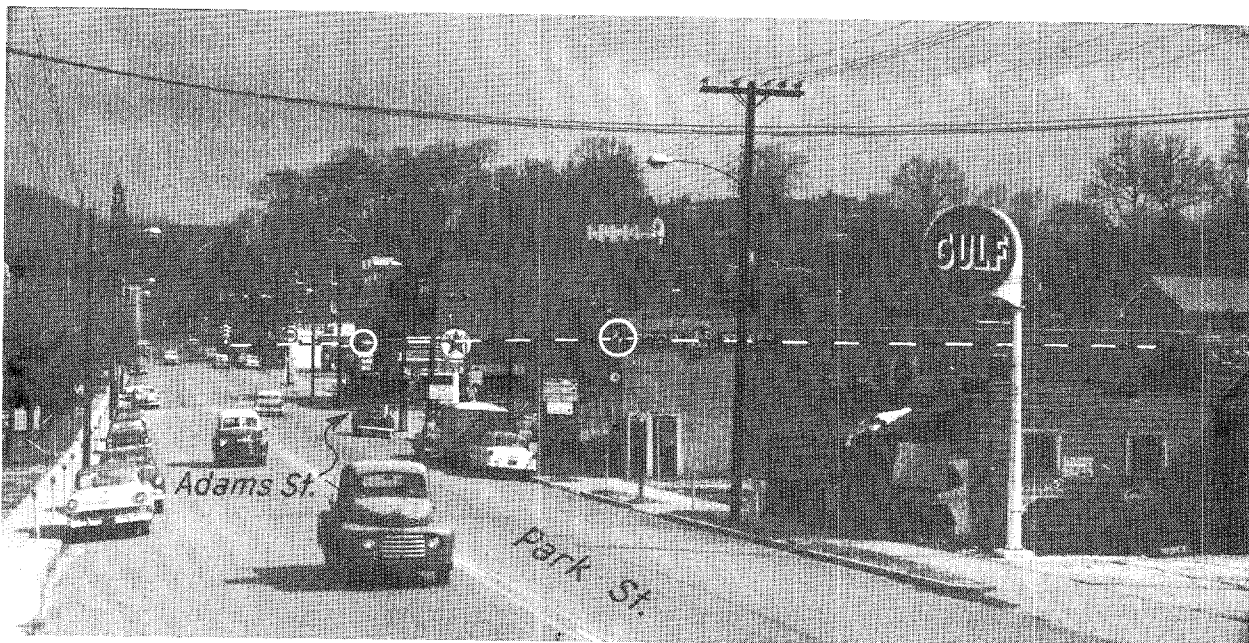
Figure 6.--PARK STREET, CANTON, COULD BE DEEPLY FLOODED

This view east from Pigeon River bridge along U. S. Highways 19 & 23 (Park Street) shows the depth to which the Maximum Probable Flood could inundate this part of Canton. The rod targets indicating the height of such a flood are in the centers of the white circles on photograph.

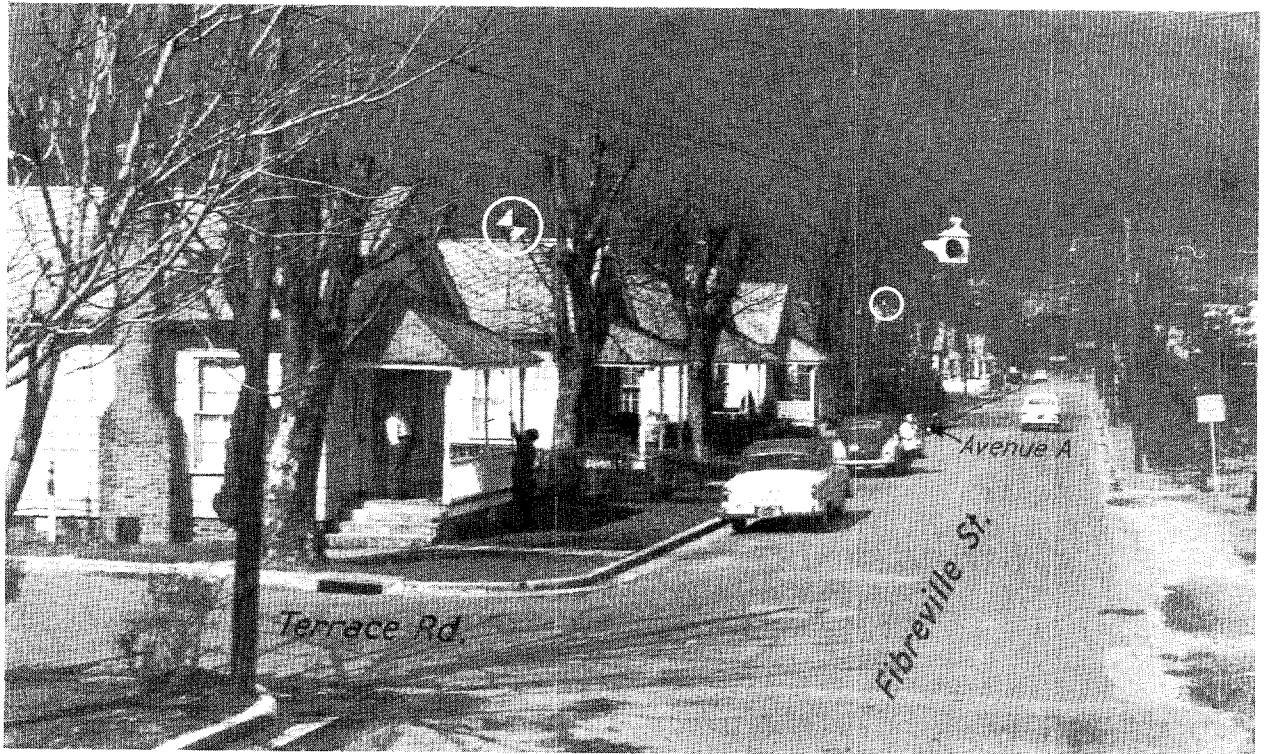
Figure 9.--CEILINGS IN FIBREVILLE COULD BE SUBMERGED

Northbound view of Fibreville Street at intersection of Terrace Road. The Maximum Probable Flood level, which is about 5 feet above the edges of these porch roofs, is shown by the targets. The distant target is just beyond Avenue A.

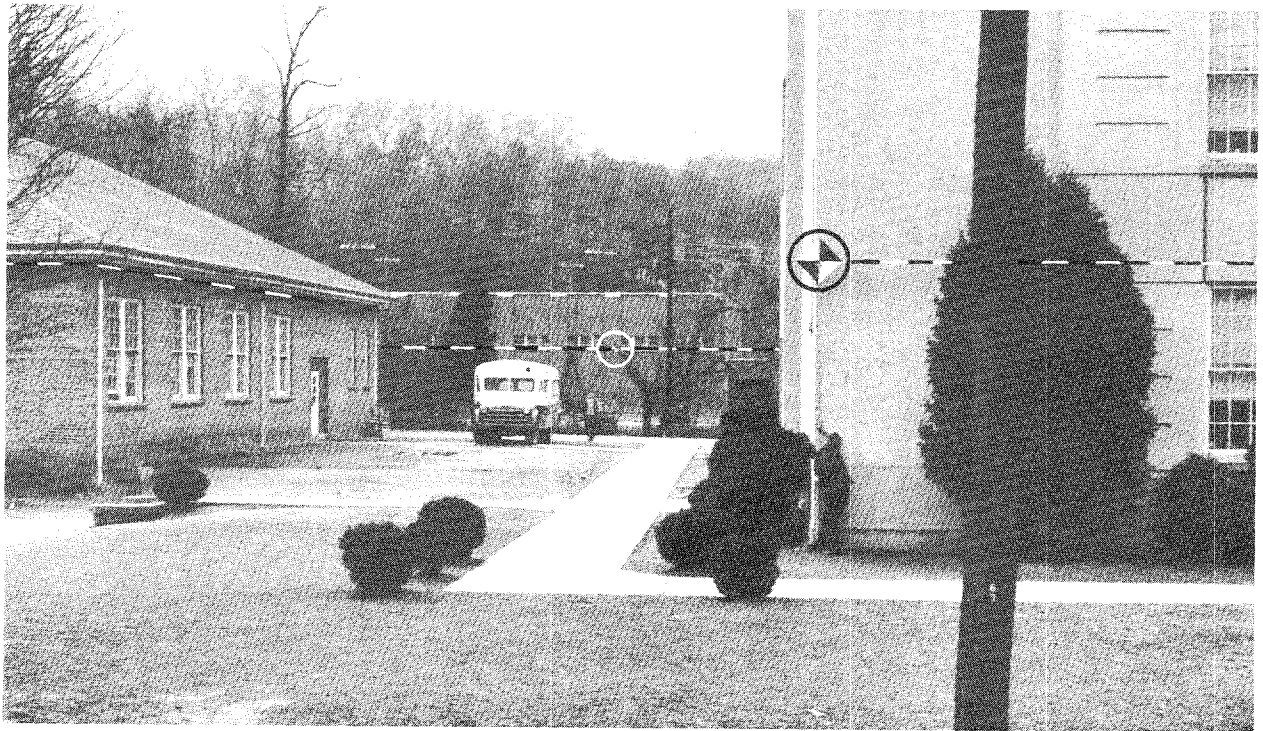
Figure 11.--PIGEON RIVER FLOWS BETWEEN CLYDE SCHOOL AND ITS GYMNASIUM

These school buildings are accessible from each other by a footbridge concealed in background. Maximum Probable Flood lines are drawn through rod targets encircled in white against the gymnasium, across the river, and in black against the schoolhouse.
