TENNESSEE VALLEY AUTHORITY
DIVISION OF WATER CONTROL PLANNING

FLOODS
ON
LITTLE TENNESSEE RIVER
CULLASAJA RIVER
AND
CARTOOGECHAYE CREEK
IN VICINITY OF
FRANKLIN, NORTH CAROLINA

REPORT NO. 0-6193

KNOXVILLE, TENNESSEE
MARCH 1963

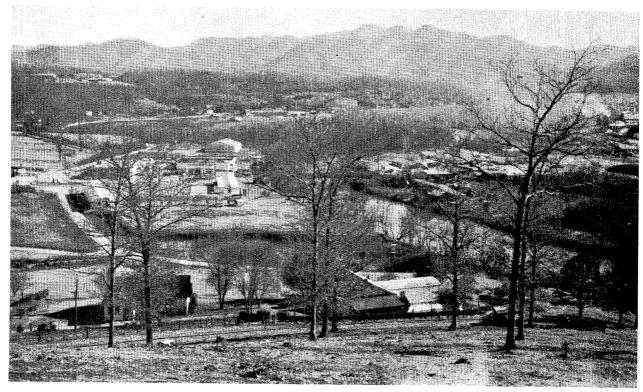
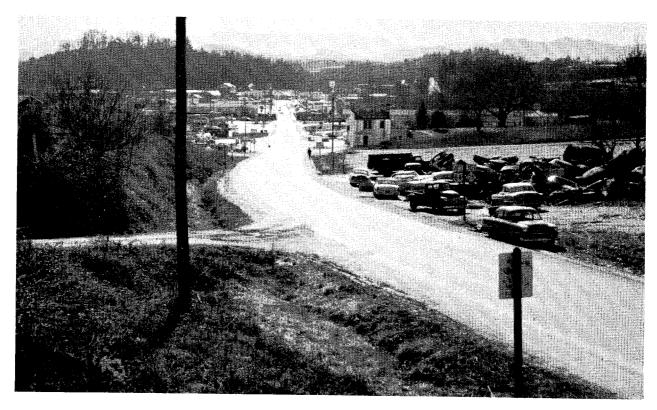
Figure 1. --THE LITTLE TENNESSEE FLOOD PLAIN IN FRANKLIN

Upper view is south or upstream from the hillside on right bank of river. The main highway bridge is partly concealed by treetops in center of picture. Motel shown in Figure 15 is at left center, and the airport is in background. Lower view is southwest along East Main Street (U. S. Highway 23, 64, 441) from a point about 1300 feet from the bridge, which can be seen in background.

Plates 7 and 8 show the flood plain of Little Tennessee River for the reach covered by this investigation. Figure 1 shows views of the flood plain in Franklin. Except for the land inundated by the reservoir above Franklin Dam and that in the immediate Franklin area, use of land in the flood plain is principally agricultural.

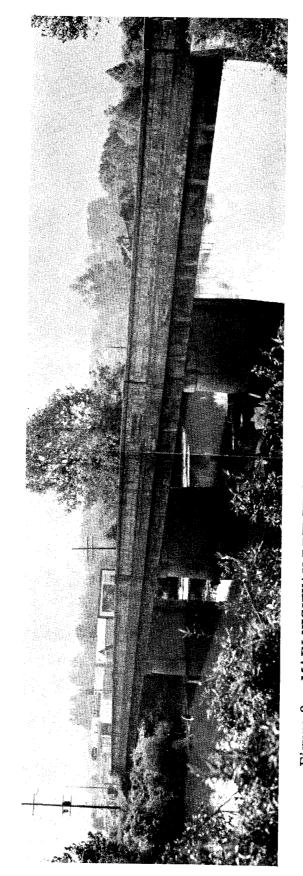
Figure 2. --MAIN HIGHWAY BRIDGE OVER LITTLE TENNESSEE RIVER AT FRANKLIN

View from right bank toward bridge which carries U. S. Highway 23, 64, 441. The river here, at Mile 116.55, is in backwater from Franklin Dam 3.4 miles downstream.

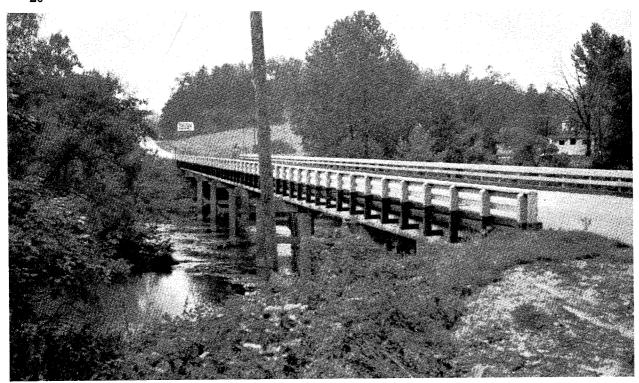
Figure 3. -- N. C. HIGHWAY 28 BRIDGE AT IOTLA

The view is from right bank of the Little Tennessee River at Mile 110.30. The bridge has steel girders and a black-topped wood floor.

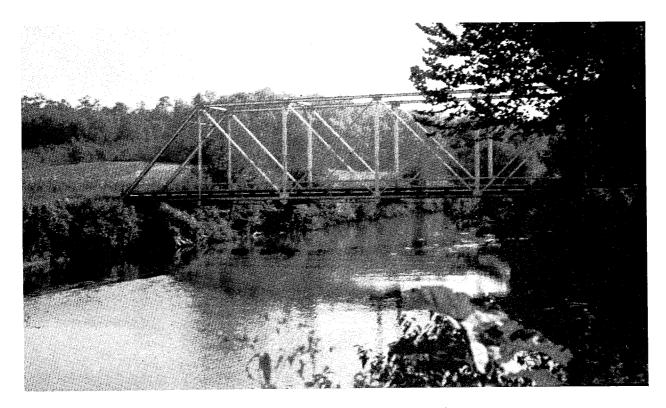
Figure 4. --PHILLIPS BRIDGE IN FRANKLIN

The view is upstream from left bank of the Little Tennessee River at Mile 117.57.

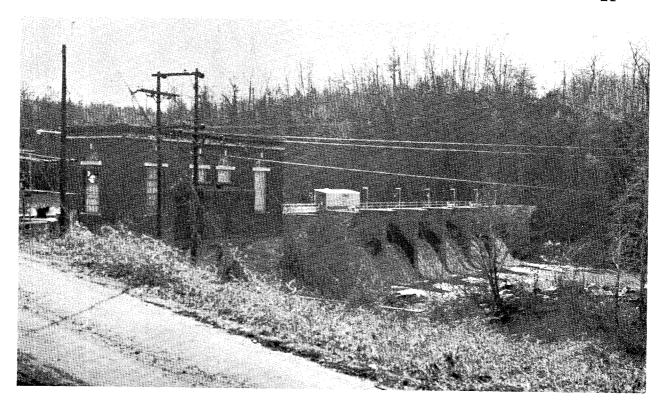
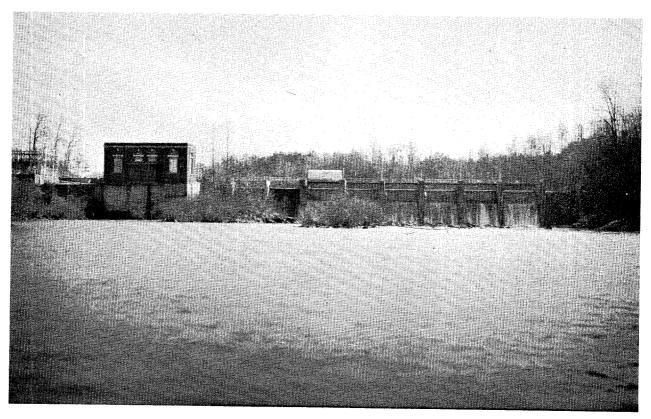
Figure 5. --FRANKLIN DAM, 3 MILES BELOW THE CITY

This dam at Mile 113. 10, otherwise known as Porters Bend Dam, is operated by the Nantahala Power and Light Company. Backwater from the dam at normal full pool extends beyond the upper corporate limit of Franklin.

Franklin Dam, Figure 5, also known locally as Porters Bend Dam, is a concrete masonry structure at Mile 113.11, built by the town of Franklin in 1925. Purchased by the Nantahala Power and Light Company in 1933, it is now operated as part of the company's electric generating system. The dam is 462 feet long, and has a maximum height of 35 feet and an effective height of 26 feet. Six Tainter gates 25 feet wide by 10 feet high regulate discharge at the dam. Two fixed spillway bays at each end of the Tainter gate section provide additional spillway capacity. The dam was altered in 1944 to raise the pool level one foot. Float-operated controls and electric gate hoists give a degree of automatic spillway gate operation. A powerhouse at the right end of the dam contains two generating units rated at 650 kva each. Backwater from the dam, at top-of-gate elevation, extends upstream to Mile 118.5, beyond the upper corporate limit of Franklin, a distance of 5.4 river miles. The reservoir is now almost completely filled with sediment, so that normally water is only 2 or 3 feet deep over much of the reservoir.

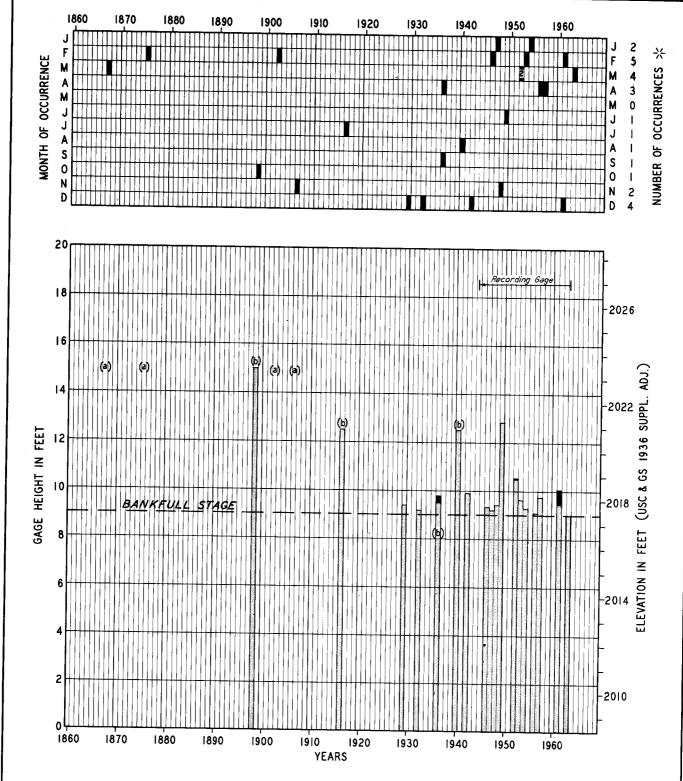
FLOODS ABOVE
BANKFULL STAGE
LITTLE TENNESSEE RIVER
NEAR PRENTISS, N.C.

- (a) Stage unknown.
- (b) Estimated from high water marks.
- Number of occurrences during period 1867 through March 1963.
 Stream gage located at River Mile 119.47.

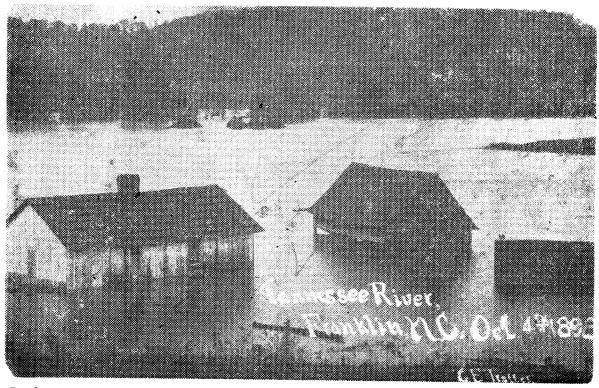
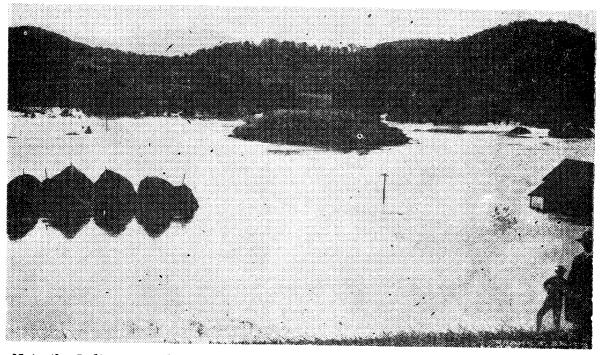
Figure 6. --LITTLE TENNESSEE RIVER FLOOD OF OCTOBER 4, 1898

In the pictures above and below, it's the Little Tennessee at Franklin on rampage. Since older people here can first remember, the river has occasionally flooded the lowlands. This photo is of what is said to have been the worst flood in the Little Tennessee's history, in the fall of 1898. (Picture above loaned by Mrs. Belle Liner).

Note the Indian Mound, almost covered, and telephone pole with only a few feet above the water. (Photo loaned by Miss Lassie Kelly).

These pictures are reproduced from <u>The Franklin Press and The Highlands Maconian</u> of June 16, 1955, and accompanied an editorial entitled "Out of the Past . . . Today". The paper was a centennial edition. A postal card containing the lower view was lent to the TVA by Miss Lassie Kelly of Franklin and bore the title "River Overflow, Looking from East Main Street, Franklin, N. C." The photographer was Frank T. Smith of Franklin.

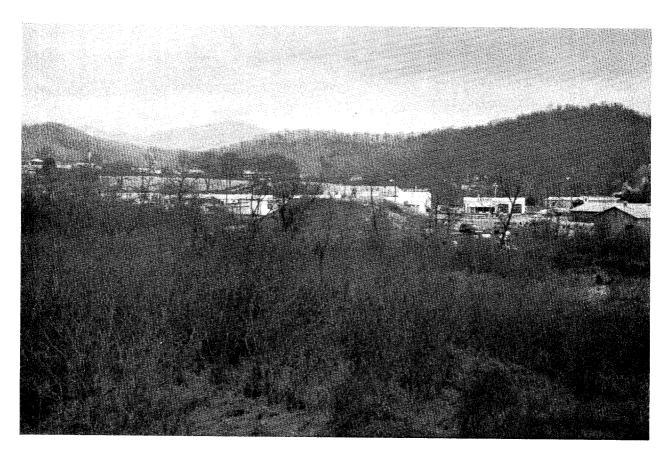
Figure 7. --VICINITY OF THE INDIAN MOUND, 1963

The picture above was taken from substantially the same point as was the lower view in the old newspaper photographs at left, and shows some of the buildings that would be inundated by a recurrence of the 1898 flood.

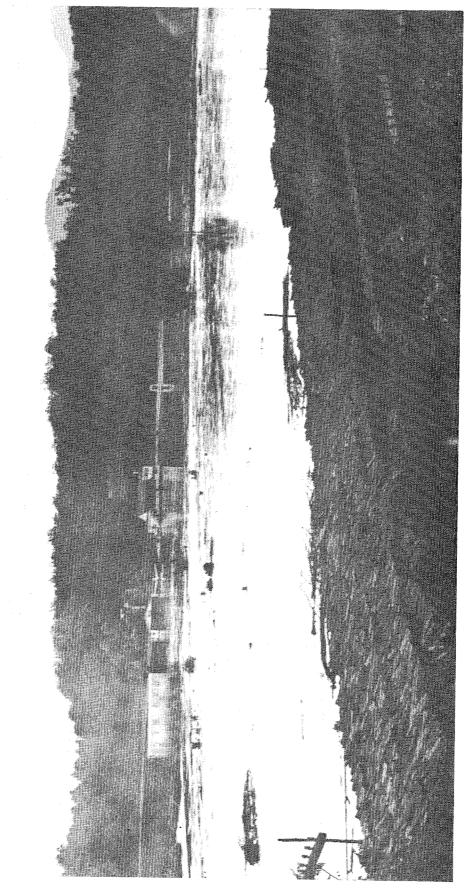
Figure 8. --FRANKLIN AIRPORT FLOODED, JUNE 16, 1949

This view is southeast across the Little Tennessee River near the crest of the flood. A storage yard of logs awaiting shipment to paper mills appears in the foreground between the river and the Tallulah Falls Railroad, now abandoned. The loss of wood amounted to about ten carloads.

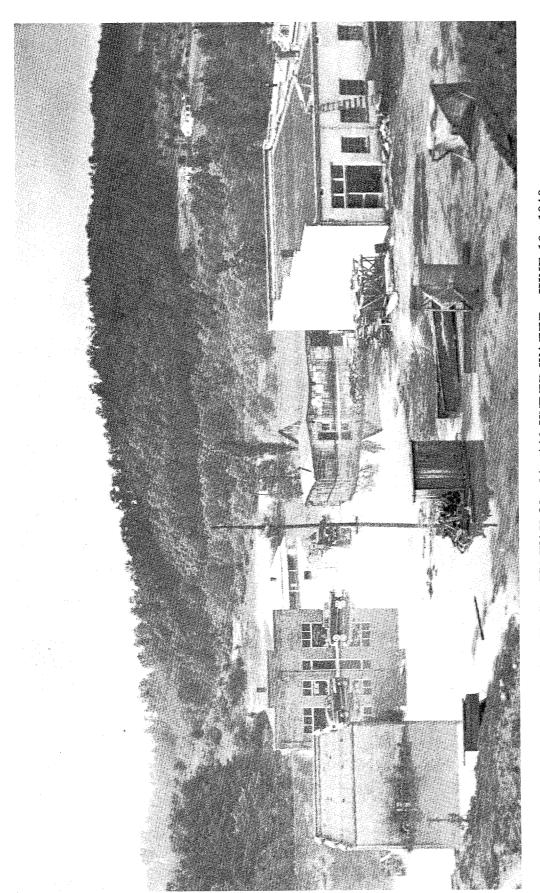
Figure 9. --U. S. HIGHWAY 23, 64, 441 UNDER WATER, JUNE 16, 1949

view at right, and the river flows into the woods at left center. The house in left center background was the only residence flooded. Picture was made near crest of flood. The highway passes across the picture in front of the cars. The Little Tennessee River bridge is out of the

Both approaches to the U. S. Highway 23, 64, 441 bridge over the Little Tennessee River at Franklin were under water on June 16, 1949. This view, looking northeasterly from a knoll on the left bank, is one of three taken by Crisp Studio of Franklin from approximately the same location. The area at the right of the cover picture is shown in Figure 8 and the area at the left in Figure 9. Logs seen in this photograph are being washed away from the stockpile seen in Figure 8.

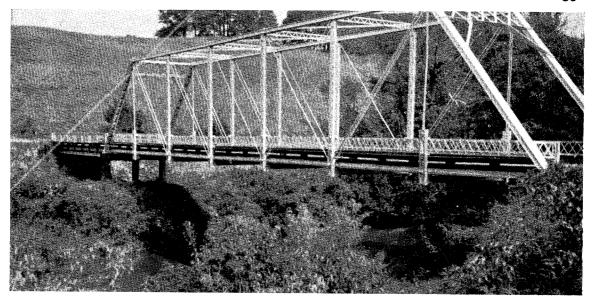
Figure 10. -- CULLASAJA RIVER BRIDGE AT MILE 1.01 NEAR FRANKLIN

The bridge at Mile 1.01 has been built in recent years to provide better access for the residents of the Porter Cove and Clark Chapel sections south of Franklin. This is a single-span steel truss bridge. The main span provides a clear opening of 110 feet, and a right-bank approach span gives an additional opening of 40 feet. Approach fills which cross the left and right bank have a length which totals about 160 feet and heights which range from 7 to 10 feet.

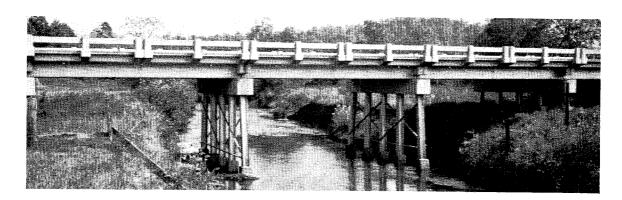
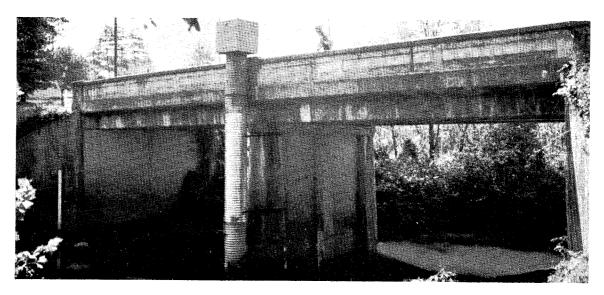
Figure 11. --BRIDGES OVER CARTOOGECHAYE CREEK

Upper view shows three spans of a 5-span bridge at Mile 1.80 carrying U. S. Highway 23 & 441. Lower view is downstream side of the former U. S. Highway 23 & 441 bridge at Mile 1.95 showing the stream gage shelter.

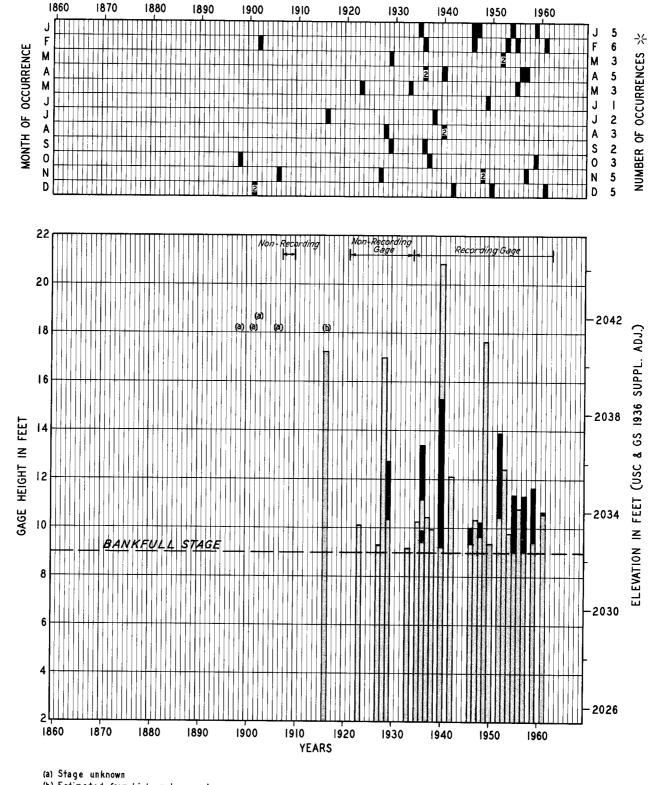
FLOODS ABOVE
BANKFULL STAGE
CULLASAJA RIVER
AT CULLASAJA, N. C.
MARCH 1963

- (b) Estimated from high water marks.
- ☆ Number of occurrences during period 1898 through March 1963.

Stream gage located at River Mile 4.24.

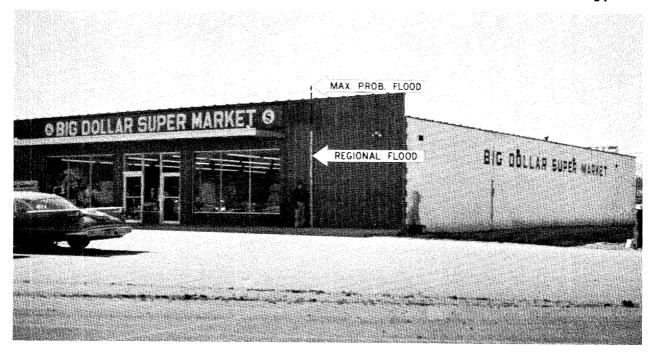
Figure 12. --SUPER MARKET ON RIGHT BANK OF LITTLE TENNESSEE

This building at Mile 116.59, just above the U. S. Highway 23, 64, 441 bridge, is built on filled ground in the flood plain. The floor is 3 feet higher than the flood of August 30, 1940. The Regional and Maximum Probable Floods would reach heights in the store as indicated by arrows on the rod.

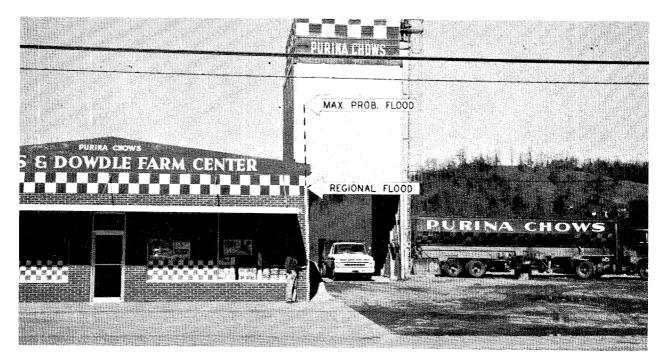
Figure 13. -- FARM CENTER BUILDING ON U. S. HIGHWAY 23, 64, 441

The building is about 1200 feet from left bank of the river and on the right side of Crawford Branch, a small tributary. The late August 1940 flood came within 0.3 foot of the elevation of the base of the rod. The heights of the Regional and Maximum Probable Floods are shown.

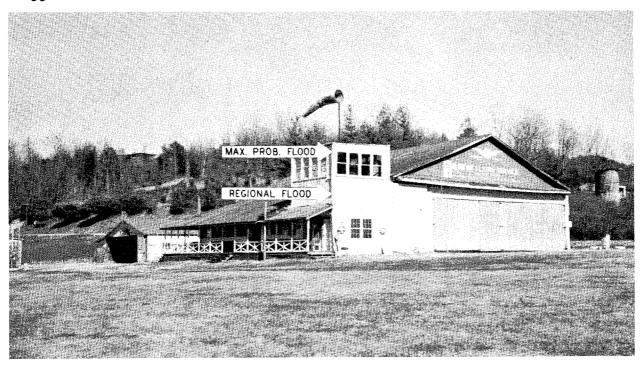
Figure 14. -- HANGAR AND OFFICE AT FRANKLIN AIRPORT

This building is about 650 feet from right bank of the Little Tennessee River at Mile 117.00. The flood of August 30, 1940, was 0.4 foot lower than the porch floor level. The Regional and Maximum Probable Flood heights are indicated.

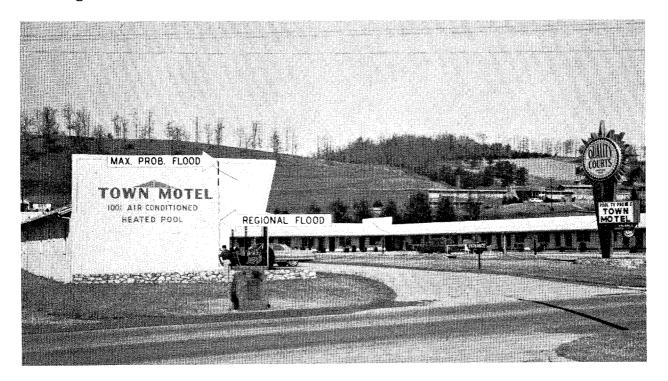
Figure 15. --MOTEL JUST BELOW U. S. HIGHWAY 23, 64, 441 BRIDGE

This motel is built on a fill, which was placed since the 1949 flood, on right bank at Mile 116.53. The 1940 flood level was $5\frac{1}{2}$ feet lower than the base of rod held against the sign. Regional and Maximum Probable Flood heights are shown.

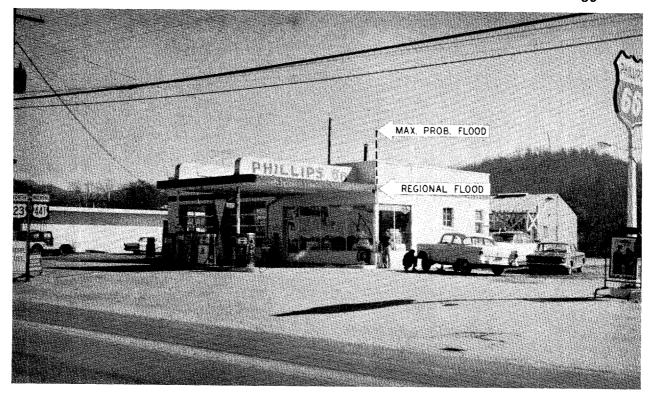
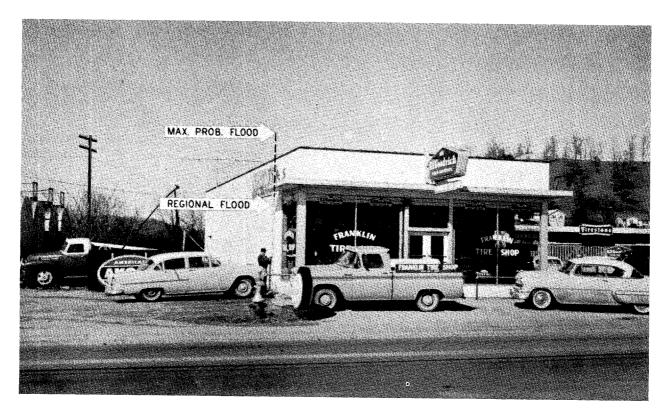
Figure 16. --AUTO SERVICE ESTABLISHMENTS ON U. S. HIGHWAY 23, 64, 441

Upper view is the Phillips 66 gasoline station on the upstream side of the highway at Mile 116.58. Lower view is the Franklin Tire Shop across the road. These are about 200 feet from left bank of the Little Tennessee River. They have both been built since the June 1949 flood and are about 2 feet above both it and the late August 1940 flood. The Regional and Maximum Probable Flood Heights are shown by arrows.

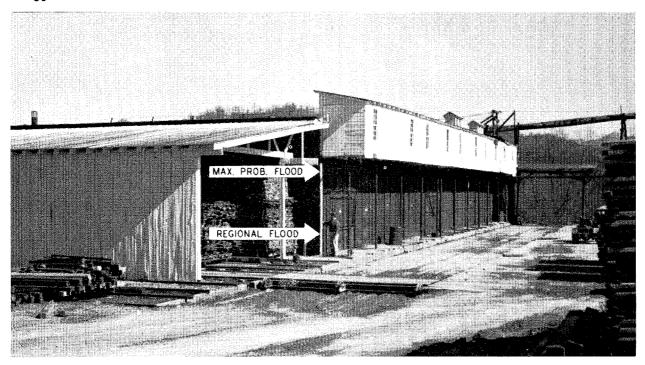
Figure 17. --ZICKGRAF HARDWOOD COMPANY AT MILE 117. 15

This dry kiln building between Depot Street and the Little Tennessee River was about 9 feet above the flood of August 30, 1940, but would be flooded by the Regional and Maximum Probable Floods to the heights shown.

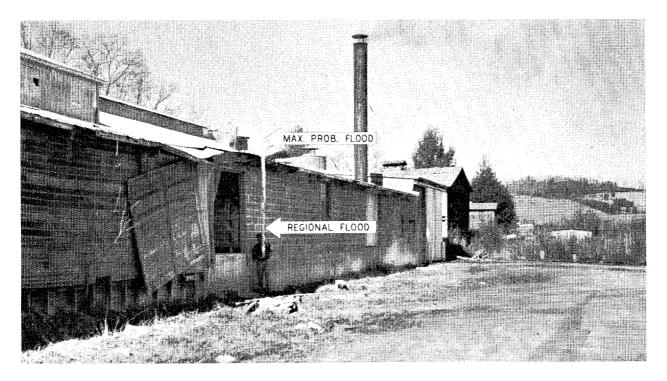
Figure 18. --STORAGE BUILDING OF FRANKLIN MINERAL PRODUCTS

Located 700 feet downstream from the building in Figure 17, this building is on ground that was about 6 feet higher than the late August 1940 flood. Heights of the Regional and Maximum Probable Floods are shown by arrows.
