TENNESSEE VALLEY AUTHORITY
DIVISION OF WATER CONTROL PLANNING

FLOODS
ON
FRENCH BROAD RIVER
IN VICINITY OF
MARSHALL, NORTH CAROLINA

REPORT NO. 0-5925

MAY 1960

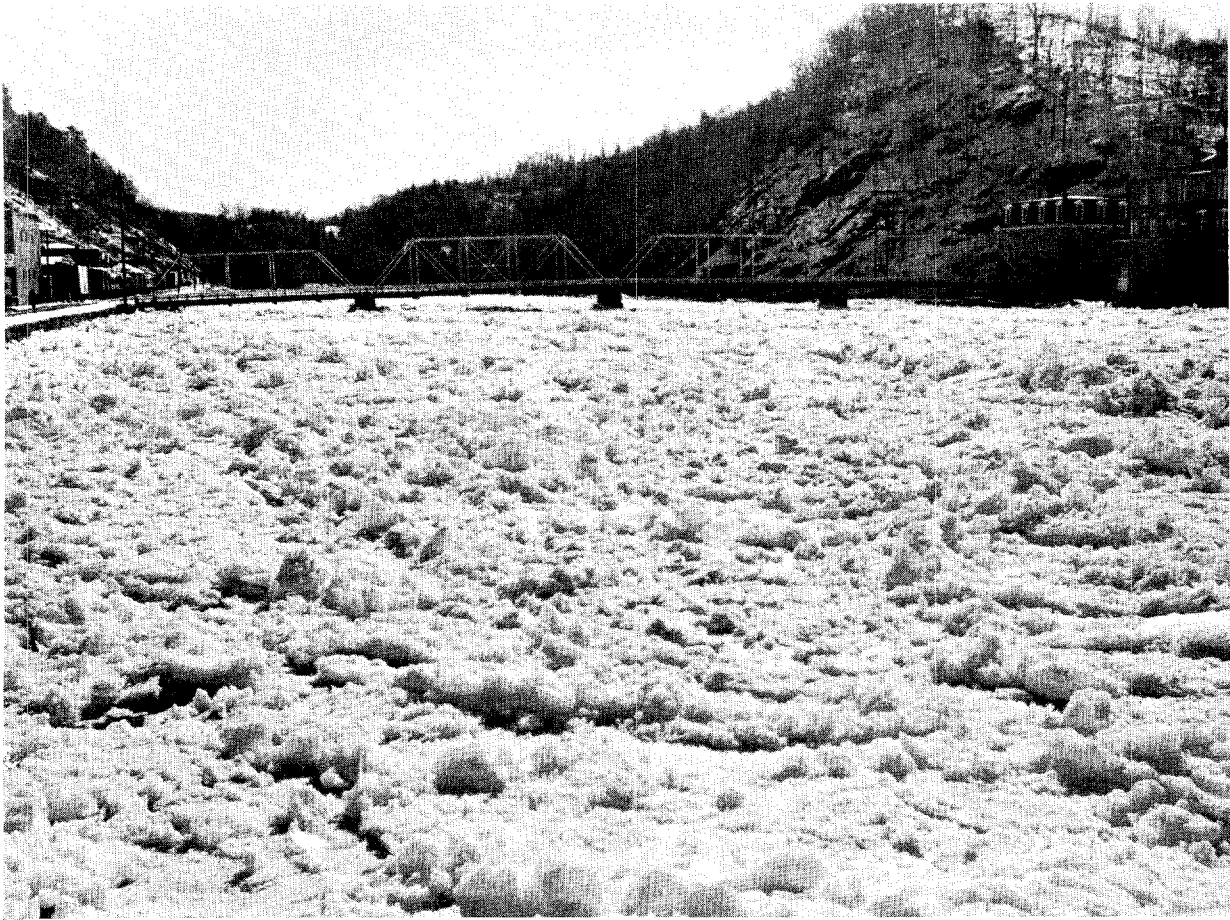
Figure 3. --ICE JAM OF FEBRUARY 18, 1958, AT MARSHALL

The top picture was taken by an Asheville "Citizen" photographer on the morning of February 18. The bottom view is in the late afternoon. Both are looking upstream from Lower Bridge.

The Marshall reach of the French Broad River is affected at times by serious ice jams that choke the channel and create a hazardous condition. One of the earliest known of these ice jams occurred in about 1883 when the river froze over sufficiently to easily support a wagon and team. When the ice moved

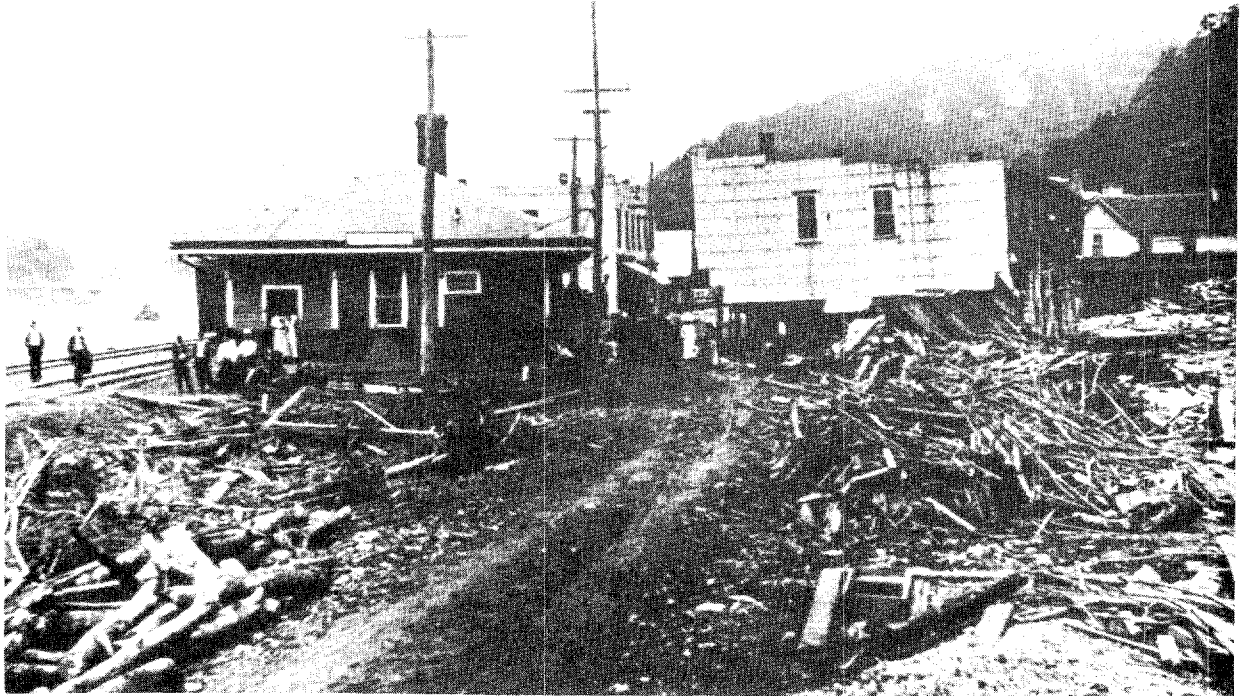
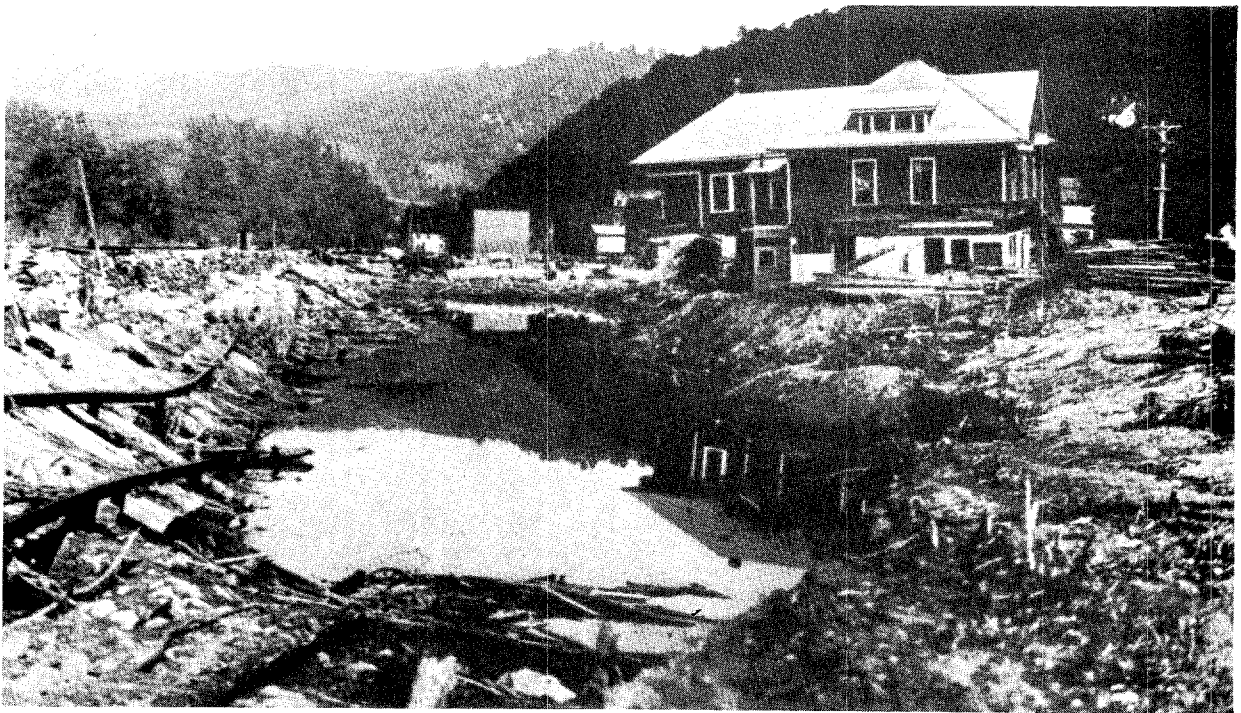
Figure 4. --DESTRUCTION BY 1916 FLOOD AT MARSHALL

The top view west along Main Street from above the depot shows debris of destroyed buildings. The building in the middle of Main Street was washed from the present site of Teague Milling Company (formerly City Milling Company). The track had been repaired when the picture was taken. The lower view is west from the depot. Two residents were drowned at this location during the flood. (Photos by Southern Railway Company)

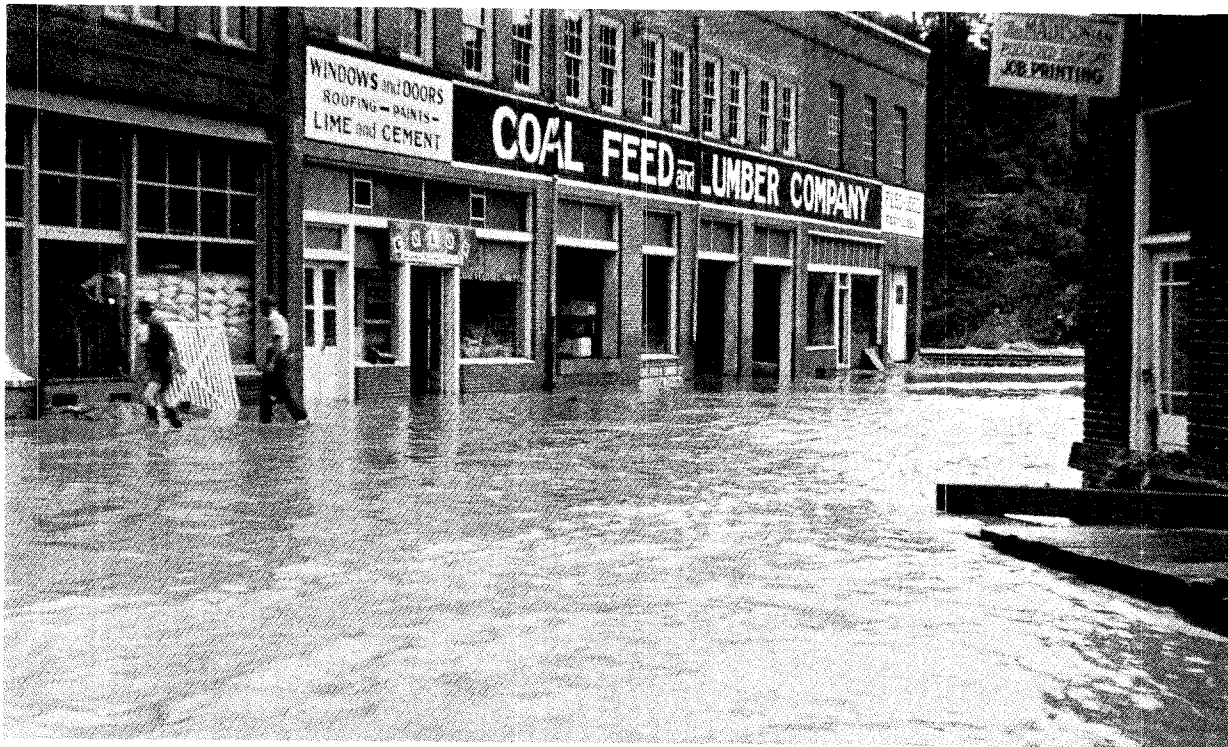
Figure 5. --MARSHALL BUSINESS PLACES FLOODED IN 1940

The Coal Feed and Lumber Company on the east side of Upper Bridge Street was flooded to depths of 15 to 48 inches on August 30, 1940. The water level in the French Broad Chevrolet Company's salesroom and garage was $3\frac{1}{2}$ feet deep at the crest stage. These views were taken at 4:45 p. m., August 30, after the flood had receded about 3 feet in the street.

Figures 5 to 11 show conditions in Marshall during and after the August 30, 1940, flood.

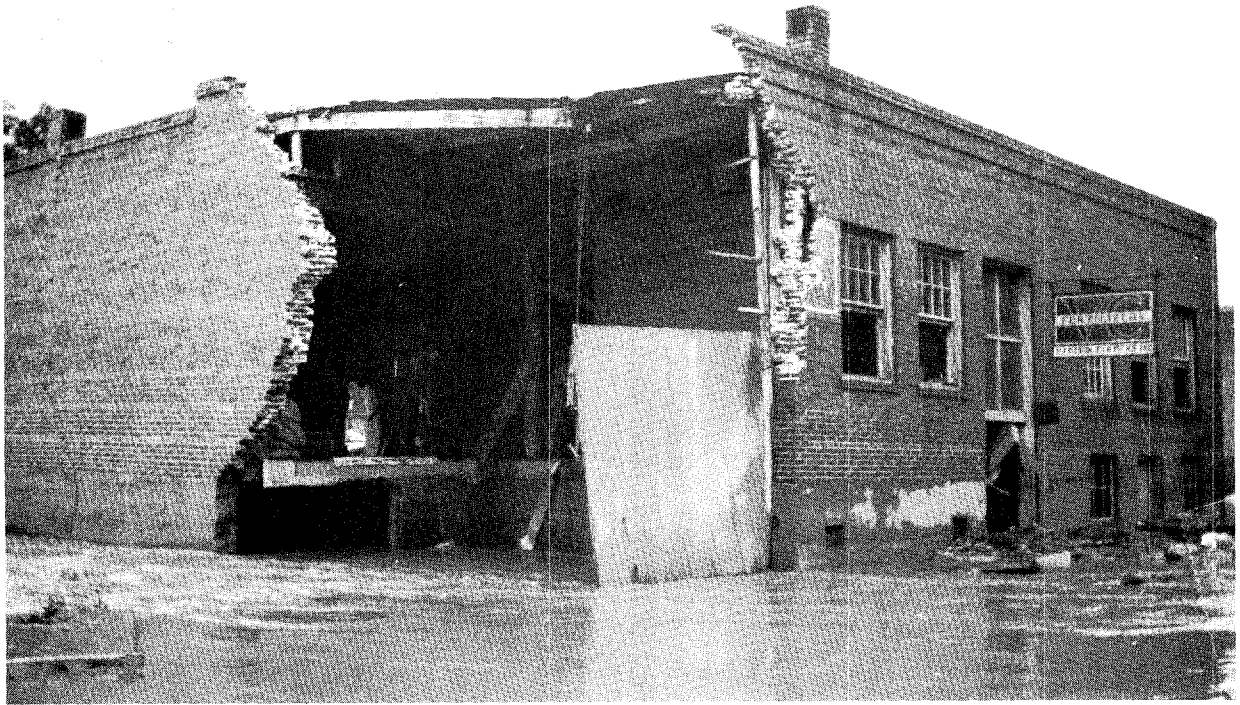
Figure 6. --BUILDING DAMAGE IN 1940 FLOOD

The Madison Farmers, Incorporated, building on the south side of Main Street, top view, was heavily damaged by drift. The 1940 flood at the crest was 7 feet deep in the street. The bottom view, looking east along Main Street, shows the Gudger warehouse lodged in the street near Builders Supply Company. This two-story wood and metal structure, which withstood the 1916 flood, was carried about 300 feet by the 1940 overflow. (Lower photograph by Asheville "Citizen-Times")

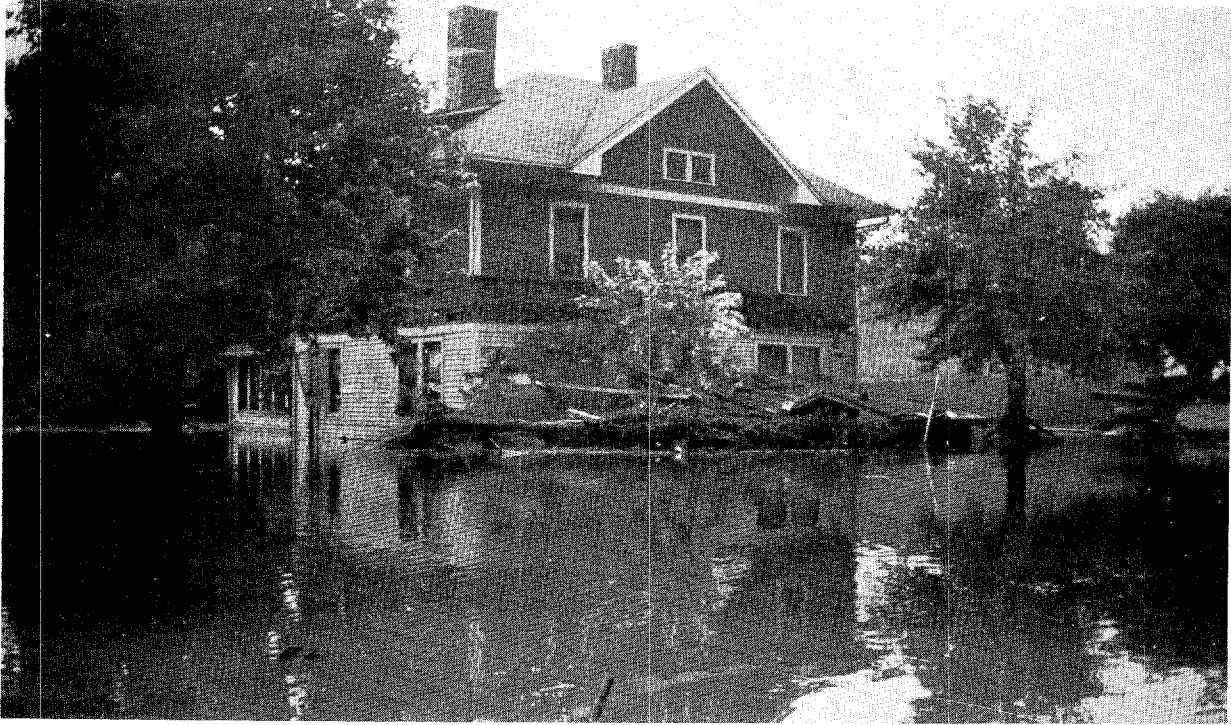
Figure 7. --HOTEL AND HOME DAMAGE IN 1940

The 1940 floodwaters were almost 5 feet deep in the French Broad Hotel, top view, causing heavy damage to furniture and demolishing the large porch in the front. In the lower view, the D. A. Robinette home, located at the upstream end of the business section, was one of 35 houses flooded in 1940. At the crest stage, water was 3.1 feet above the floor. (Lower photograph by Asheville "Citizen-Times")

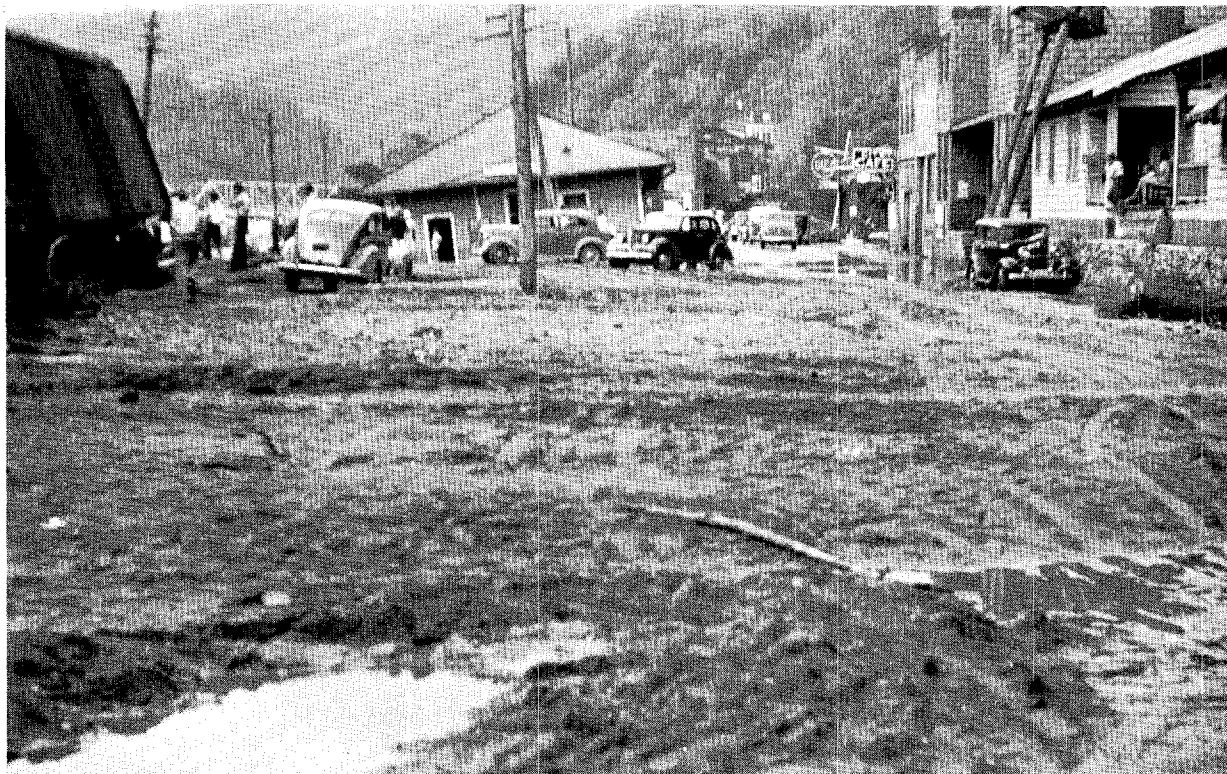
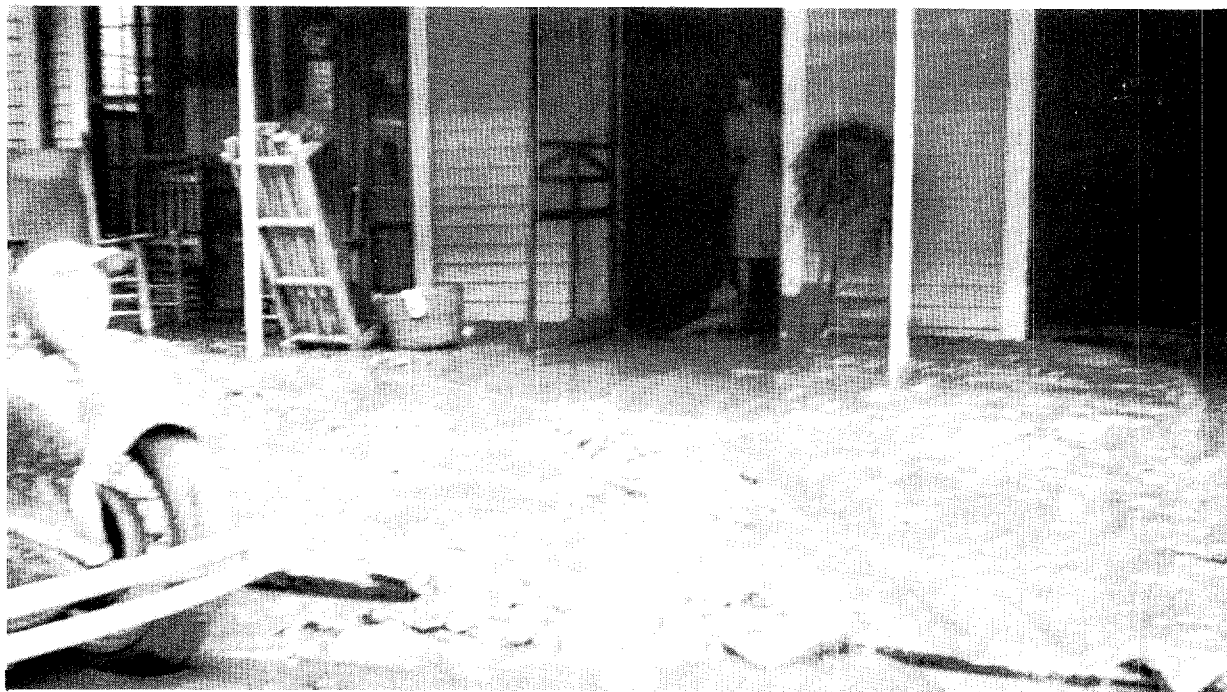
Figure 8. --CLEANUP AFTER 1940 FLOOD

The top view, taken at 6:00 p. m. August 30, is looking west down Main Street from the vicinity of the City Milling Company and the Southern Railway depot. The Gudger warehouse was located just beyond the depot. The bottom view shows silt on the porch of the Rector Hotel which was flooded to a depth of about 5 feet.

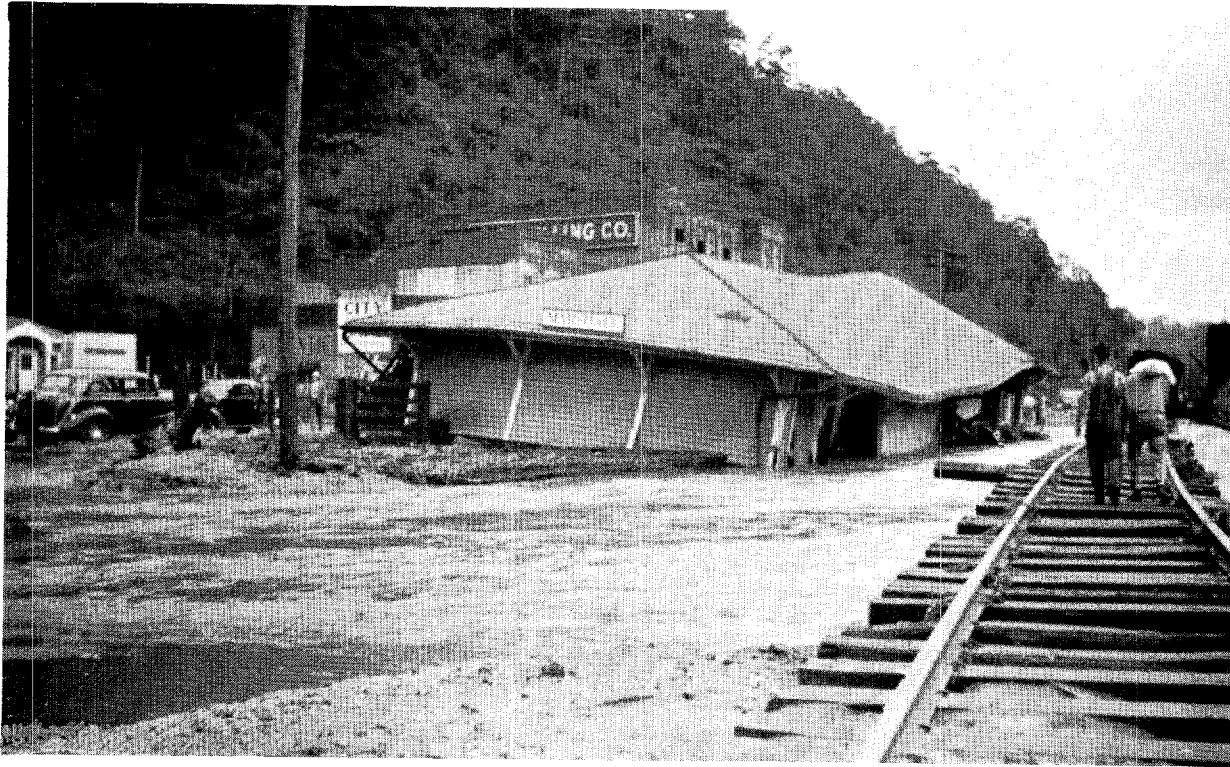
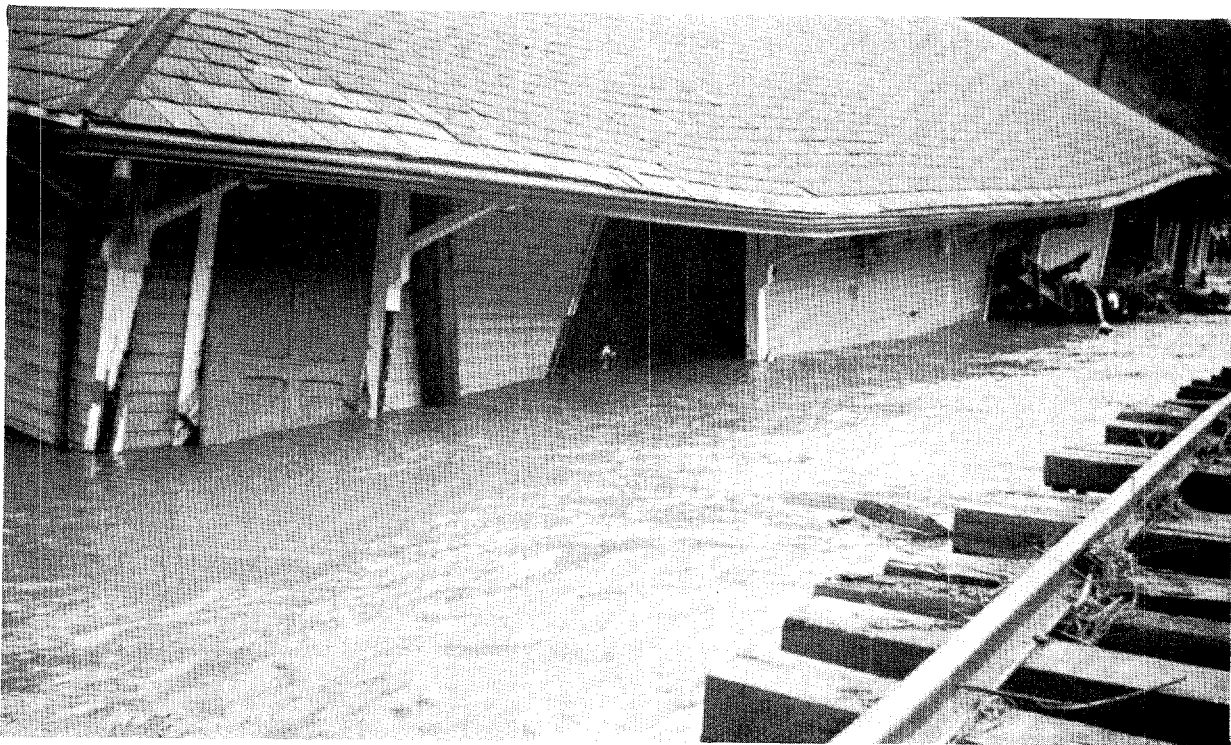
Figure 9. --SOUTHERN RAILWAY DEPOT AFTER 1940 FLOOD

These two views looking east show the heavy damage to the Southern Railway's Marshall Depot and tracks on August 30, 1940. At the crest stage, water was 4 to 5 feet deep over the tracks and velocities were very high.

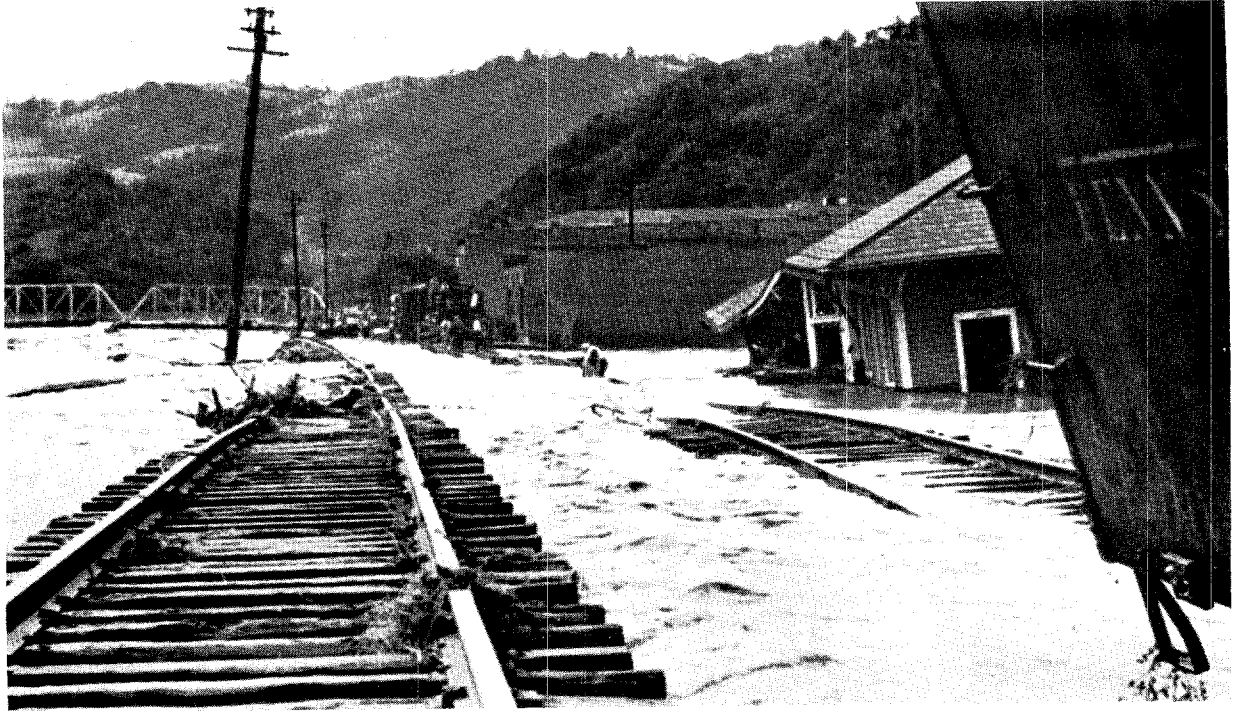
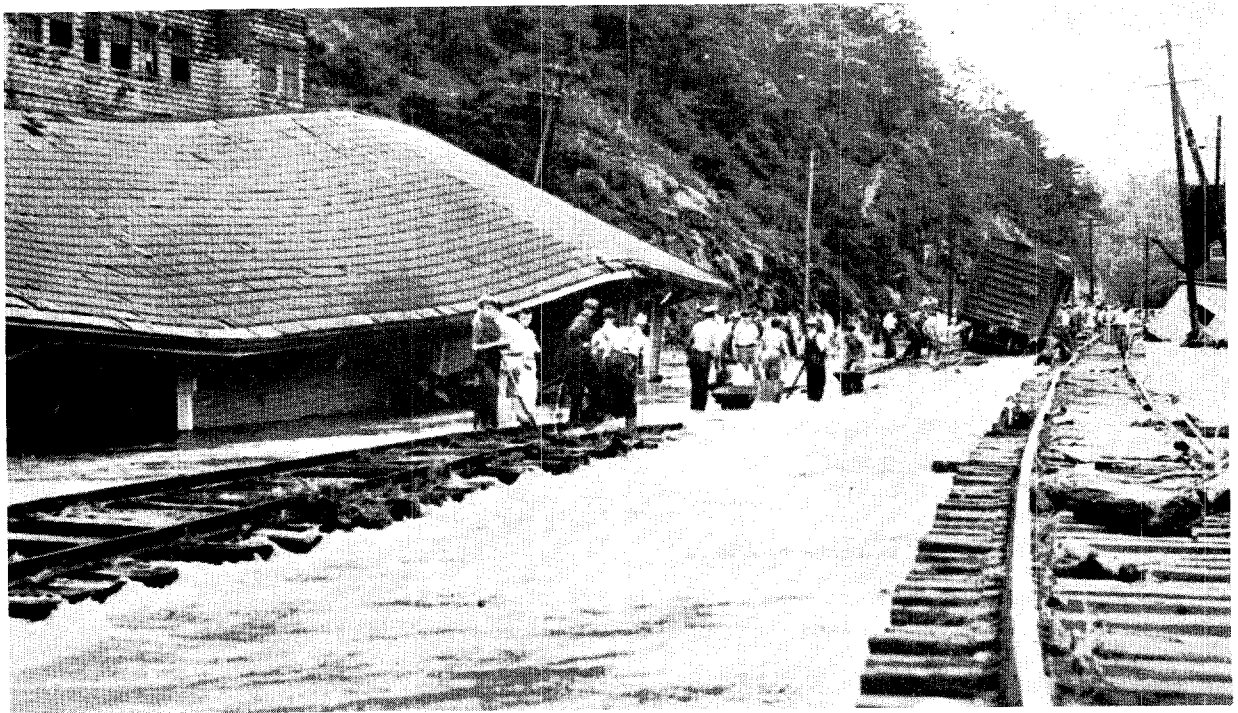
Figure 10. --SOUTHERN RAILWAY DAMAGE IN 1940

The top view looking downstream toward the Upper Bridge shows the heavy track damage caused by the high velocity flow of the French Broad River on the left. The bottom view shows Southern Railway track crews already at work on repairs with flood waters still around them. (Photos by Asheville "Citizen-Times")

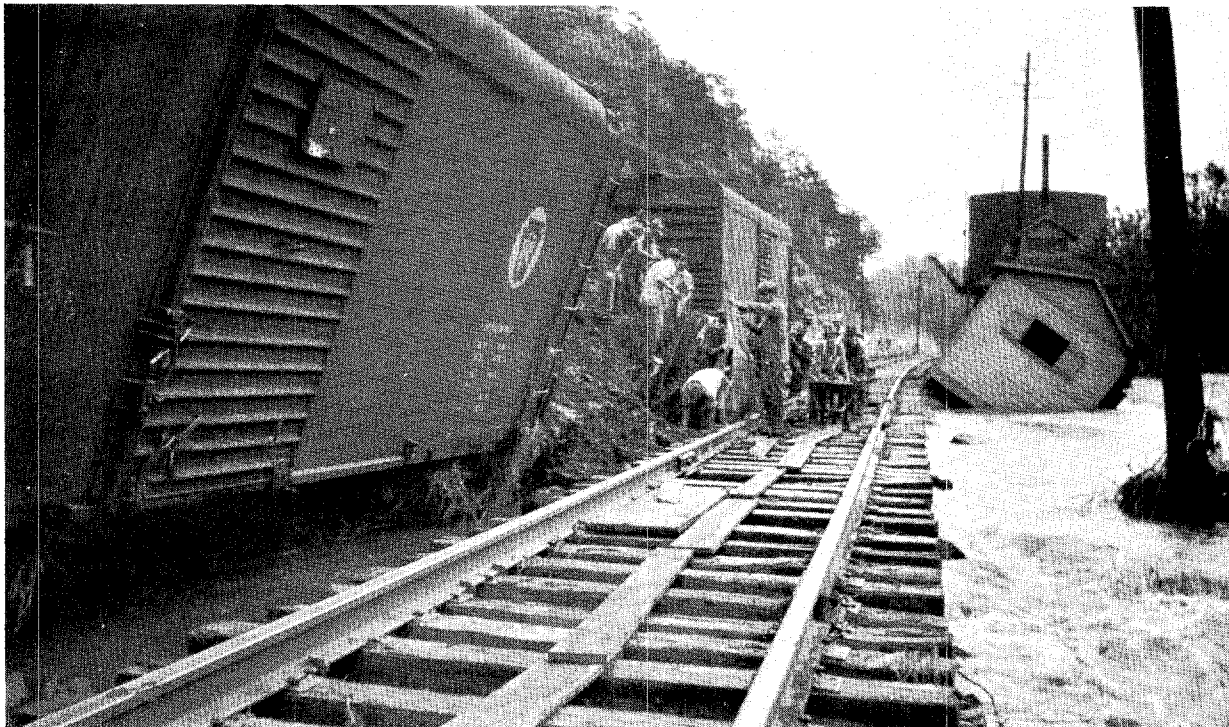
Figure 11. --RAILROAD TRACK DAMAGE IN 1940

Over 1000 feet of Southern Railway track were washed over the retaining wall and into the raging French Broad River by the August 1940 flood. The top view is looking upstream from below the depot. The bottom view is upstream from above the depot.

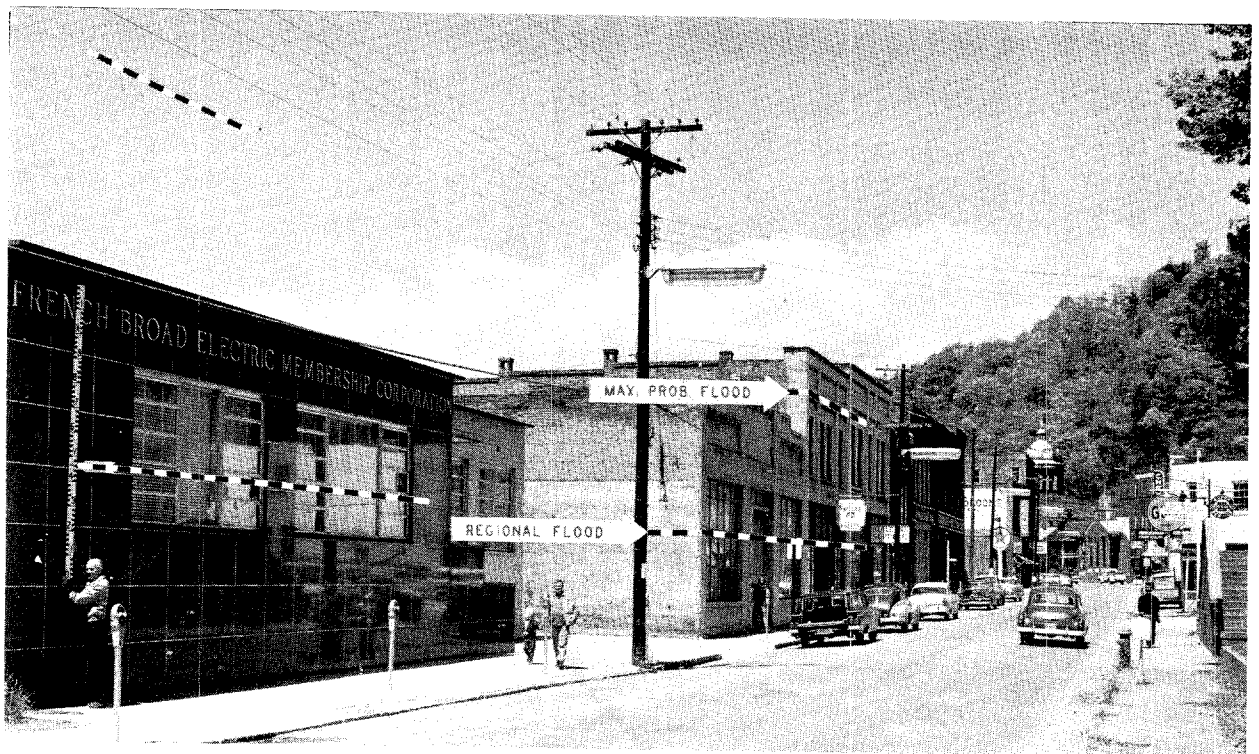
Figure 12. --MAXIMUM PROBABLE AND REGIONAL FLOODS AT MARSHALL

Both of these views are northwestward along Main Street. The top picture shows the Southern Railway depot and Teague Milling Company at the upper end of the business district. The lower view shows business buildings upstream from Upper Bridge Street. The arrows and dashed lines indicate the height of the Maximum Probable Flood and of the Regional Flood which is the same as the July 1916 flood. The difference between the two floods is 16 to 17 feet.

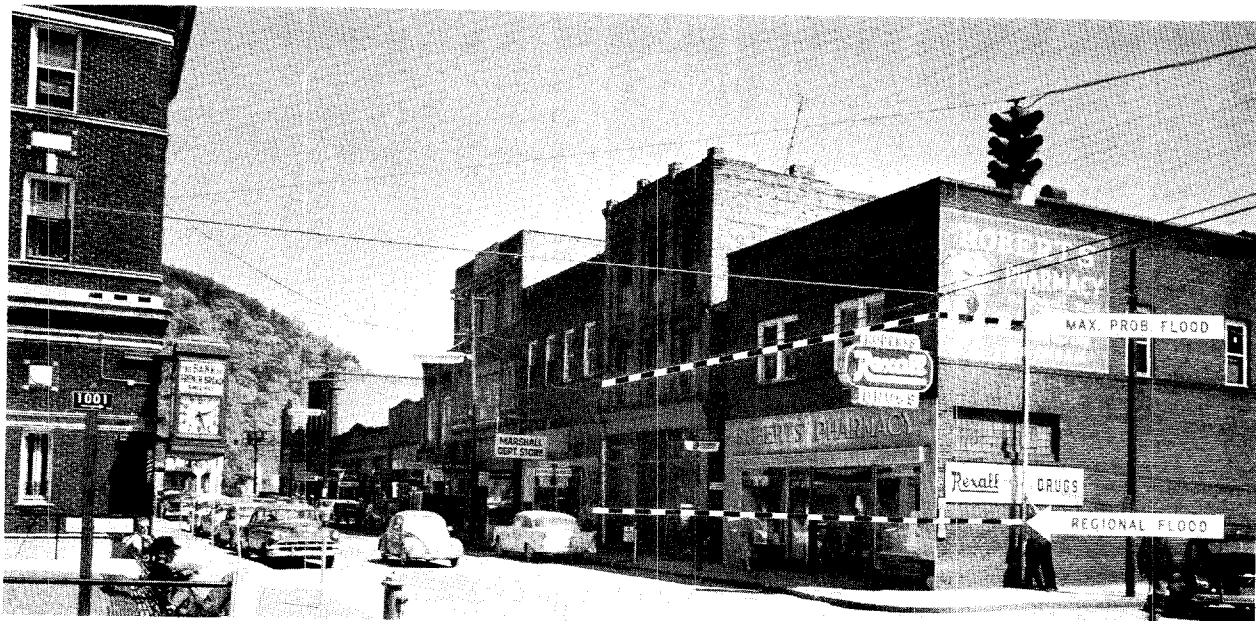
Figure 13. --BUILDINGS NEAR MADISON COUNTY COURT HOUSE

These views are on Main Street at its intersection with Lower Bridge Street. The upper view shows the court house and the Bank of French Broad. The lower view is southeastward along Main Street showing business buildings upstream from Lower Bridge Street. Arrows and dashed lines identify the height of the Maximum Probable and Regional (1916) Floods. The difference between the two floods in these views is about $14\frac{1}{2}$ to 15 feet.

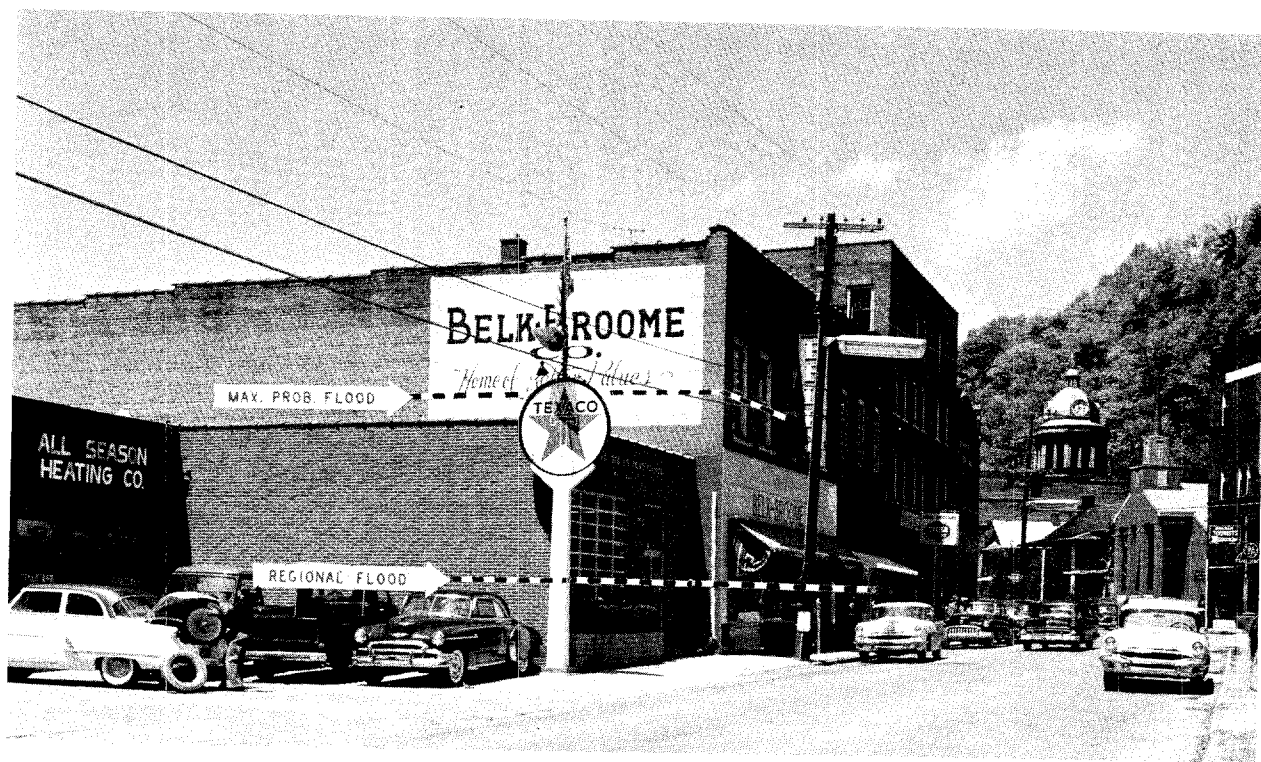
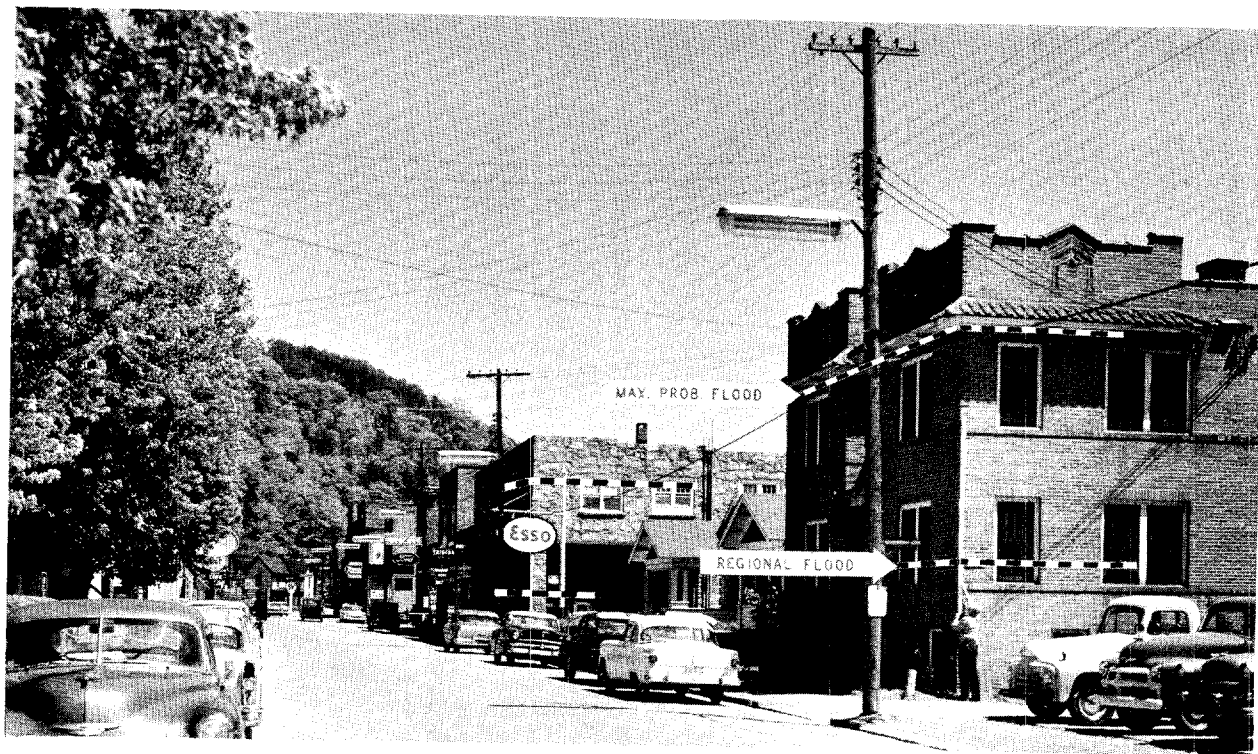
Figure 14. --FLOOD HEIGHTS ALONG MAIN STREET

The top view is west along Main Street from its intersection with Upper Bridge Street. The Marshall Post Office is in the center of the picture. The bottom view is east along Main Street near the lower end of the business section. Arrows and dashed lines show the height of the Maximum Probable and Regional (1916) Floods. The difference between the two floods is about 15 feet in the upper view and 14 feet in the lower view.
