**FLOODS**  
ON  
**FRENCH BROAD RIVER**  
**AND TRIBUTARIES**  
IN VICINITY OF  
**ROSMAN**  
**NORTH CAROLINA**

**TENNESSEE VALLEY AUTHORITY**  
**DIVISION OF WATER CONTROL PLANNING**

REPORT NO. 0-6878

**APRIL 1971**

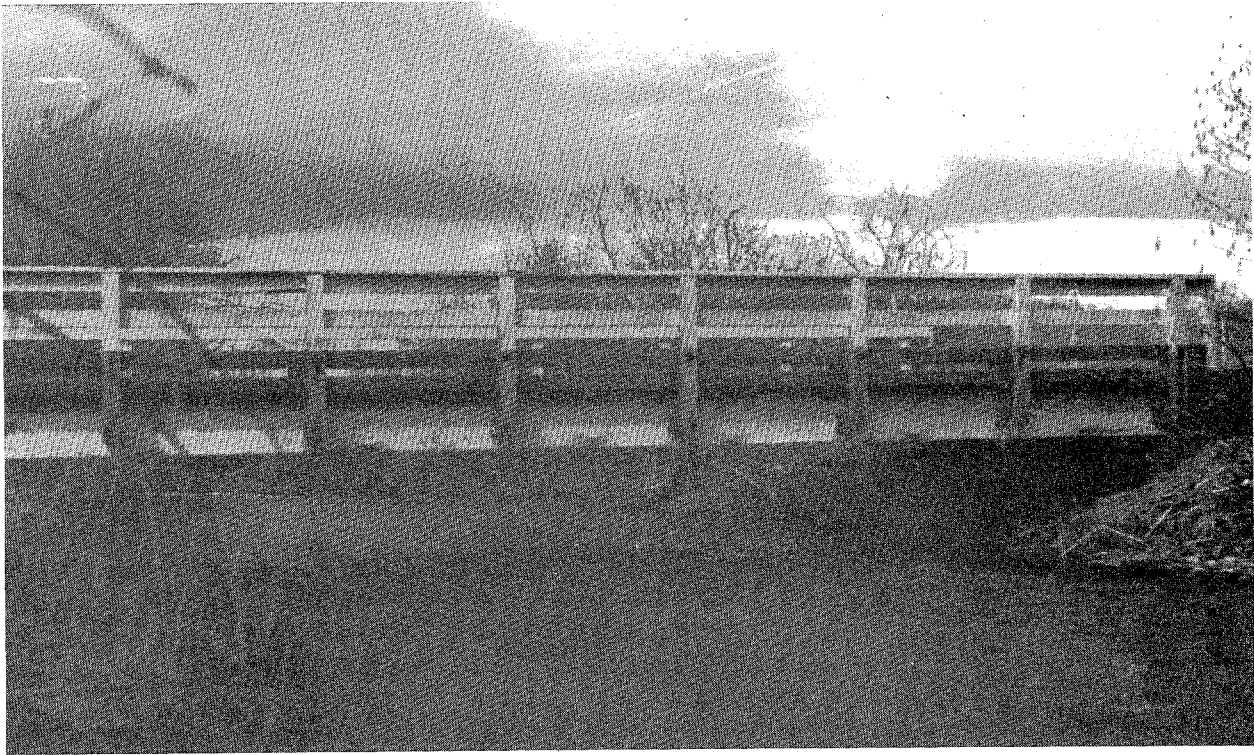
Figure 4.--BRIDGES ON MIDDLE FORK FRENCH BROAD RIVER

Upper view is upstream side of bridge on Secondary Route 1107 at Mile 0.24. The October 1964 flood was almost 2 feet higher than the bridge floor. Lower view is upstream side of the U. S. Highway 178 bridge at Mile 1.95. During the October 1964 flood, debris partially blocked the culvert and caused water to overflow the highway.

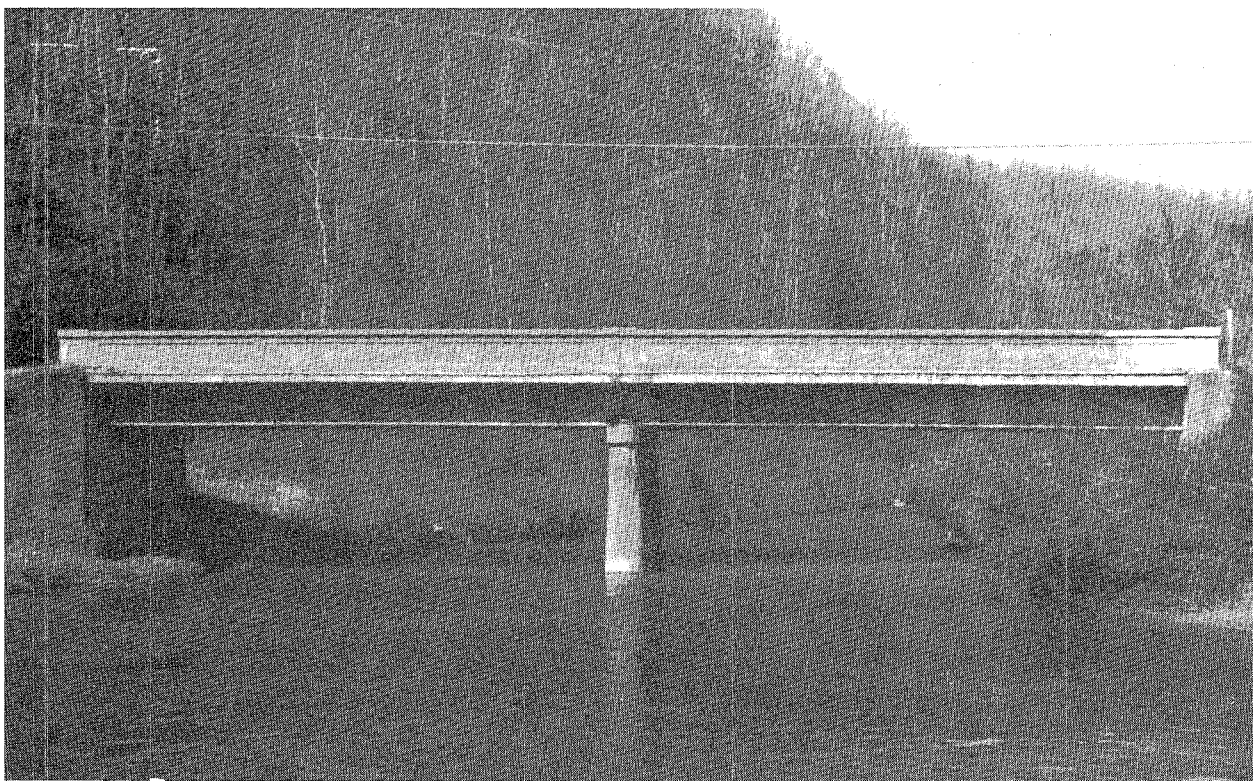
Figure 5.--BRIDGES ON NORTH FORK FRENCH BROAD RIVER

Upper view shows downstream side of the U. S. Highway 64 bridge at Mile 0.02. Lower view is downstream side of the bridge on Secondary Route 1322 at Mile 1.10. The October 1964 flood was above the underclearance level of both these bridges so that heading up occurred, but neither road was overtopped.

U. S. Highway 64 bridge and its approach fills caused heading up of about one foot during the October 1964 flood, but during larger floods the heading up would not be important. At Secondary Route 1322, heading up of less than one foot occurred during the 1964 flood, and this would increase to 2.5 feet during a Regional Flood.

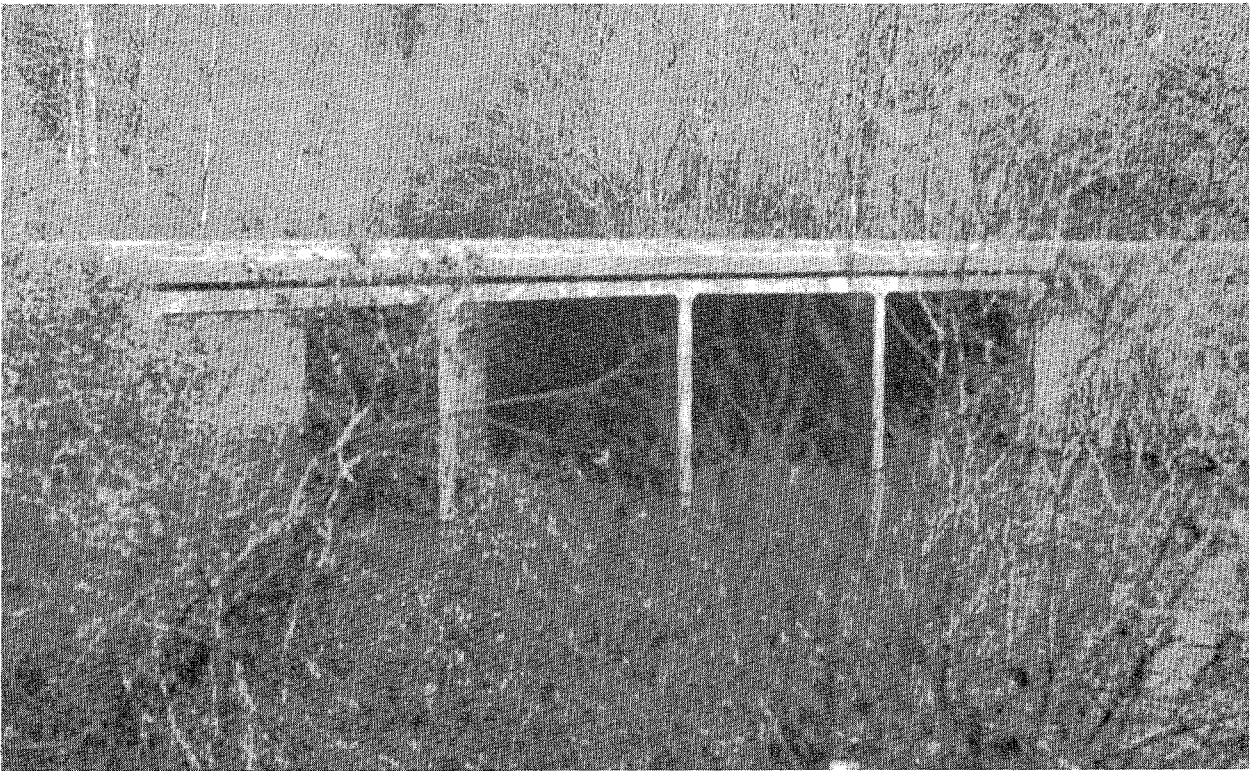
Figure 6. --BRIDGES ON WEST FORK FRENCH BROAD RIVER

Upper view is upstream side of the bridge on Secondary Route 1135 at Mile 0.05. Lower view shows downstream side of the U. S. Highway 64 bridge at Mile 1.20. During the October 1964 flood, debris almost blocked this bridge opening; water overflowed the bridge and several hundred feet of the highway (see Figure 10).

U. S. Highway 64 crosses the stream and flood plain at Mile 1.20 and is on the left bank from that point to the mouth. Changes made to the highway some years ago included a relocation of the West Fork stream channel to eliminate a sharp bend at Mile 0.7 and a relocation of the road across the old streambed. During the October 1964 flood, West Fork sought to follow its old channel and cut out a portion of the highway at Mile 0.7. About 800 feet of the highway was flooded where it crosses the flood plain at Mile 1.20, when a mass of debris almost blocked the bridge opening. During a Regional Flood, about 1,400 feet of the highway would be flooded with depths up to 4 feet. Almost one-half mile of the highway would be under water during a Maximum Probable Flood. Secondary Route 1135 crosses the flood plain on a high bridge at Mile 0.05. The road is above the Regional Flood but about 2 feet below the Maximum Probable Flood.

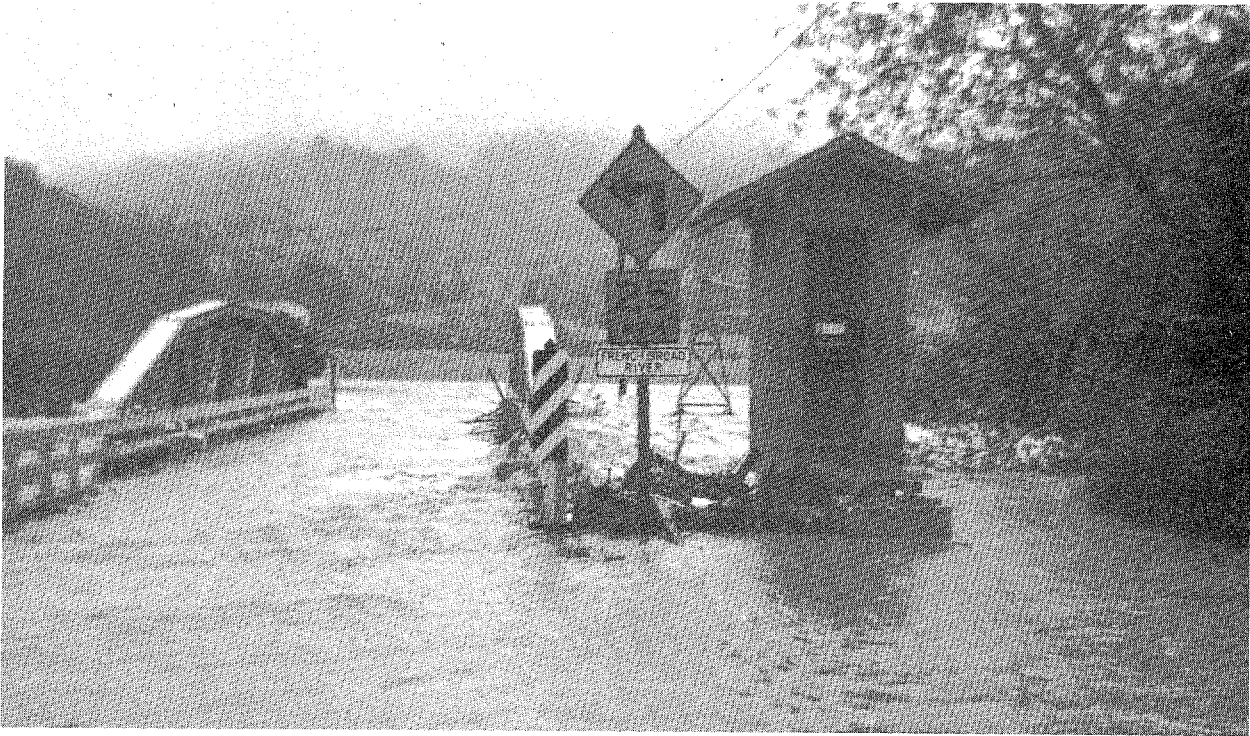
Figure 8.--OCTOBER 4, 1964, FLOOD ON U. S. HIGHWAY 178, ROSMAN

Upper view shows bridge over the French Broad River and the U. S. Geological Survey stream gage on upstream side of the bridge. The stage had fallen about 0.2 foot below crest when the picture was taken. Lower view is southwest along the highway on left bank, looking toward the bridge at right, a few minutes after the crest. The water had reached to approximately an inch below the floor of the house.

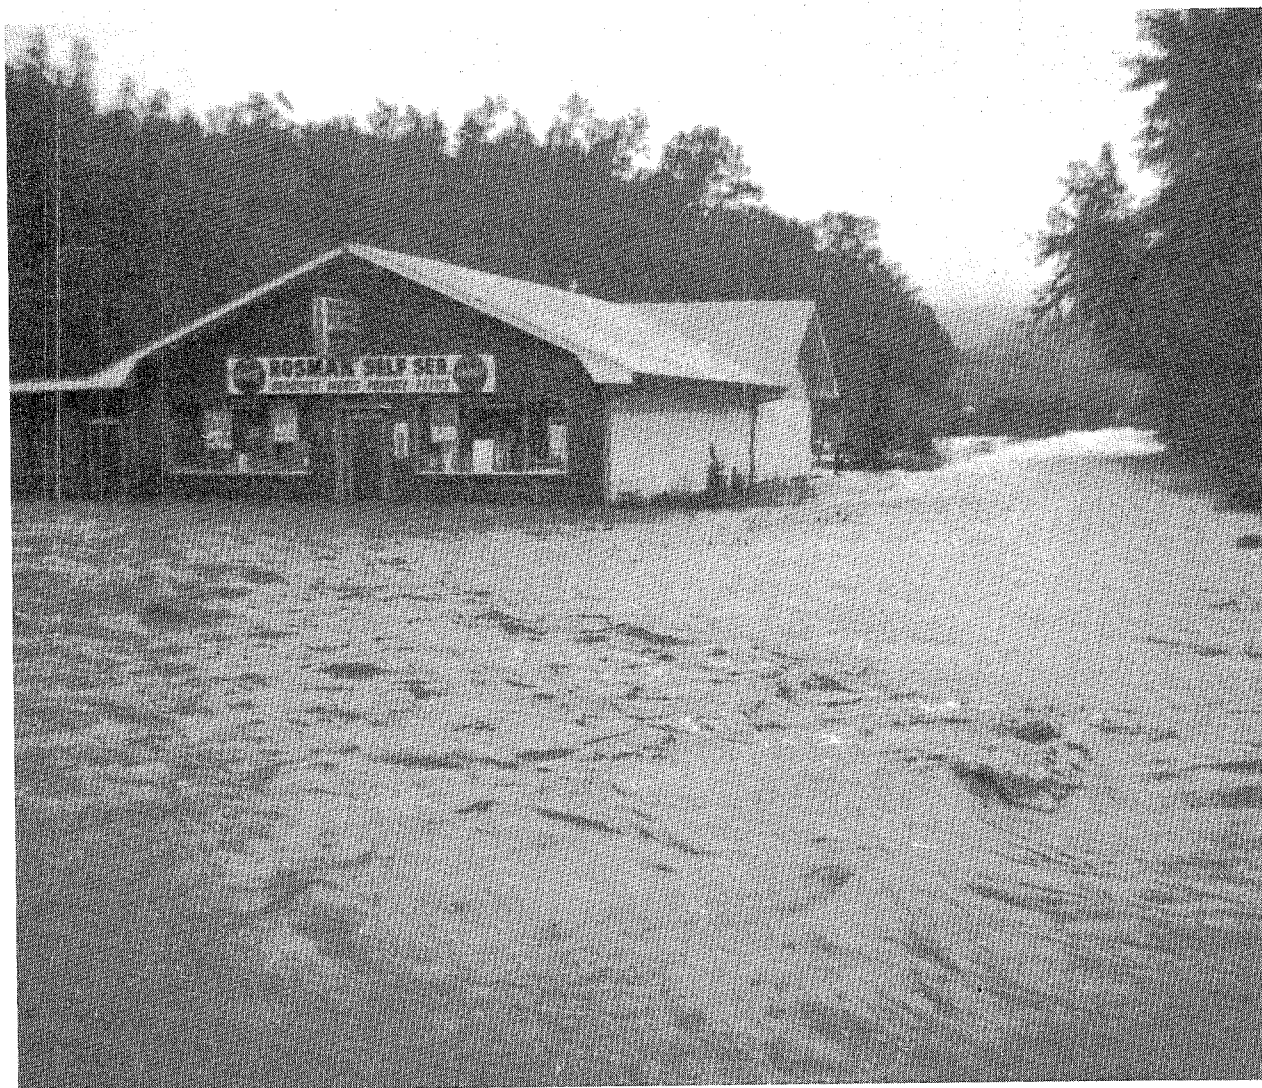
Figure 9.--OCTOBER 4, 1964, FLOOD ALONG SOUTHERN RAILWAY IN ROSMAN

The view is downstream along the tracks from U. S. Highway 178, about 500 feet from the left bank of the French Broad River. At the crest of the flood, which occurred about one-half hour earlier, water had been 1.2 feet deep at the front of the store.

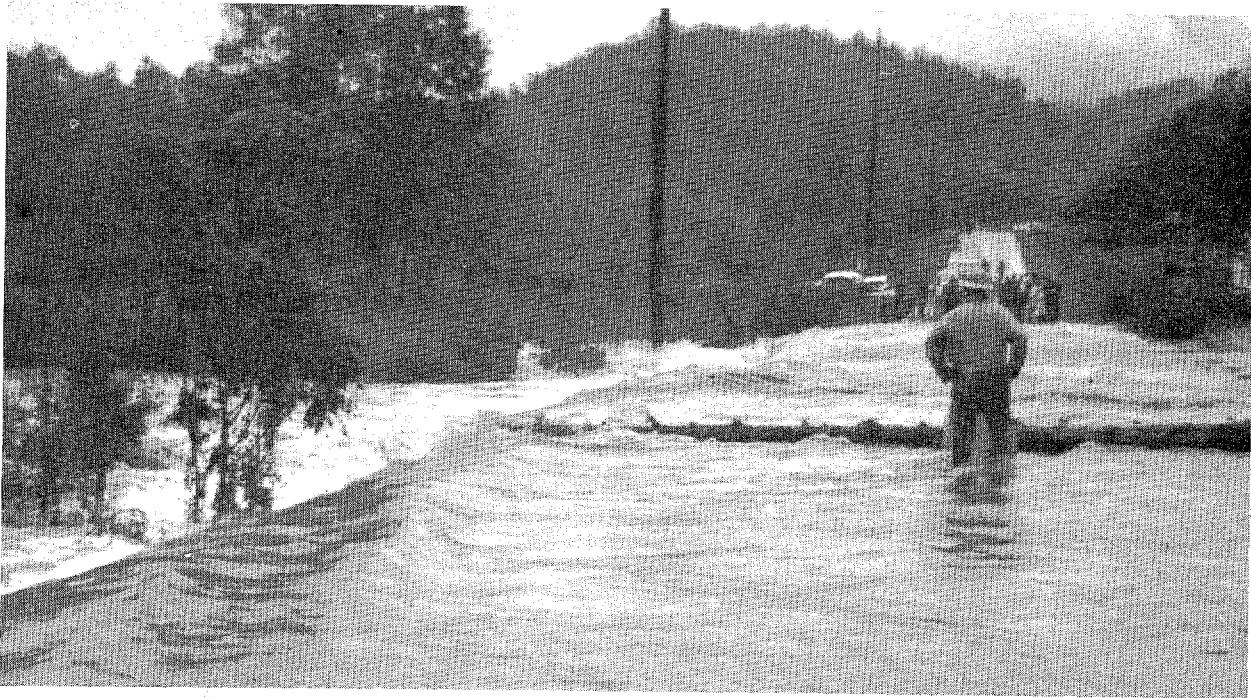
Figure 10. --OCTOBER 4, 1964, FLOOD ON WEST FORK FRENCH BROAD RIVER

Upper view is west along U. S. Highway 64 at the bridge. Flooding of the highway was due partially to a large amount of drift, which almost blocked the bridge opening and resulted in a heading up of more than 5 feet. Lower view is downstream from the highway just east of the bridge. The West Fork flows from right to left at the foot of the wooded slope about 300 feet behind the building. At the flood crest, water was about 1 foot deep outside the plant but only 3 inches deep inside.

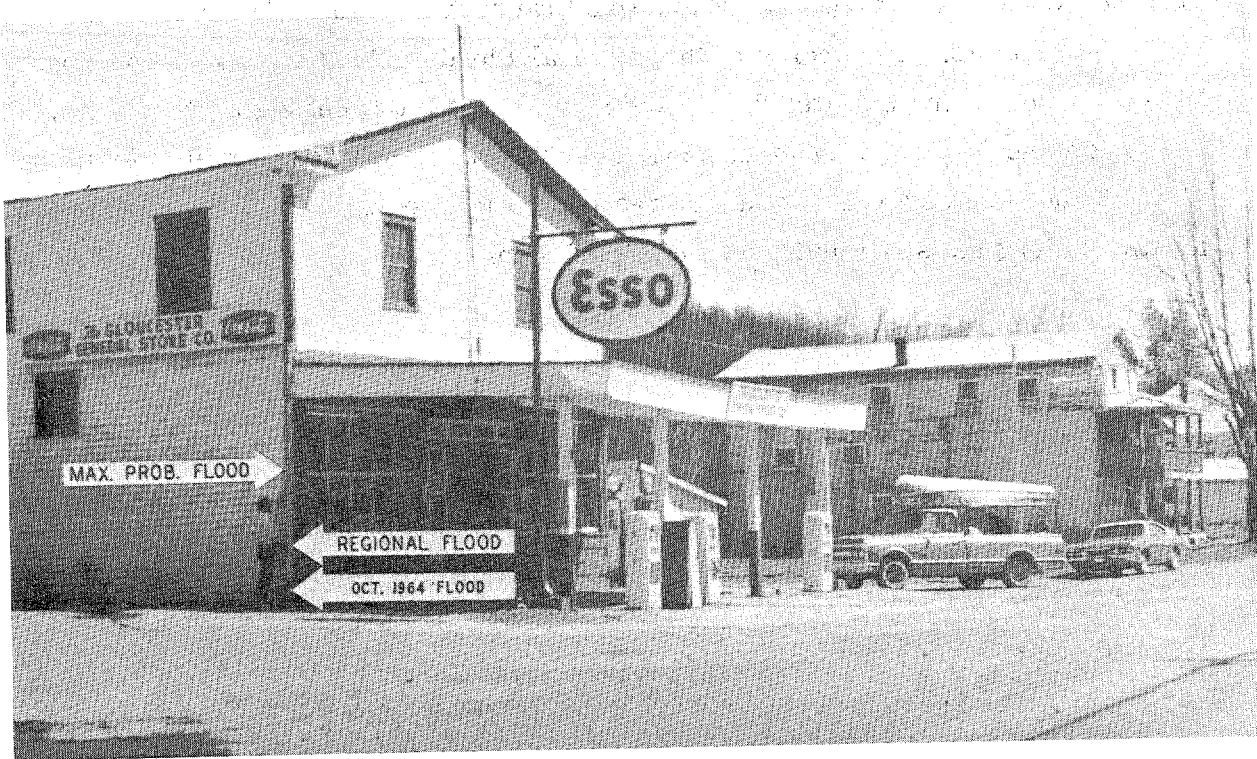
Figure 11. --FLOOD HEIGHTS AT UPPER END OF ROSMAN

Upper view shows Duke Power Company substation on right bank of the French Broad River at Mile 216.75, looking north toward the railway trestle. The October 1964 flood caused some land scour and fence damage at the station. Lower view is the Gloucester General Store on left bank at Mile 216.53. During October 1964, floodwater was about 2 feet deep in front of the store, but was 6 inches below the floor. Arrows show the heights of the October 1964 flood and the Regional and Maximum Probable Floods.

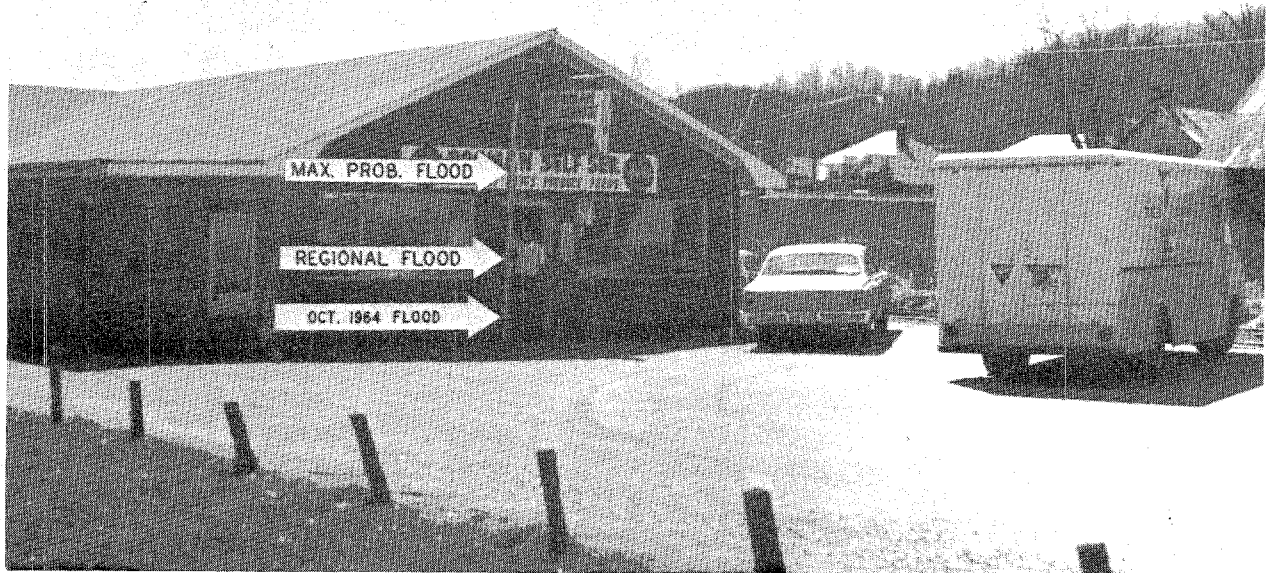
Figure 12.--FLOOD HEIGHTS ALONG U. S. HIGHWAY 178 IN ROSMAN

McCall's Auto Supply is on the upstream side of the highway. The October 1964 flood did not quite reach the building, but was about one-half foot below the floor level. The Rosman Self Service grocery store is on the downstream side of the highway, beside the Southern Railway track. A view of this store during the October 1964 flood is shown in Figure 9. Arrows show the October 1964, Regional, and Maximum Probable Flood heights.

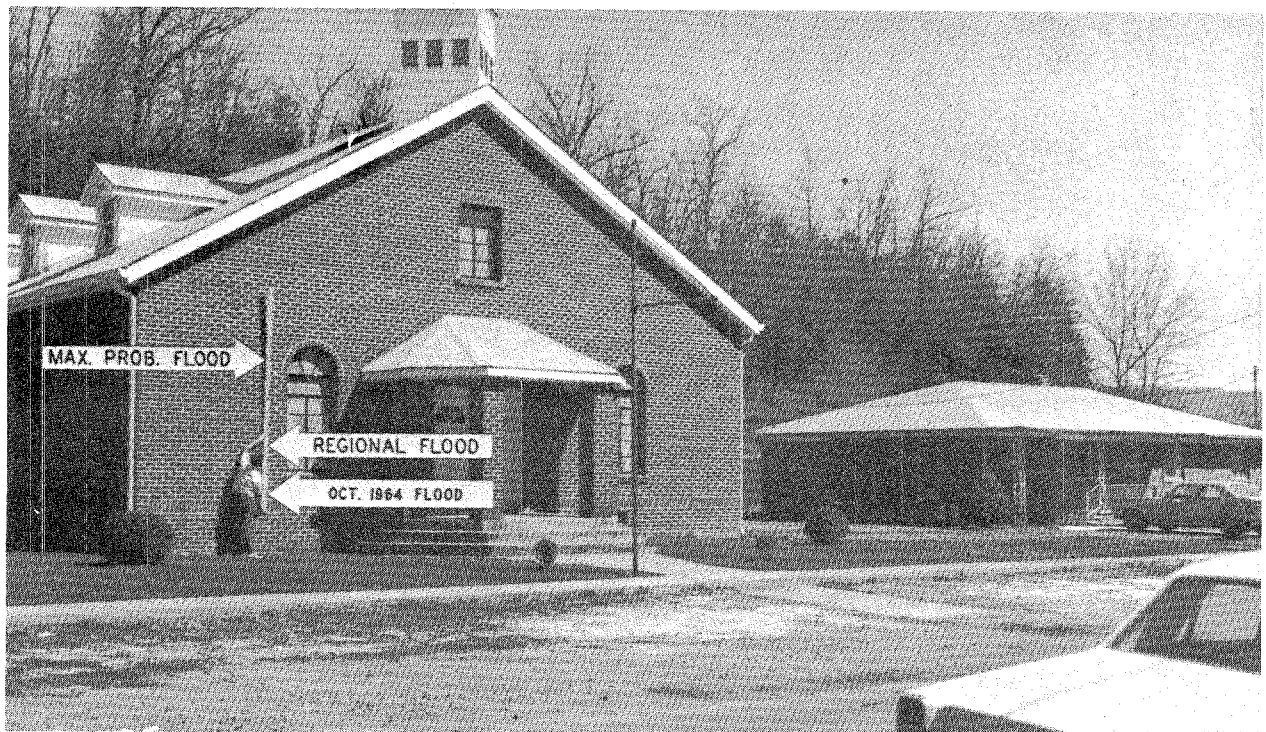
Figure 14.--FLOOD HEIGHTS AT LOWER END OF ROSMAN

The Zion Baptist Church is on Main Street at Mile 216.27 of the French Broad River. The floor slopes down from front to rear, and the lower portion was flooded by both the September and October 1964 floods (see Figure 7). Lower view shows the Rosman sewage treatment plant on left bank at Mile 215.92. Operation of the plant, which was built in 1968, would not be seriously affected until the concrete structures were overtopped, but the fence has been damaged by floods in 1969 and 1970. Arrows show the heights of the October 1964, Regional, and Maximum Probable Floods.
