FLOODS
ON
SWANNANOA RIVER
AND
BEETREE CREEK
IN VICINITY OF
SWANNANOA, NORTH CAROLINA

REPORT NO. 0-6198

KNOXVILLE, TENNESSEE
MAY 1963

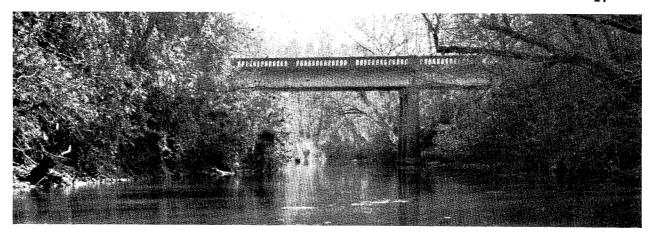
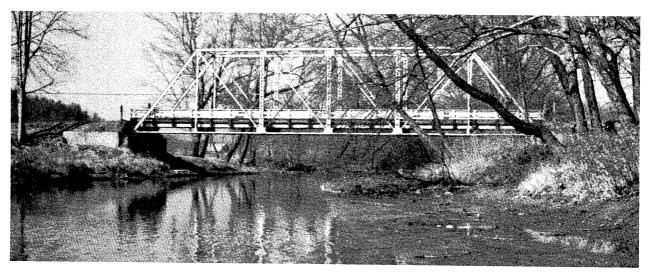
Figure 1. --SWANNANOA RIVER BRIDGES, AZALEA TO ASHEVILLE FARM SCHOOL

Top view shows the U. S. Highway 70 bridge, upstream side, at Mile 7.58. Middle view shows the upstream side of a private bridge at Mile 8.97. The bridge on Farm School Road at Mile 12.21 is shown in bottom picture, looking downstream.

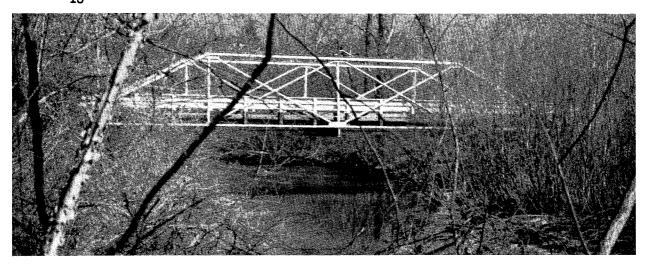
Figure 2. --SWANNANOA RIVER BRIDGES, PINEY GROVE TO SWANNANOA

Top view is upstream side of bridge on a secondary road at Piney Grove, Mile 13.92. Middle view is the old U. S. Highway 70 bridge at Mile 14.80, upstream side. This bridge was built in 1920. Bottom view shows the Whitson Avenue bridge in Swannanoa at Mile 15.43, upstream side. The bridge was built in 1928 and raised about $3\frac{1}{2}$ feet in 1947.

The old U. S. Highway 70 bridge, Mile 14.80, just below Swannanoa School, is a three-span concrete bridge built in 1920. Flood flow at the site is restricted by a solid bridge rail, by an approach fill 6 to 8 feet high on the narrow left-bank flood plain, and by the road fill which follows the right bank upstream from the bridge. During the August 13, 1940, flood there was a drop of 3.4 feet through this bridge.

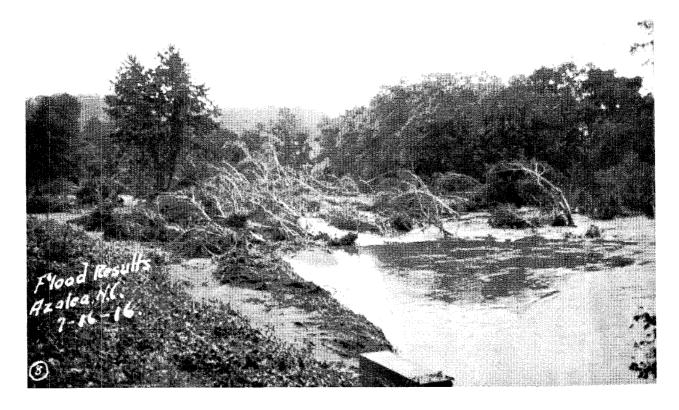
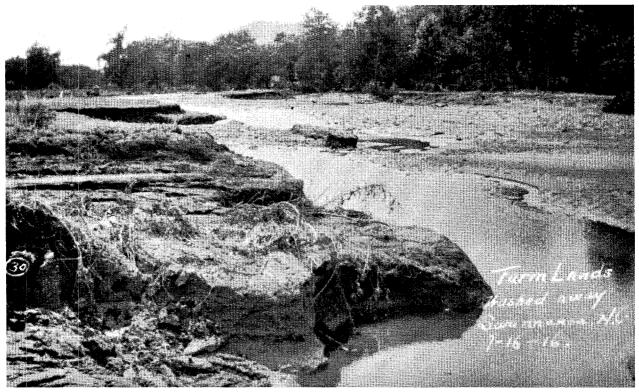
Figure 3. -- EFFECTS OF FLOOD VELOCITIES, JULY 1916

These photographs bear witness to the force of the Swannanoa River floodwaters. Upper view shows trees bent over by the flow, and the lower view is upstream toward a farm field which was lost to the flood. The original channel is at the extreme right of picture.

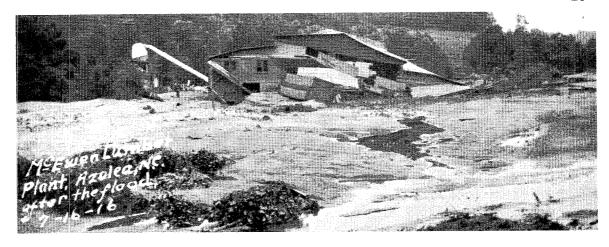
Figure 4. --WRECKAGE OF LUMBER PLANT, JULY 1916

The view is downstream toward the McEwen Lumber Company at Azalea. The buildings were repaired and most of them are still in use. Much stacked lumber was lost here in the flood.

Over the length of the Swannanoa River the flood exacted a heavy toll in land and property. Figures 4 through 7 are photographs of damage in the Swannanoa-to-Azalea reach of the river. These are part of a group of photographs located in the course of flood history investigations which were made in the Black Mountain vicinity in 1962. One of the photographs shows conditions in the vicinity of the bridge at Swannanoa, at the site of the present Whitson Avenue bridge. Others show the severe damage inflicted to private property and the railroad in this reach of the river.

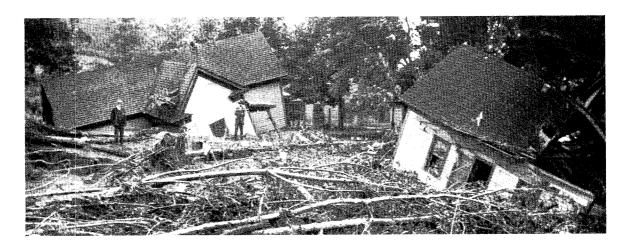
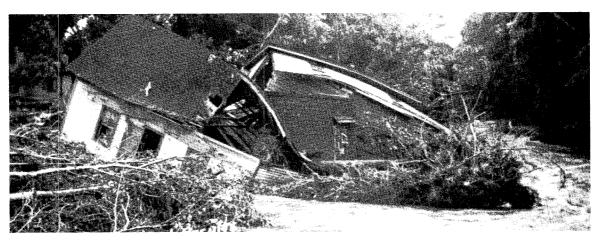
Figure 5. --WRECKED HOUSES AT AZALEA, JULY 1916

These views are on left bank of the Swannanoa River a short distance above the McEwen Lumber Company.

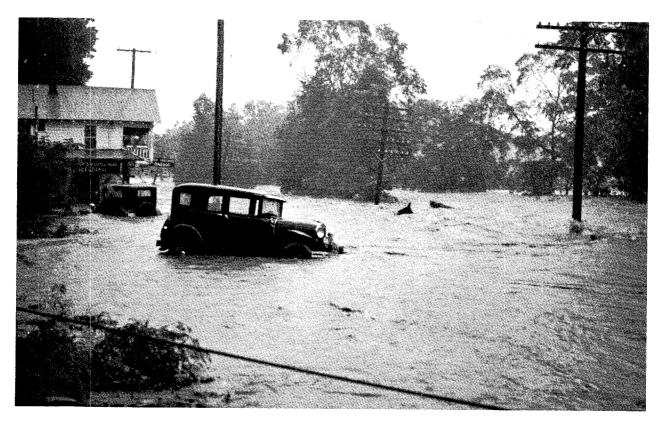
Figure 8. --FLOOD OF AUGUST 13, 1940, AT SWANNANOA

Upper view is from right bank across Whitson Avenue bridge. Lower view is east along U. S. Highway 70 from approximately the same point, and was taken about 3 p.m.

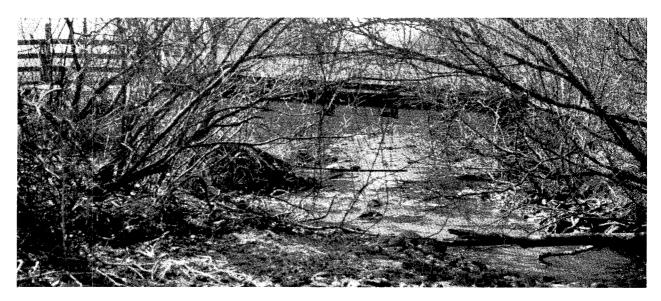
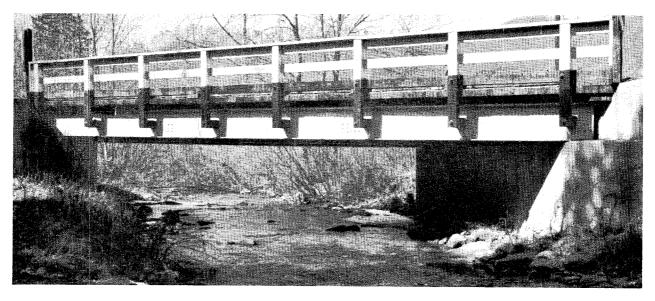
Figure 9. --BRIDGES OVER BEETREE CREEK

Top view is upstream side of Farm School Road bridge at Mile 0.18. Middle view is upstream side of Gregg Branch Road bridge at Mile 1.64, about 1/3 mile above Gregg Branch. Bottom view is upstream side of Long Branch Road bridge, Mile 2.22.

Two bridges and a culvert cross Beetree Creek in the reach investigated. Table 8 lists pertinent elevations for the bridges and shows their relation to the crest of the flood of July 1916. Plate 10 shows the relation of the floor and underclearance at the bridges to the flood profiles on Beetree Creek. Figure 9 shows photographs of the bridges.

All of the bridges have underclearances which are lower than some of the large floods of the past. Most would be carried away by any flood that approached the magnitude of the flood of July 1916.

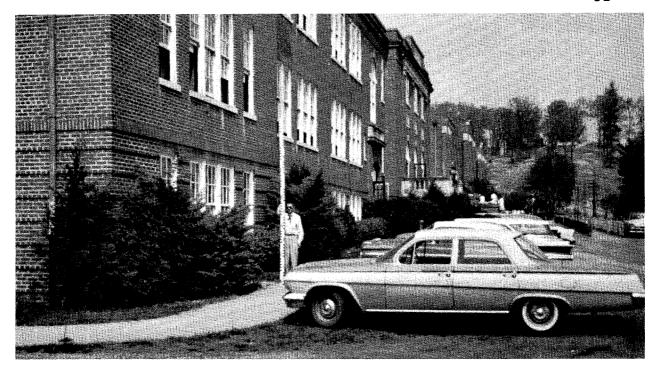
Figure 10. --FLOOD HEIGHTS AT SWANNANOA SCHOOL

The rod is held at the downstream or southwest corner of the school, located on the north side of old Highway 70 below town. The regulated Maximum Probable Flood level would be about two feet below the base of the rod.

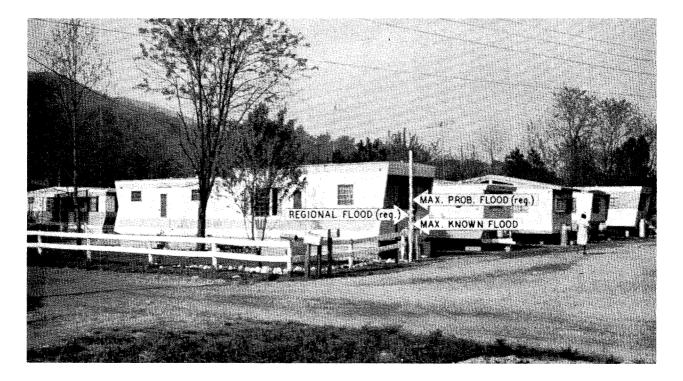
Figure 11. --FLOOD HEIGHTS AT SWANNANOA TRAILER PARK

The park is at Welch Road at Mile 15.13 of the Swannanoa River, on south side of U. S. Highway 70. Arrows show heights of the maximum known (July 1916) flood and the regulated Regional and Maximum Probable Floods.

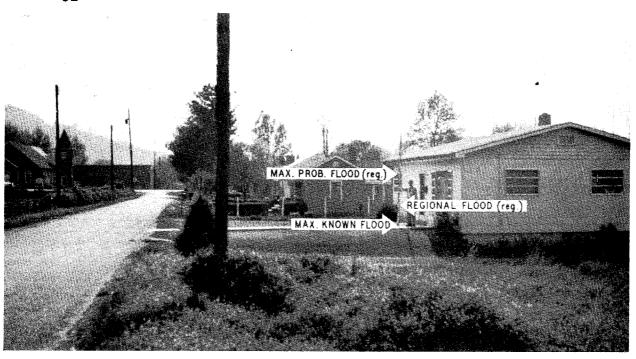
Figure 12. --FLOOD HEIGHTS ON NORTH AVENUE

These houses are on North Avenue downstream from Whitson Avenue, at Mile 15.40. The view is westerly toward Park Street. Arrows show heights of the maximum known (July 1916) flood and the regulated Regional and Maximum Probable Floods.

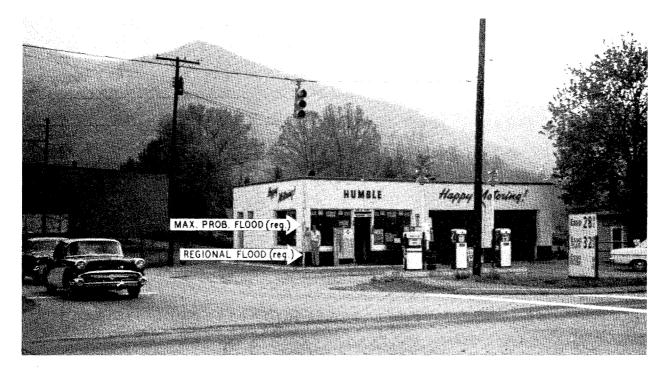
Figure 13. -- FLOOD HEIGHTS AT WHITSON AVENUE

This service station is on U. S. Highway 70 on the southwest corner of the Whitson Avenue intersection, Mile 15.43. The 1916 flood was one foot lower than the base of the rod in the photograph. Arrows show the regulated Regional and Maximum Probable Flood heights.
