FLOOD PLAIN INFORMATION MORGANTON, NORTH CAROLINA

HUNTING CREEK & TRIBUTARIES

PREPARED BY THE CORPS OF ENGINEERS, U. S. ARMY

CHARLESTON, SOUTH CAROLINA, DISTRICT JULY 1969

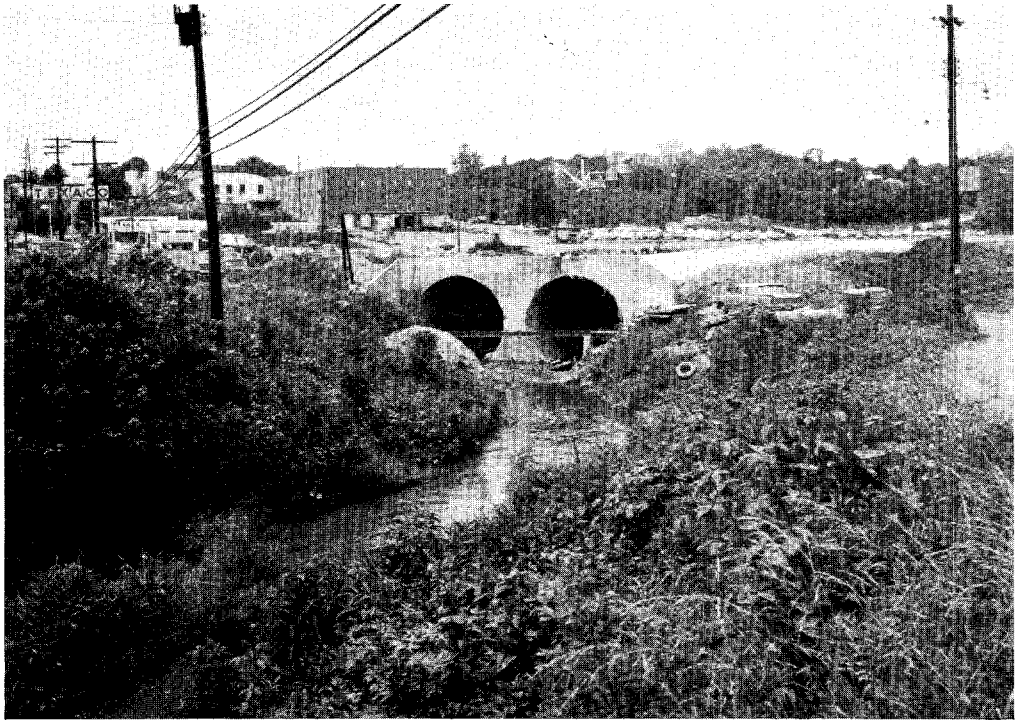
Figure 1 **FLOOD PLAIN ENCROACHMENT**
Obstruction to flow increases future flood heights.

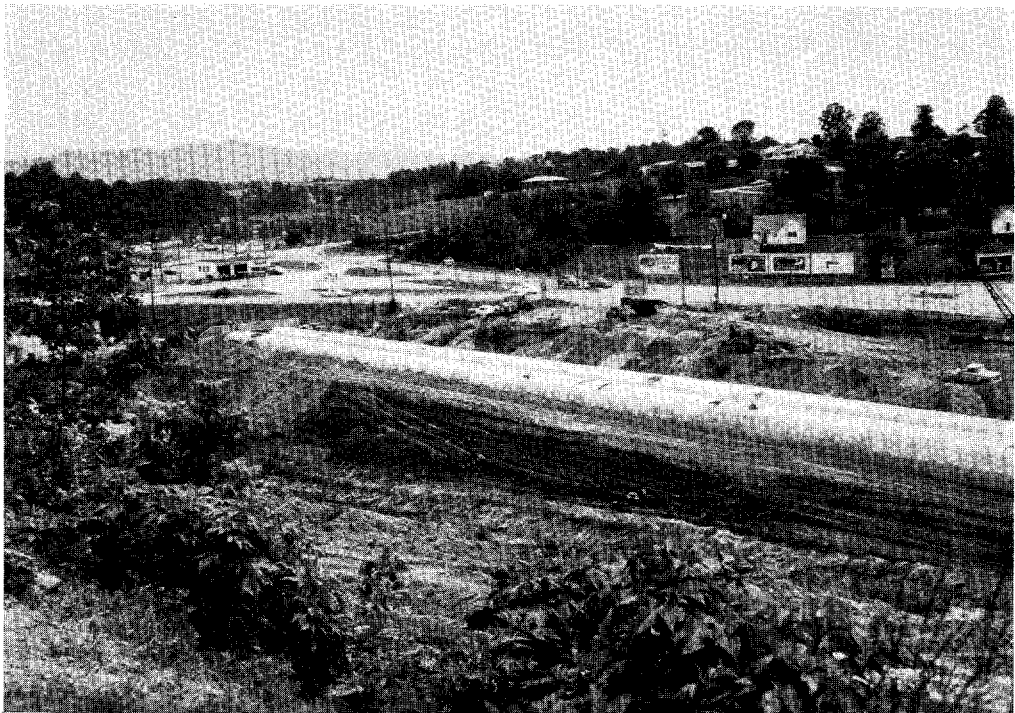
Figure 2 **FILL IN THE FLOOD PLAIN**
Fill in the flood plain reduces the natural flow area and may increase future flood heights.

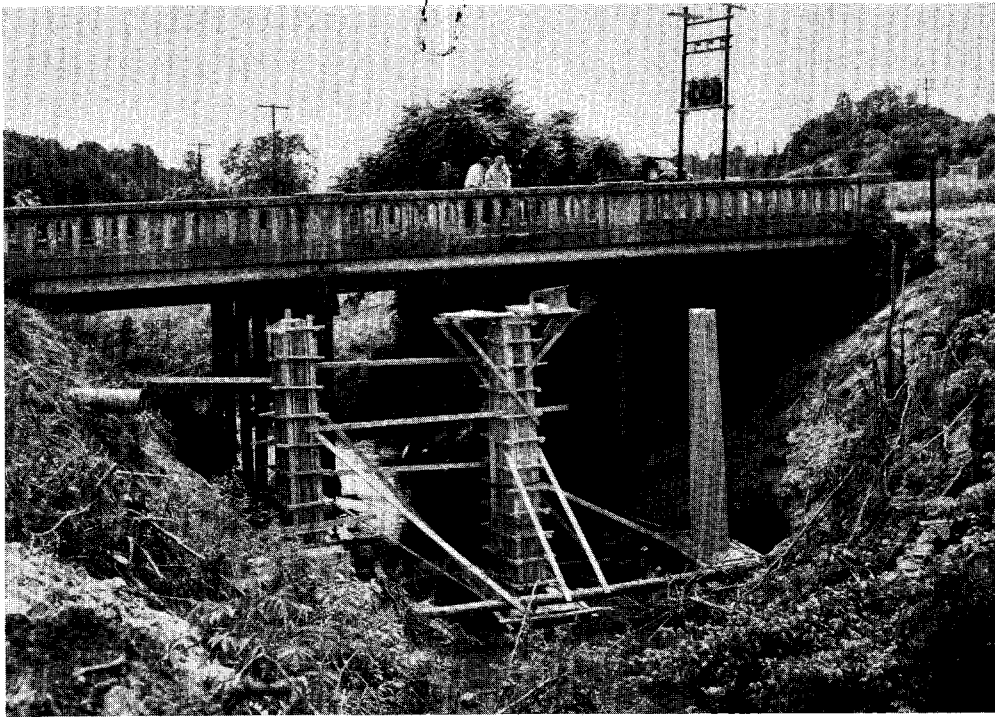
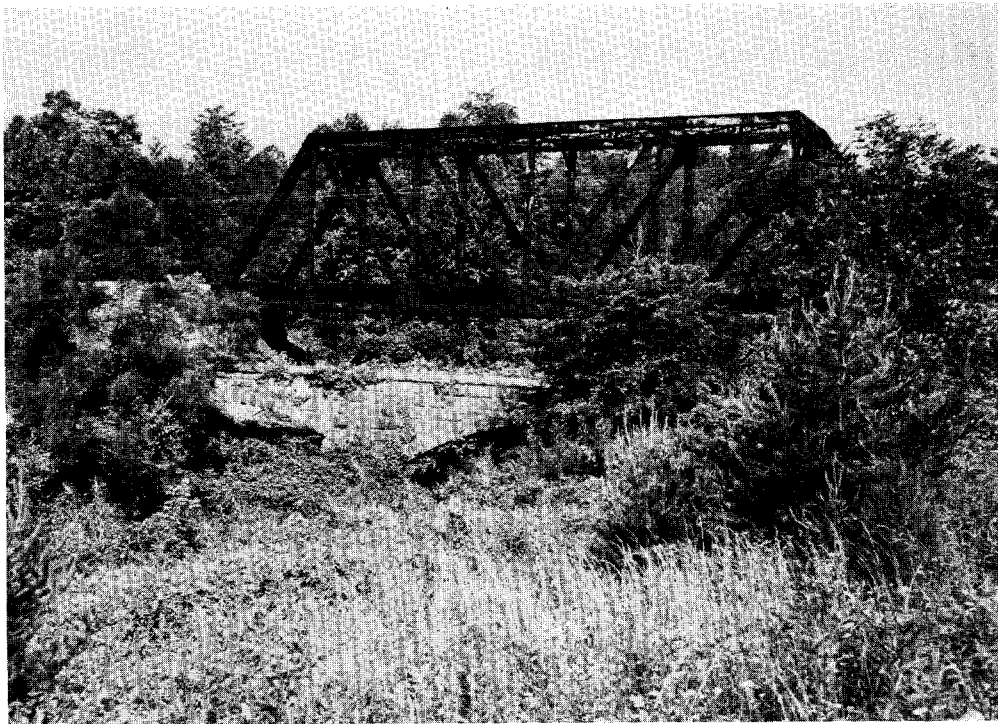
Figure 3

Man-made obstructions which may affect future flood heights.

Natural obstructions which increase flood heights.

OBSTRUCTIONS TO FLOW

The effect of obstruction due to bridges and the collection of debris has been discussed under the preceding topic. Other types of obstructions frequently encountered are fills, pipe crossings, dams, and heavy growth in the channel and overbank flow areas. Land filling is one form of flow obstruction common along urban streams. In order to protect new structures from flooding, developers often fill flood plain areas before beginning construction. As other filling operations occur, the stream's natural floodway decreases and consequently the flood heights increase with a loss of the flood protection gained from earlier filling operations.

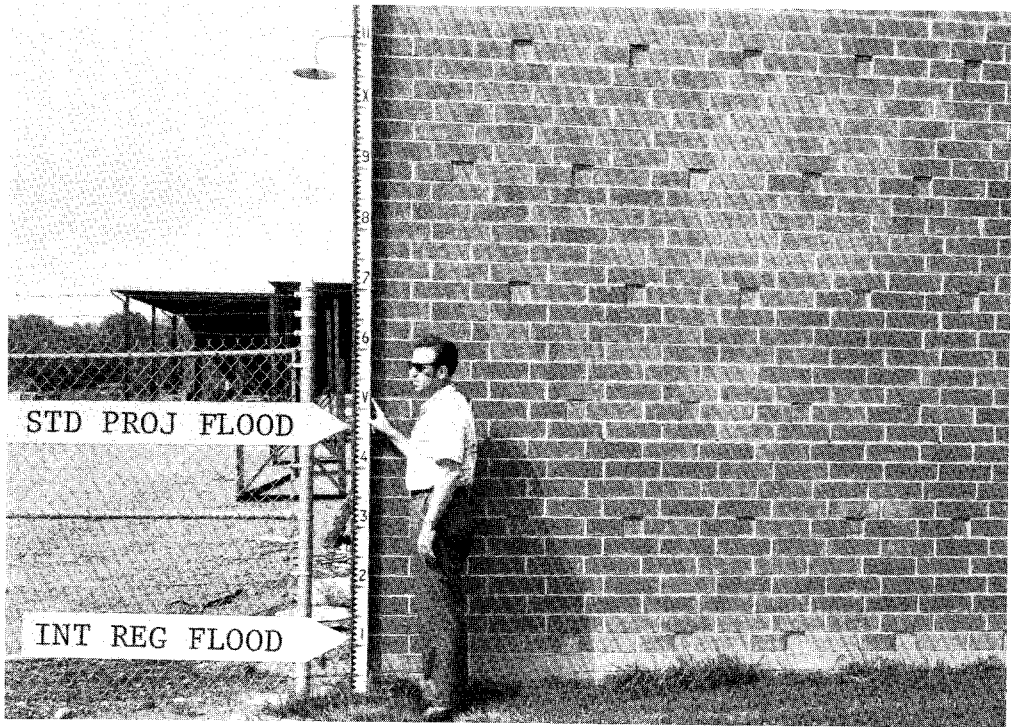
Arrows show approximate heights that would be reached by the Standard Project and Intermediate Regional Floods at an industrial building upstream from Bethel Road.

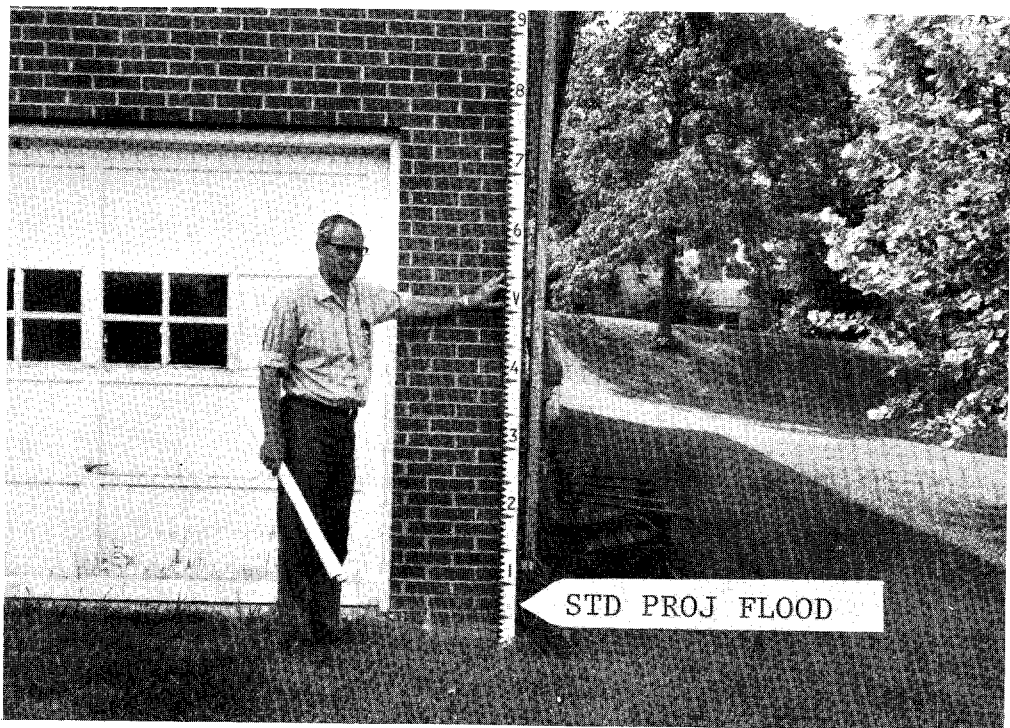
Arrow shows approximate height that would be reached by the Standard Project Flood at a home on Bethel Road.
