**FLOODS**  
ON  
**NORTH TOE RIVER**  
AND  
**BEAVER & GRASSY CREEKS**

IN VICINITY OF  
**SPRUCE PINE**  
**NORTH CAROLINA**

TENNESSEE VALLEY AUTHORITY  
DIVISION OF WATER CONTROL PLANNING

REPORT NO. 0-6372

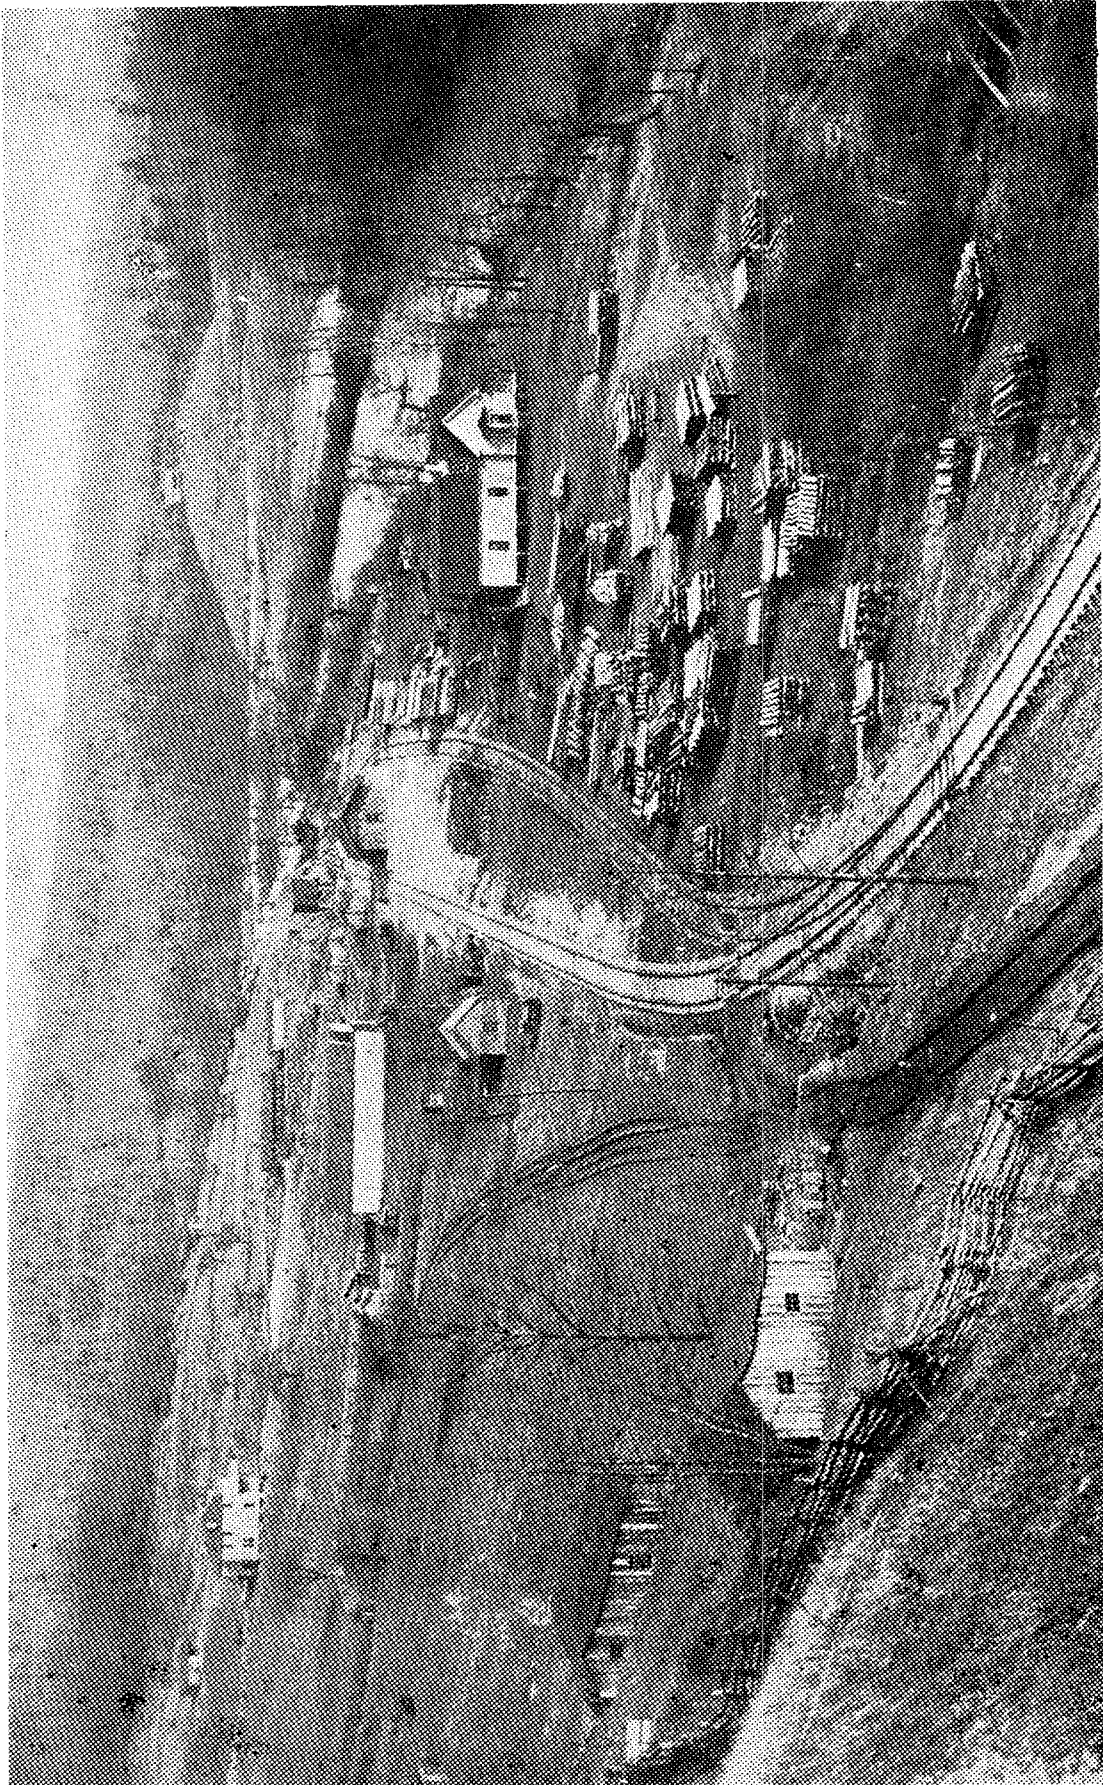
Figure 1. --SPRUCE PINE SOON AFTER COMPLETION OF RAILROAD

This view of the settlement was taken in 1905, soon after the Clinchfield Railroad was built. The photograph appeared in the Tri-County News, Spruce Pine, on January 21, 1960. Landmarks identified include the Phillips Hotel at upper left, a livery stable in center background, the L. A. Berry store and post office with white roof at center, and the Berry home beyond the piles of crossties. The picture was taken from a point near the present U. S. Highway 19E bridge.

The view is upstream from a vantage point near that used for the picture in Figure 1. The highway bridge can be seen at lower right corner, and the business development along Locust Avenue is at left.

Spruce Pine was incorporated by an act of the North Carolina General Assembly on February 5, 1907. According to the 1960 census report the population of Spruce Pine is 2504 persons and that of Mitchell County is 13,906 persons. Figures 1 and 2 are photographs of the Town of Spruce Pine made in 1905 and in 1963, respectively.

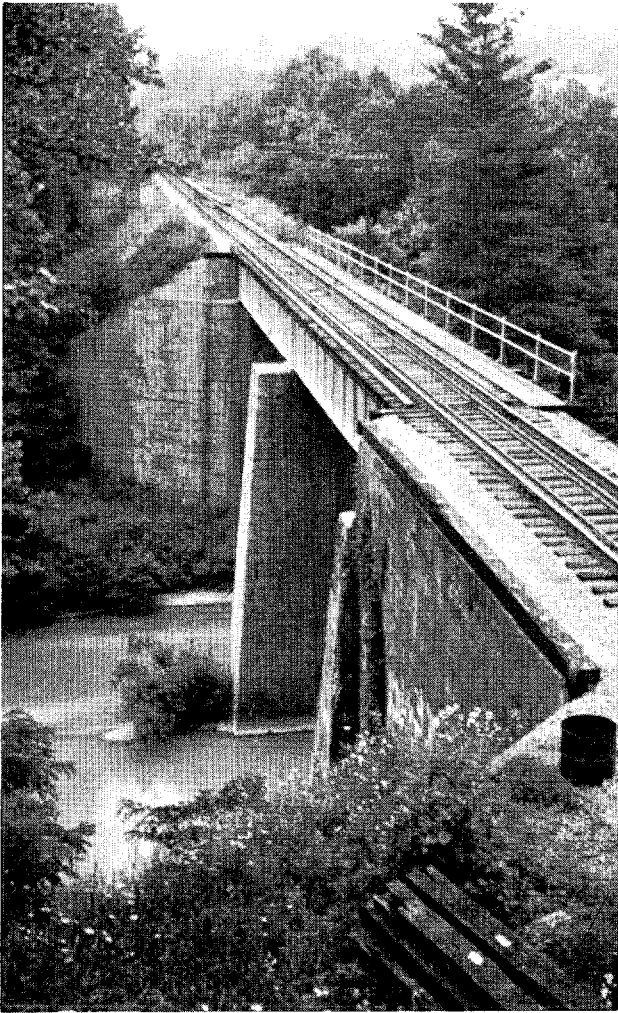
Figure 7. --NORTH TOE RIVER  
BRIDGES ABOVE SPRUCE PINE

The Clinchfield Railroad bridge at Mile 33.86 is seen from left bank in the upper view. The lower picture shows the bridge on the highway leading to Altapass, viewed from right bank at Mile 35.04; the bridge was built in 1916.

Two highway bridges, one railroad bridge, and three footbridges cross North Toe River in the vicinity of Spruce Pine. Table 3 lists pertinent elevations for these bridges and shows their relation to the crest of the flood of July 1916 and the Regional Flood. Plate 6 shows the relation of the floor and underclearance at the bridges to the flood profiles for the reach. Figures 6 and 7 are photographs of the bridges.

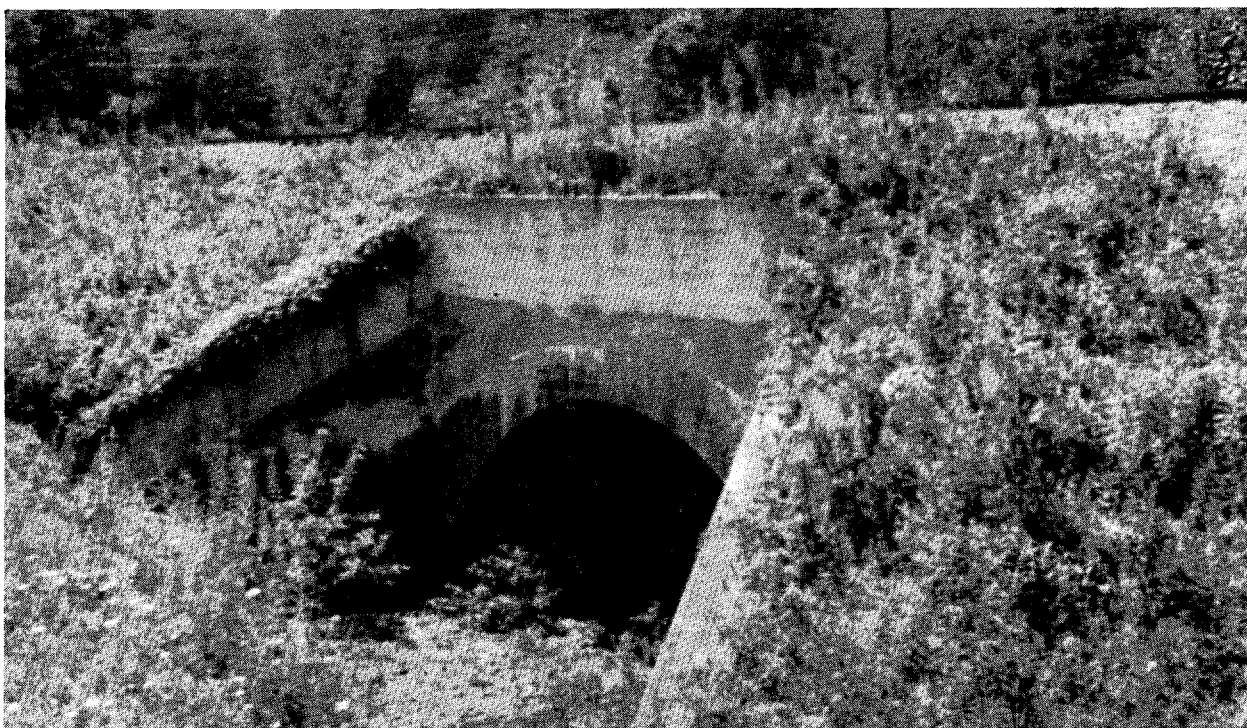
Figure 9.--CLINCHFIELD RAILROAD CULVERT OVER BEAVER CREEK

This view of upstream side of the culvert shows the small opening which, with the railroad fill, controls the flow in the lower reaches of the creek. The creek mouth is just below the culvert.

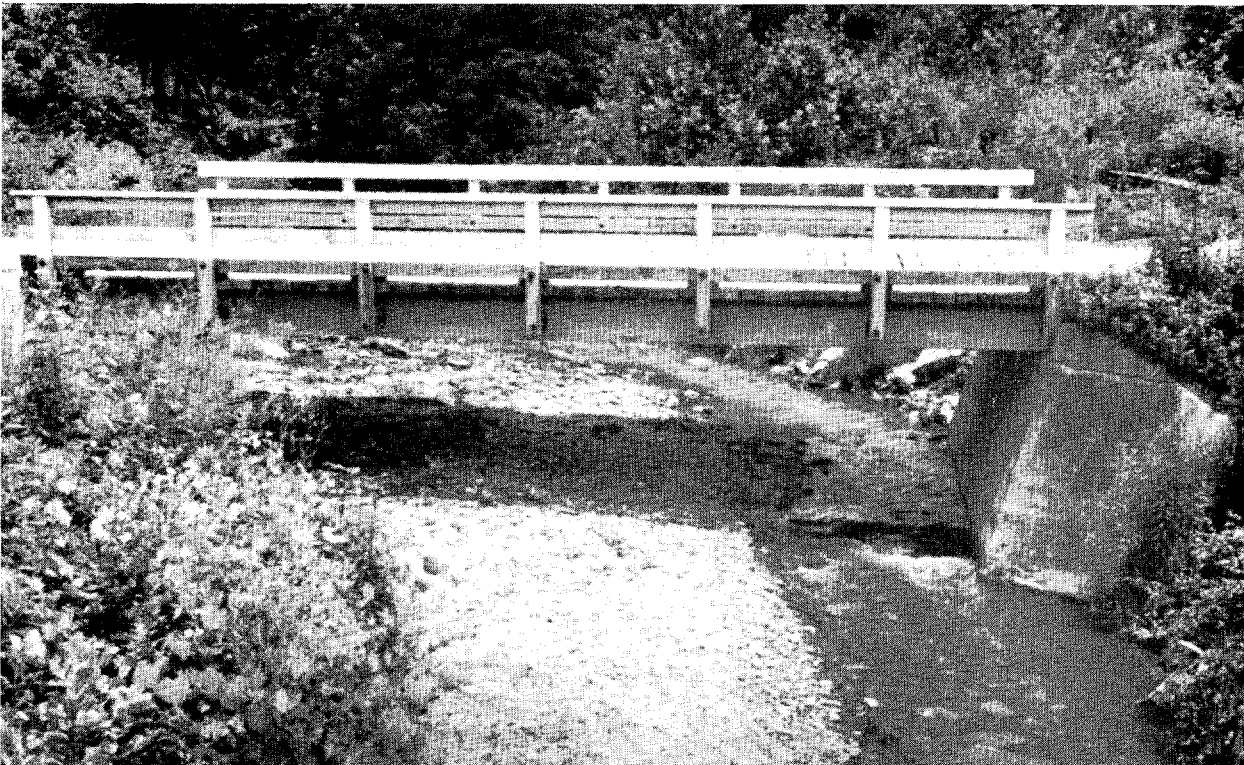
Figure 10.--HIGHWAY BRIDGES NEAR MOUTH OF BEAVER CREEK

Upper view is the Altapass Highway bridge at Mile 0.04, upstream side. The head-wall of the railroad culvert in Figure 9 can be seen in background. These two culvert openings are the same size. Lower view shows the Gulf Street bridge, downstream side, at Mile 0.06.

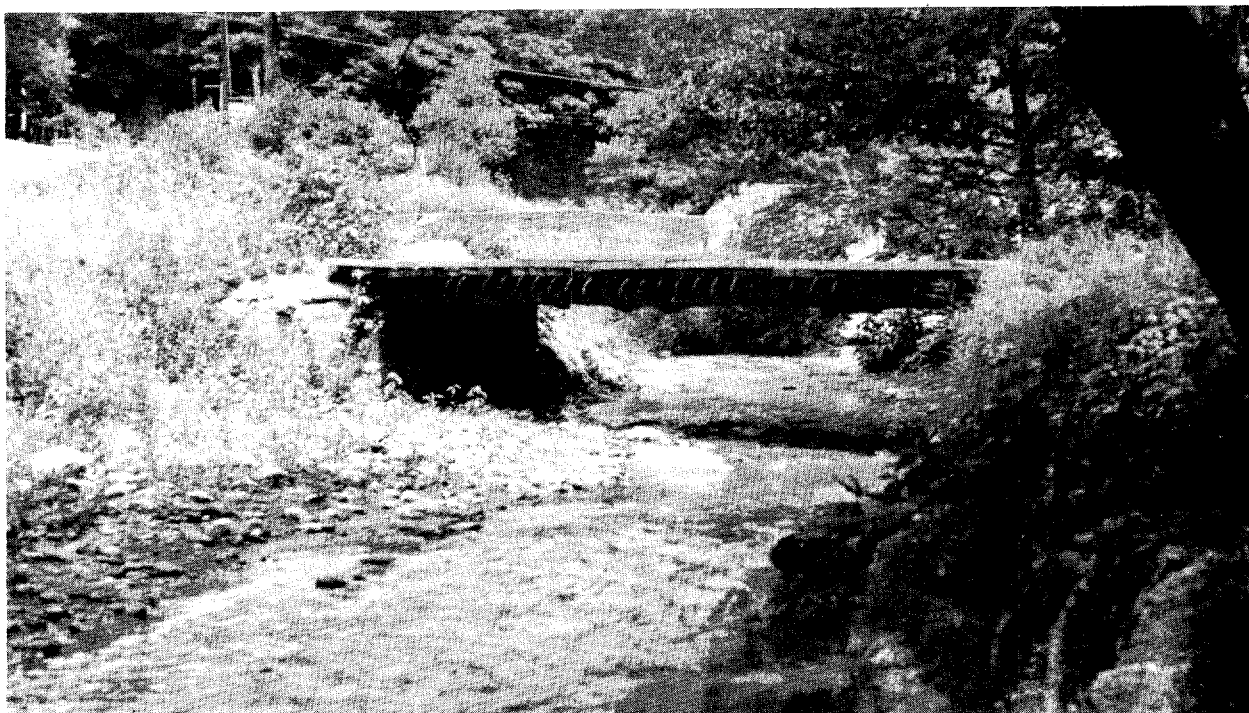
Figure 11. --WARD STREET BRIDGE OVER BEAVER CREEK

View upstream toward log and plank bridge at Mile 0.42. In the background is an old concrete dam of which a section at the channel is gone; the remainder is broken and would probably be washed out by a large flood.

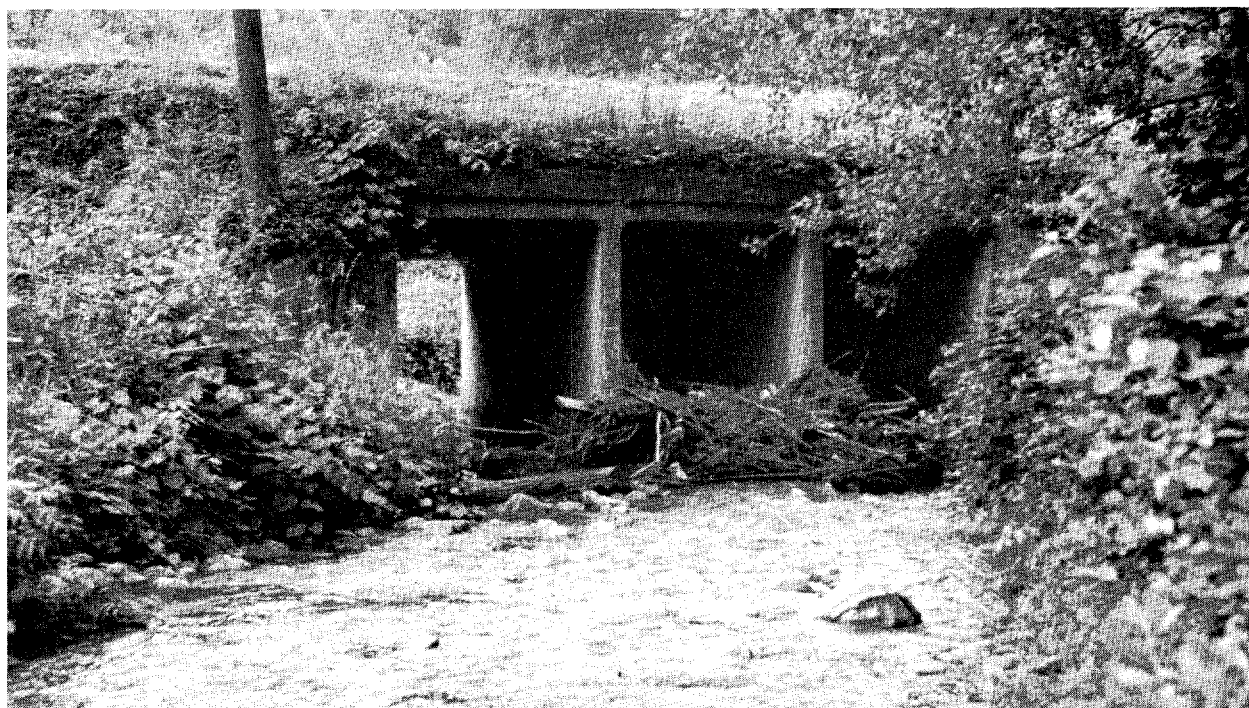
Figure 12. --U. S. HIGHWAY 19E BRIDGE OVER BEAVER CREEK

This 3-opening box culvert at Mile 1.00, seen from upstream, accumulates debris which remains to obstruct the waterway for subsequent high flows.

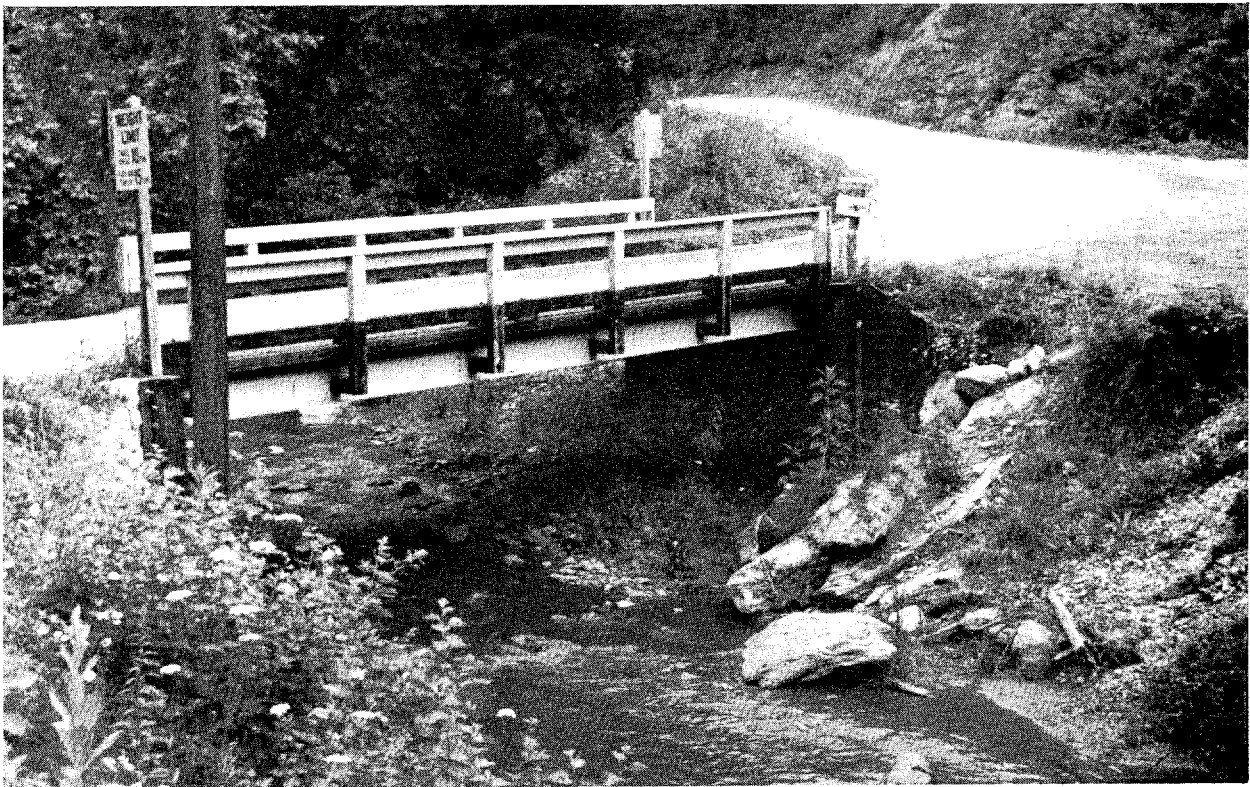
Figure 13. --MINOR BRIDGES ON BEAVER CREEK ABOVE SPRUCE PINE

Upper view shows the upstream face of Cabin Road bridge at Mile 1.07. This concrete bridge was built in 1921. Lower view is the downstream side of Hanging Rock Road bridge at Mile 1.27.

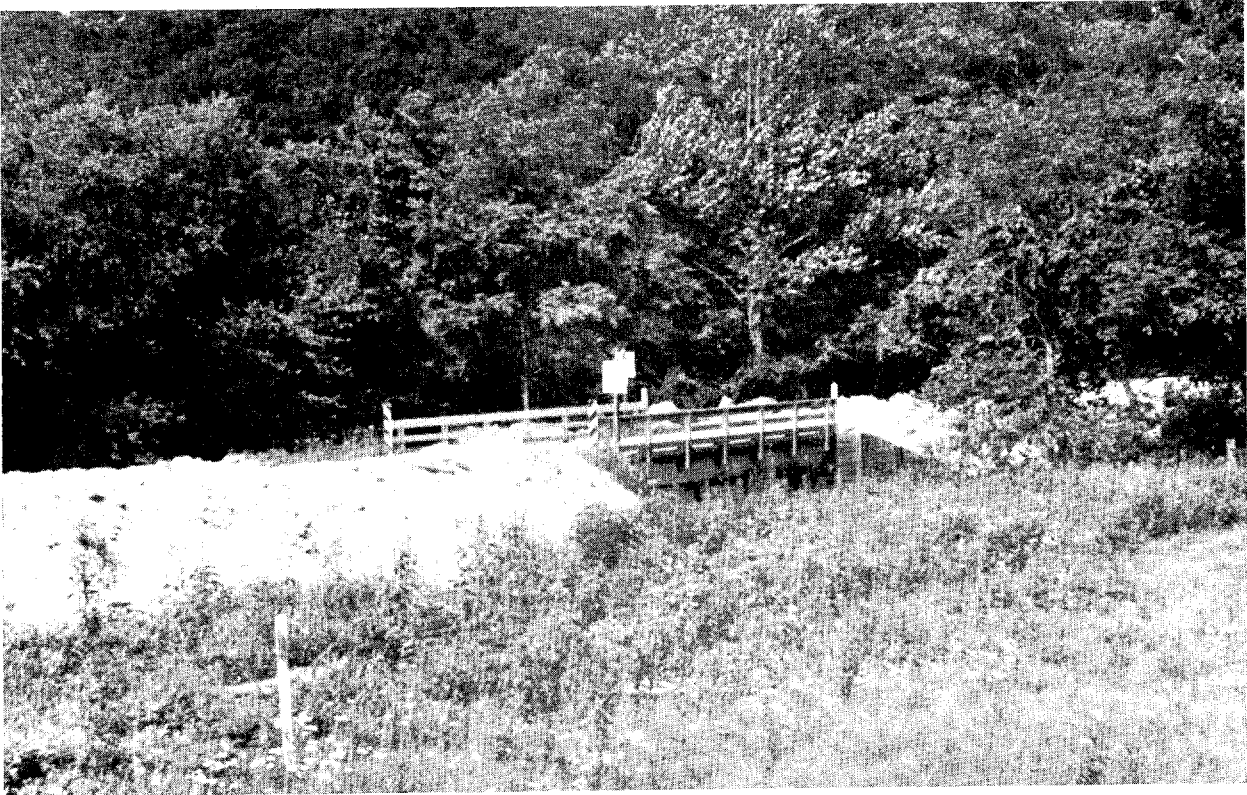
Figure 16.--GRASSY CREEK BRIDGES

Upper view shows the bridge on Carter Ridge Road over Grassy Creek at Mile 0.97, as seen from left bank toward the northwest. Lower view is the downstream side of the North Carolina Highway 226 bridge at Mile 2.23.

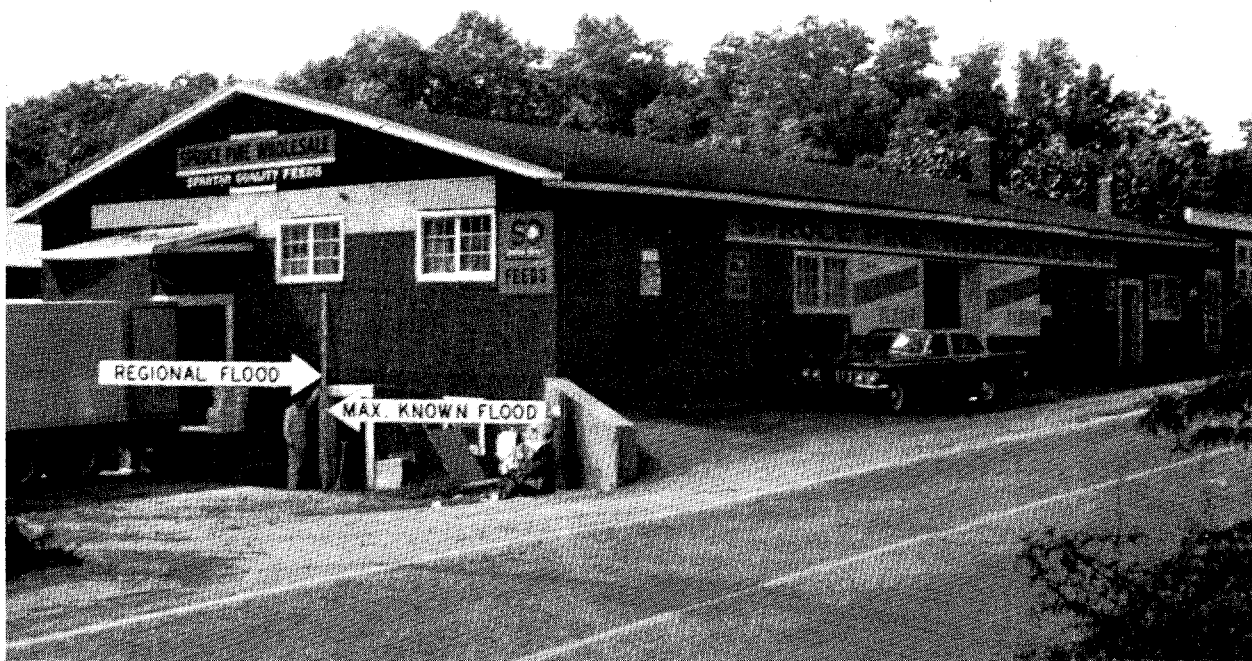
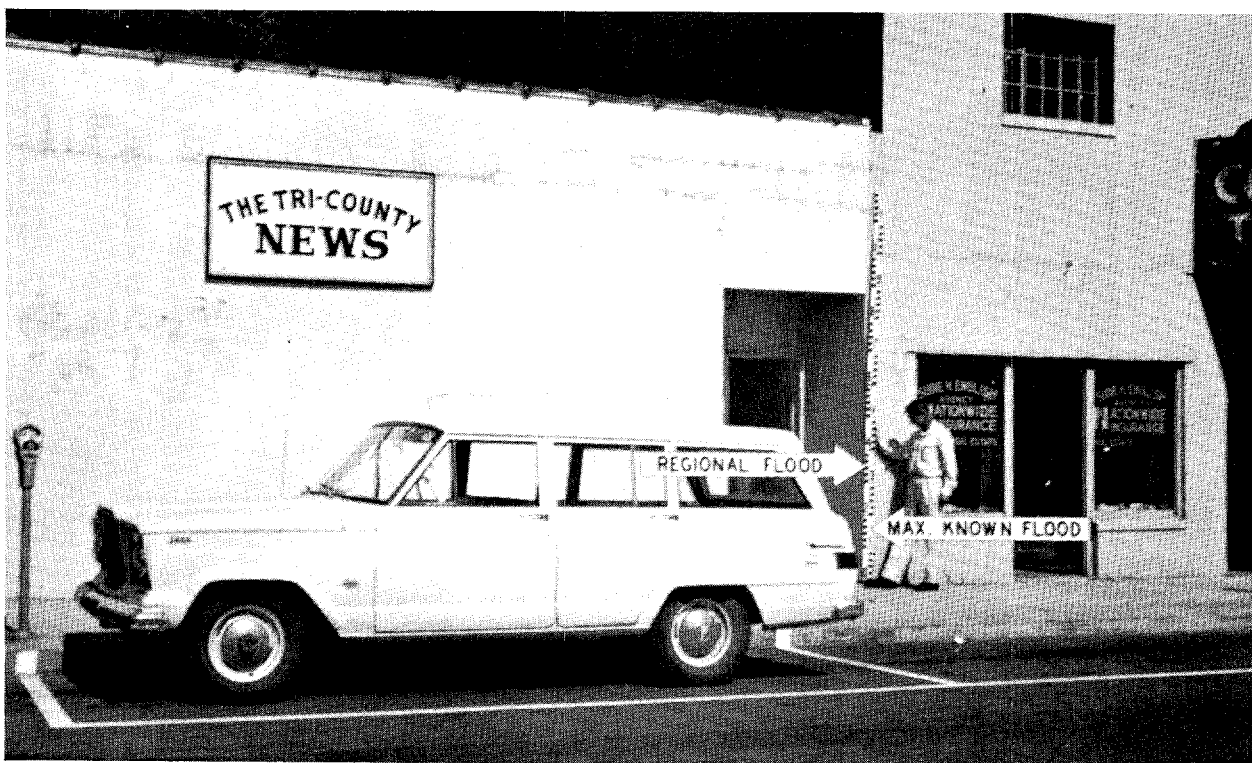
Figure 17. --FLOOD HEIGHTS BELOW SPRUCE PINE

Spruce Pine Wholesale Company, at Mile 31.18 on North Toe River, is shown in upper view. Lower picture is the Tri-County News building at Mile 31.53, near the lower end of Locust Avenue. Arrows show the heights of the July 1916 flood and the Regional Flood. The Maximum Probable Flood would be respectively 10 and 14 feet higher than the Regional Flood in the two views.

The profile of the Regional Flood on North Toe River is shown on Plate 6. Plates 7 and 8 show the Regional Flood profiles on Beaver Creek and Grassy Creek. Figures 17 to 24 show the height that would be reached by the Regional Flood at several locations in the vicinity of Spruce Pine.

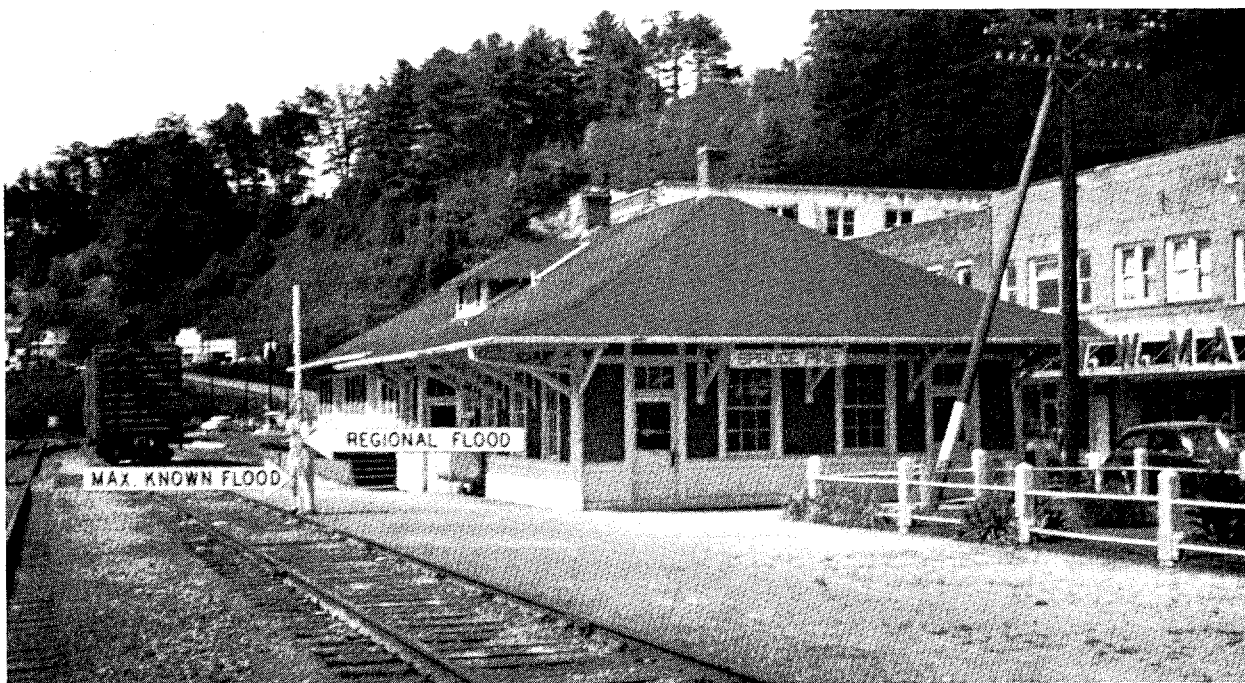
Figure 18. --FLOOD HEIGHTS AT CLINCHFIELD RAILROAD STATION

The depot is at Mile 31.59, and the river is some 200 feet (to left) of the tracks. Arrows show heights of the 1916 and Regional Floods; the Maximum Probable Flood would exceed the Regional Flood by 14 feet.

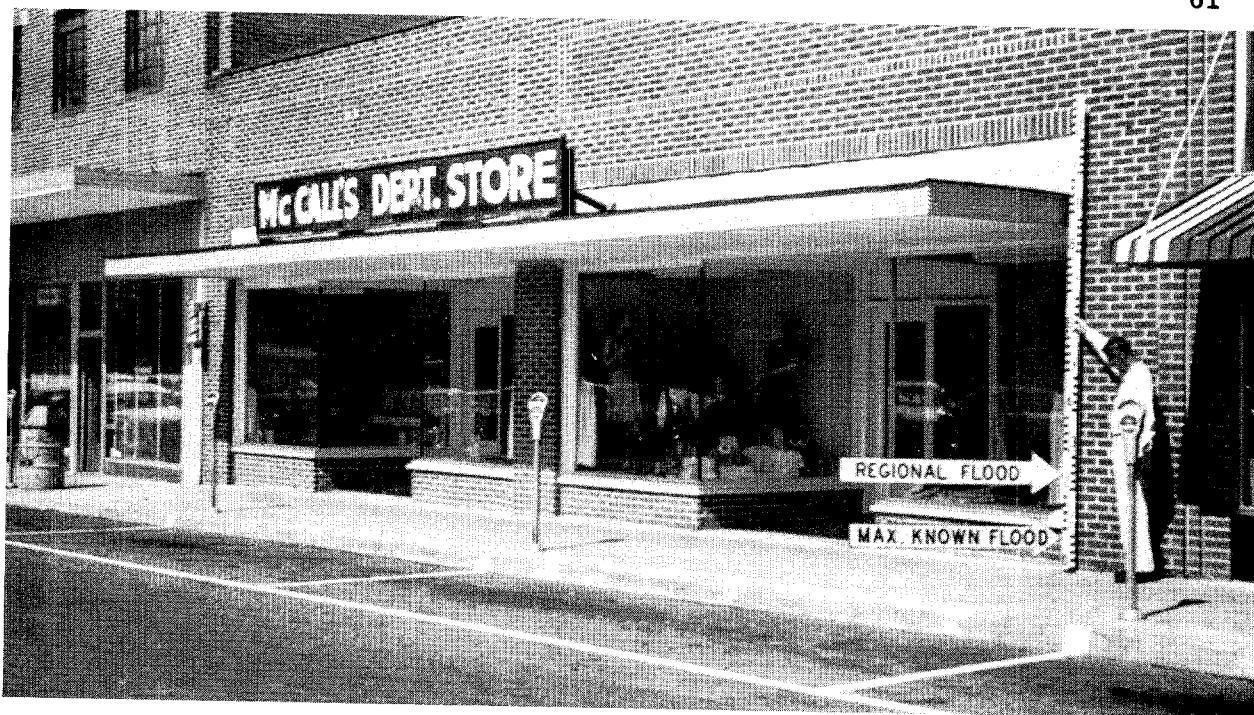
Figure 20. --FLOOD HEIGHTS ALONG LOCUST AVENUE

Arrows show the July 1916 and Regional Flood heights at McCall's Department Store, on Locust Avenue a block upstream from the depot, opposite Mile 31.66 on the river. The Maximum Probable Flood would be  $13\frac{1}{2}$  feet higher than the Regional Flood.

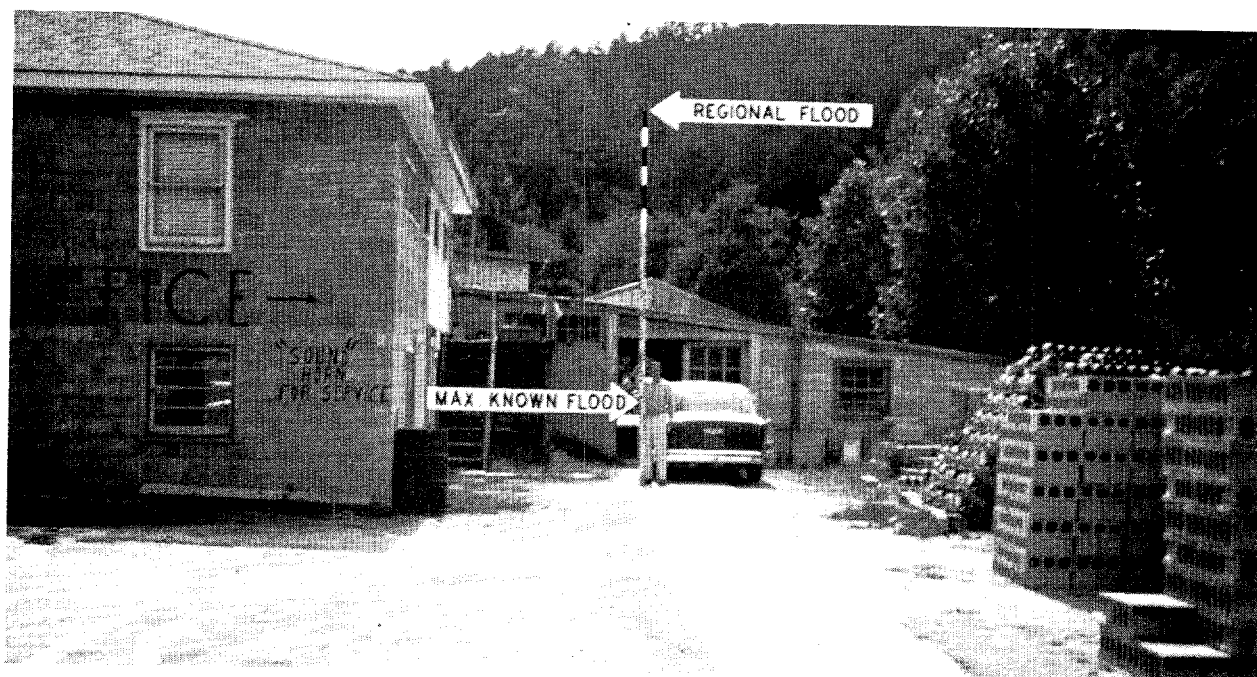
Figure 21. --FLOOD HEIGHTS ABOVE SPRUCE PINE

This concrete block factory is on the North Toe River at Mile 34.87, about 3 miles upstream from the center of town. Arrows show the July 1916 and Regional Flood heights. The Maximum Probable Flood would exceed the Regional Flood by 12 feet. The 1916 flood under present conditions would be  $6\frac{1}{2}$  feet higher than it actually was.

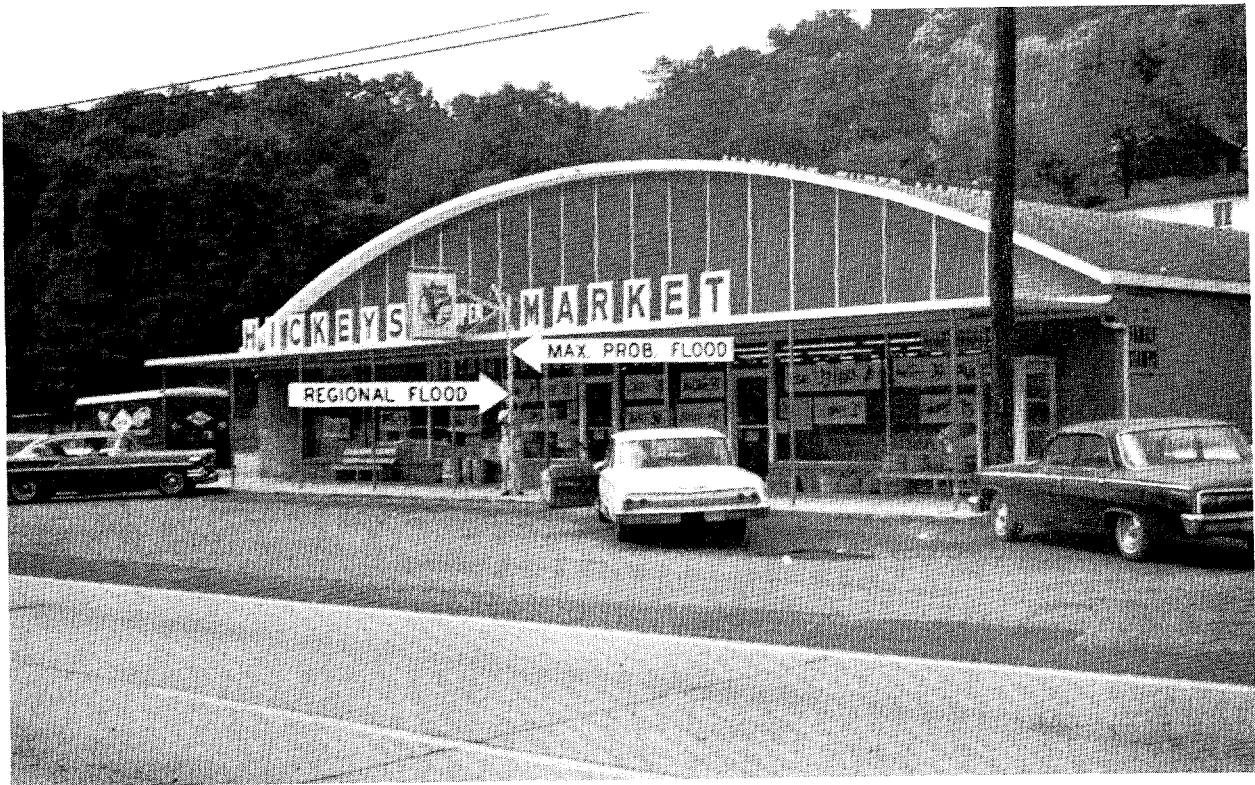
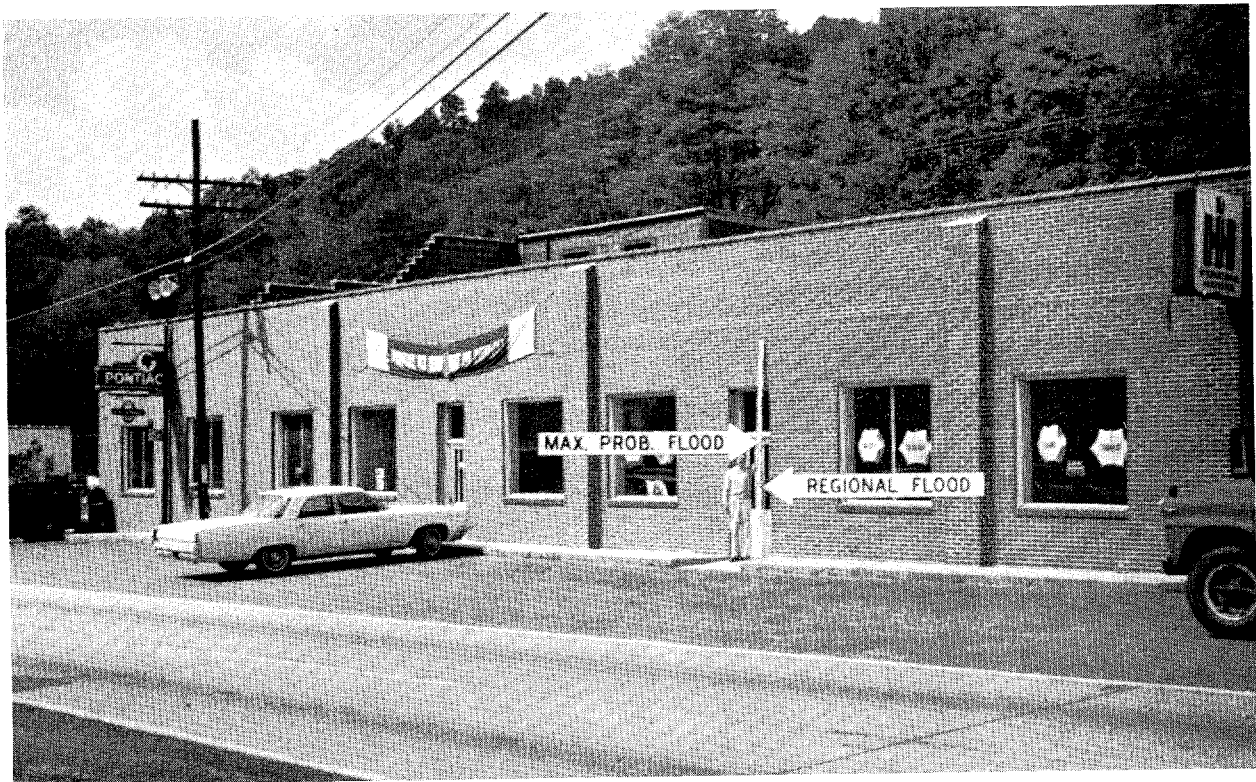
Figure 22.--FLOOD HEIGHTS ALONG BEAVER CREEK

Upper view shows Hickey's Super Market on U. S. Highway 19E, opposite Mile 0.61 on Beaver Creek. Lower view is the salesroom of the Maryland Motor Company at Mile 0.69. Arrows show heights of the Regional and Maximum Probable Floods.

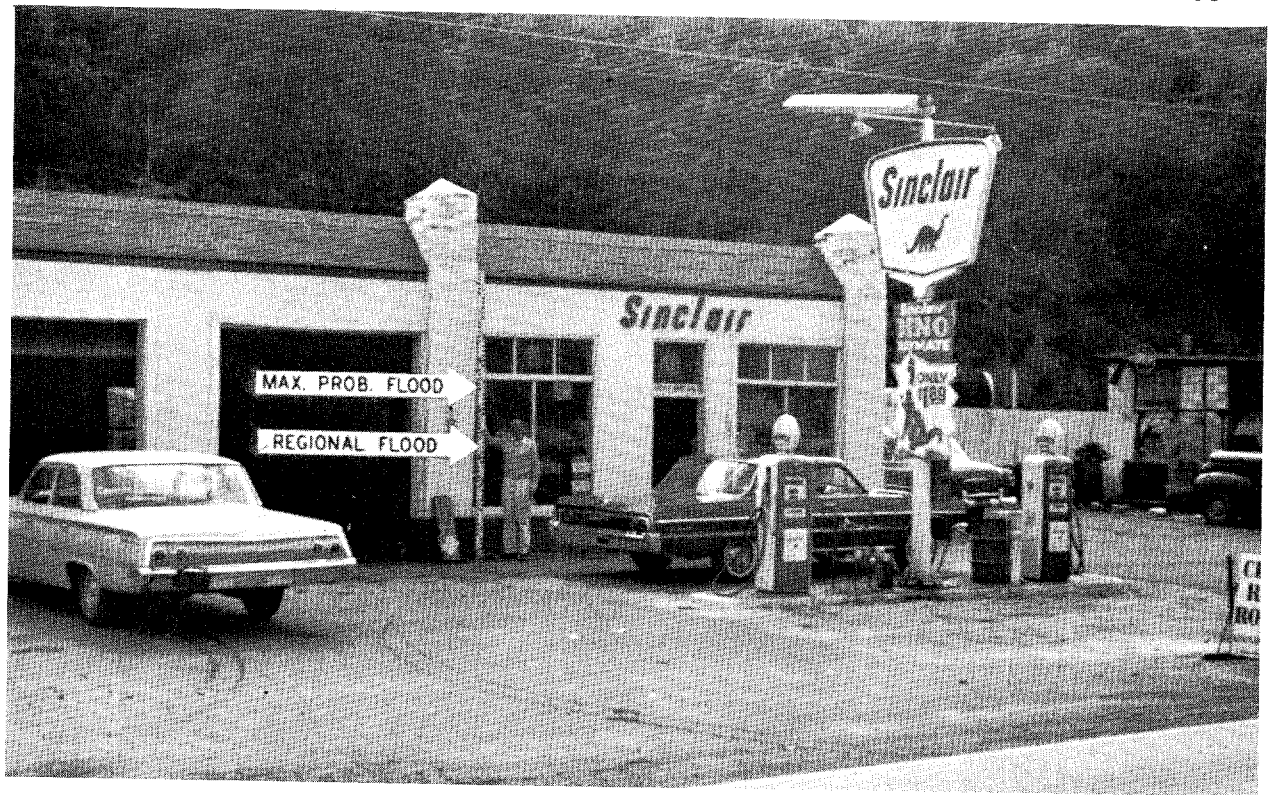
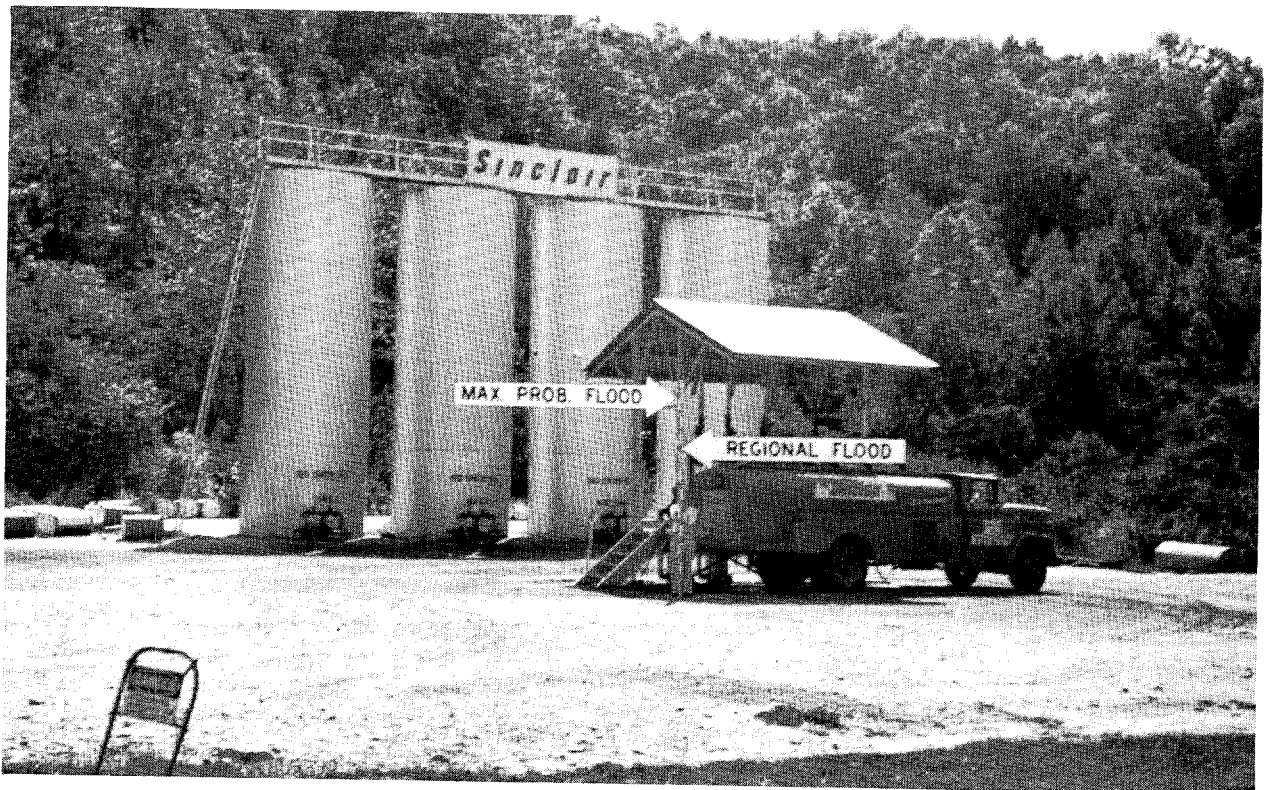
Figure 23. --RETAIL AND WHOLESALE OUTLETS SUBJECT TO FLOOD

Upper view is the Barksdale service station opposite Mile 0.72 on Beaver Creek. Lower view shows the pump and storage tank area of D. O. Blevins' Sons at Mile 0.96, near the U. S. Highway 19E crossing. Arrows show Regional and Maximum Probable Flood heights.

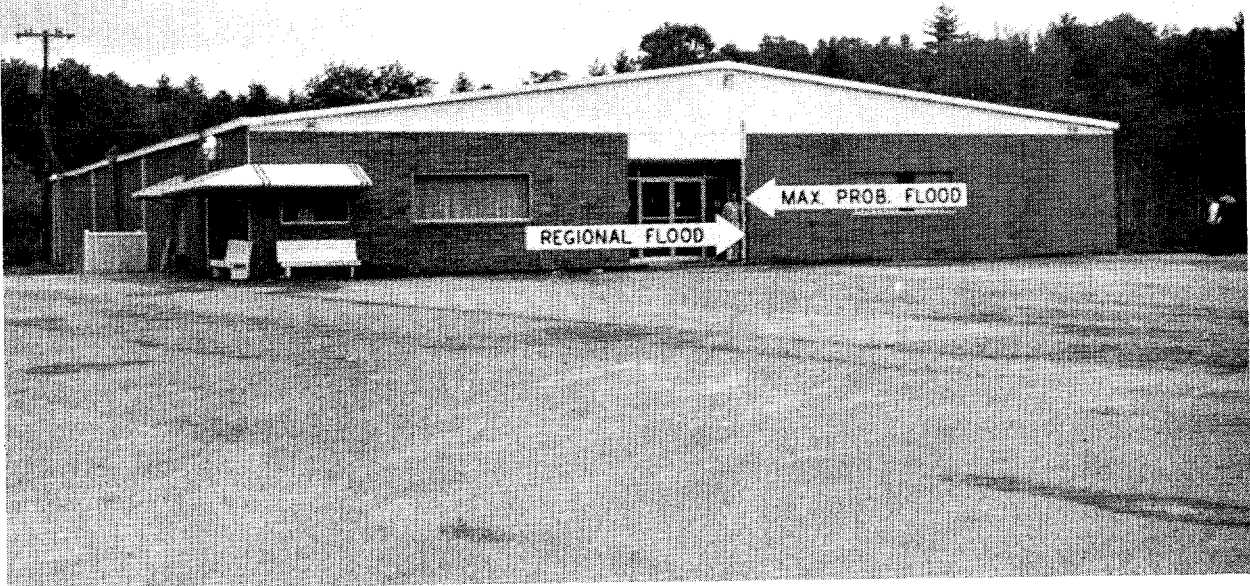
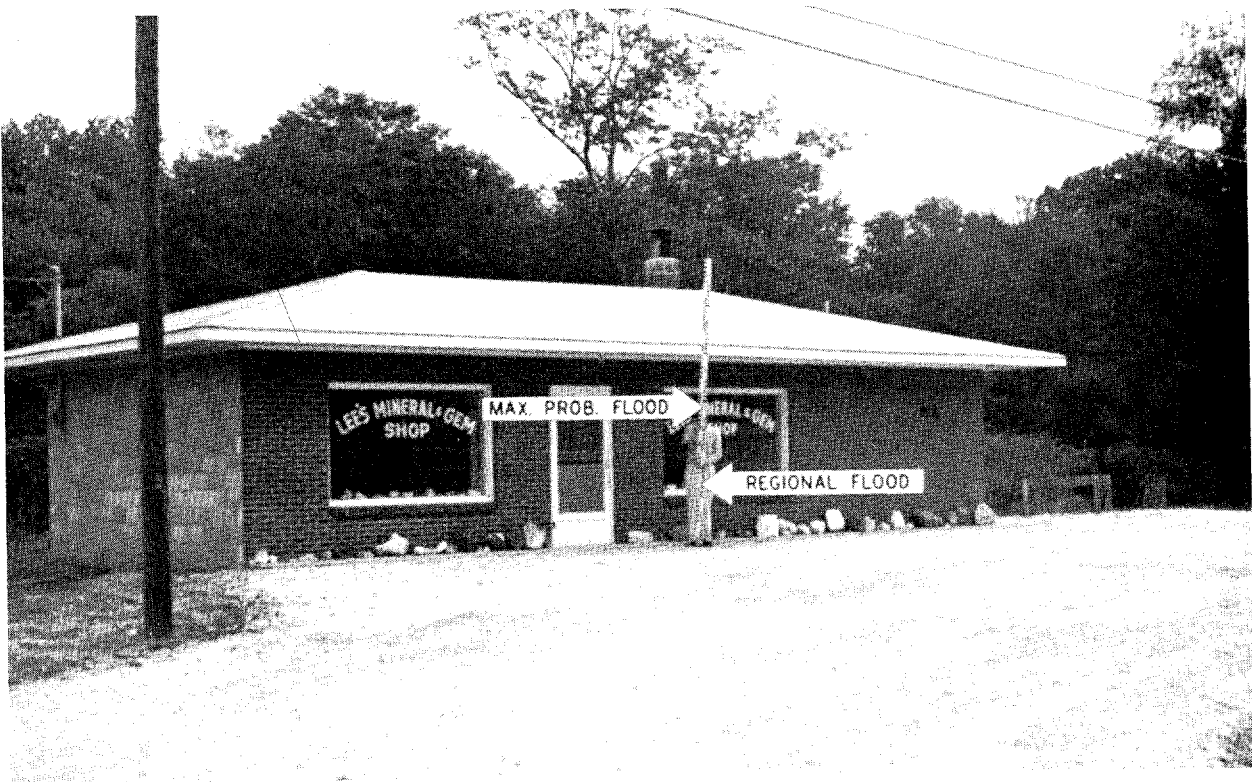
Figure 24.--FLOOD HEIGHTS ALONG GRASSY CREEK

Upper view shows the Pine Valley Lanes on North Carolina Highway 226, at Mile 1.05 on Grassy Creek. Lower view is Lee's Mineral and Gem Shop on the same highway in the community of Grassy Creek, Mile 2.15. Arrows show the Regional and Maximum Probable Flood heights.
