FLOODS
ON
FRENCH BROAD & DAVIDSON RIVERS
AND
KING, NICHOLSON, & TUCKER CREEKS
IN VICINITY OF
BREVARD, NORTH CAROLINA

REPORT NO. 0-6373

KNOXVILLE, TENNESSEE
MAY 1964

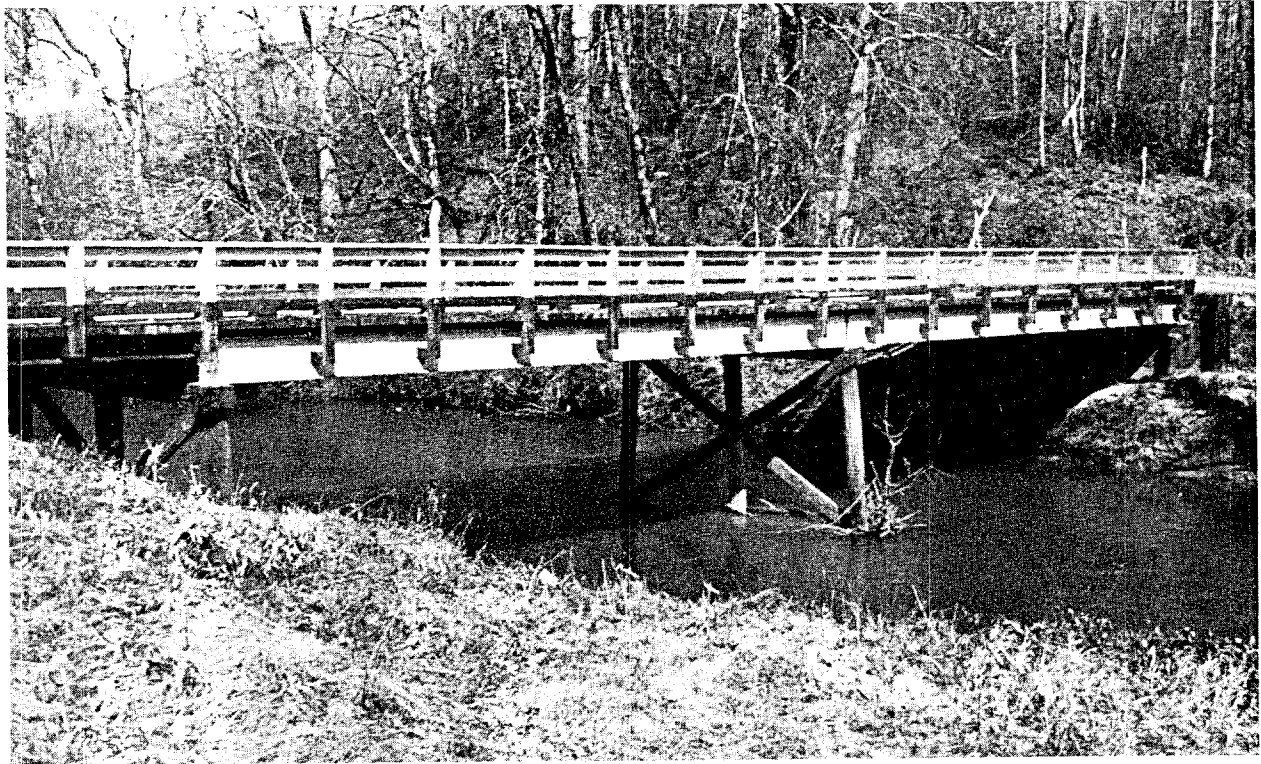
County bridge at Mile 202.27, upstream side.

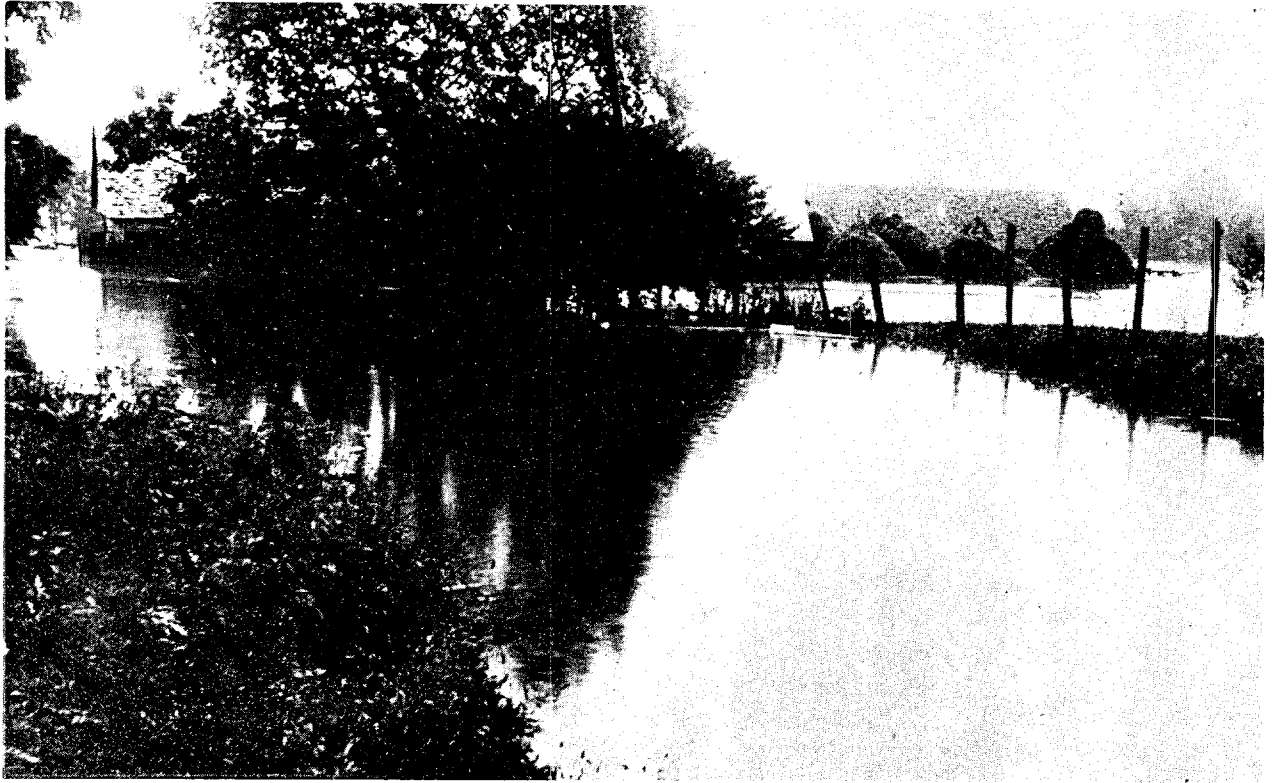
Figure 4. --FLOOD OF JULY 1916 NEAR PISGAH FOREST

Upper view is east along the main road, from a point about 500 feet west of the Davidson River, taken during the flood of July 16-17, 1916. Lower view shows the same stretch of road in 1964. The road is now known as old U. S. Highway 64.

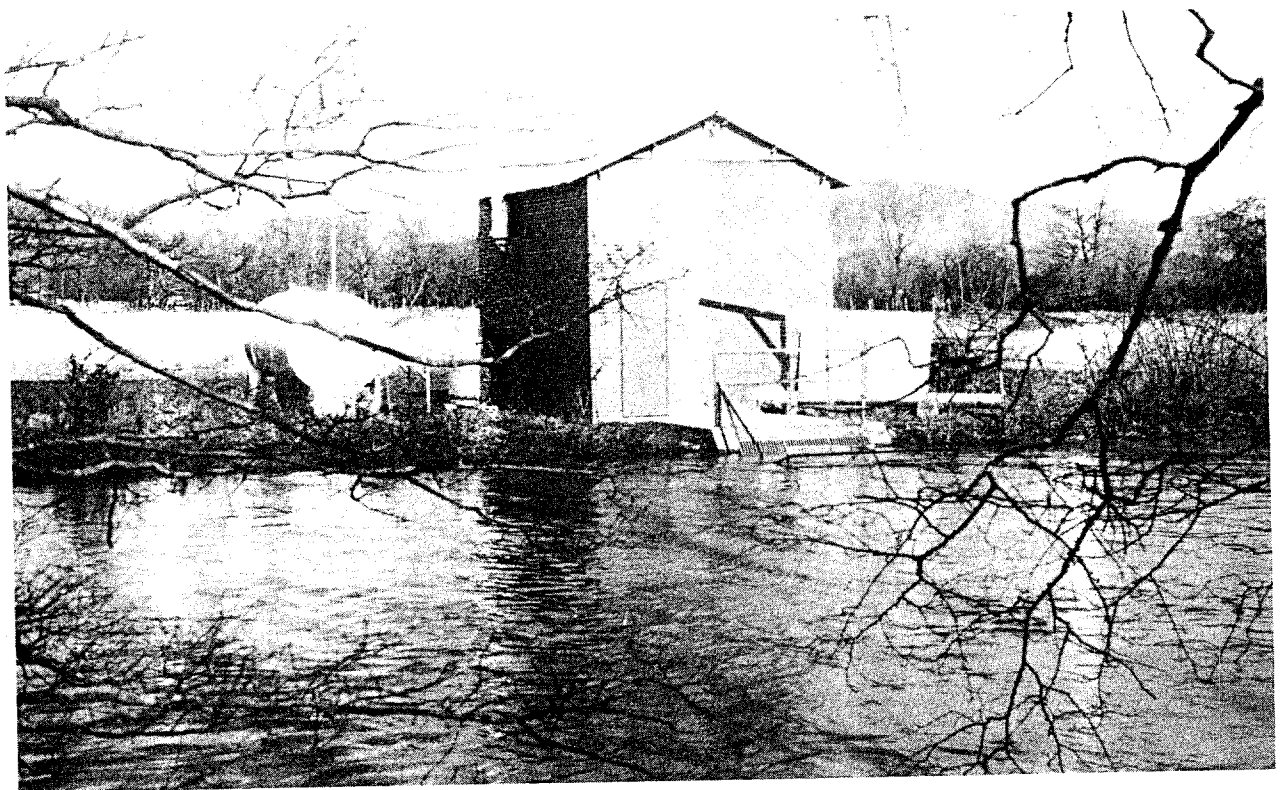
Figure 5. --WATER INTAKES FOR OLIN MATHIESON PLANT

Upper view shows low intake dam on Davidson River at Mile 1.38, as seen from left bank. The intake structure is built in the dike. Lower view is the auxiliary water intake on left bank of French Broad River just upstream from mouth of Davidson River.

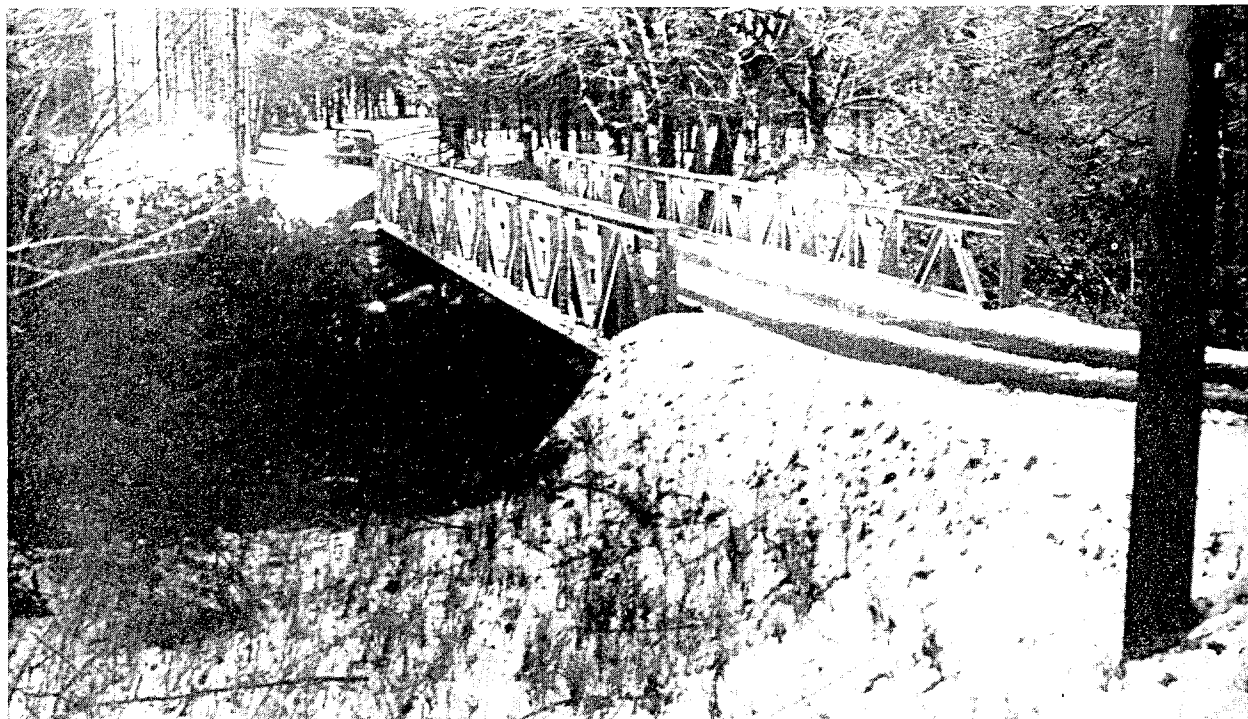
English Chapel Bridge at Mile 4.18 as seen from U. S. Highway 276 on left bank, downstream side. The bridge provides access to a church and to a Forest Service recreation area just across bridge at right.

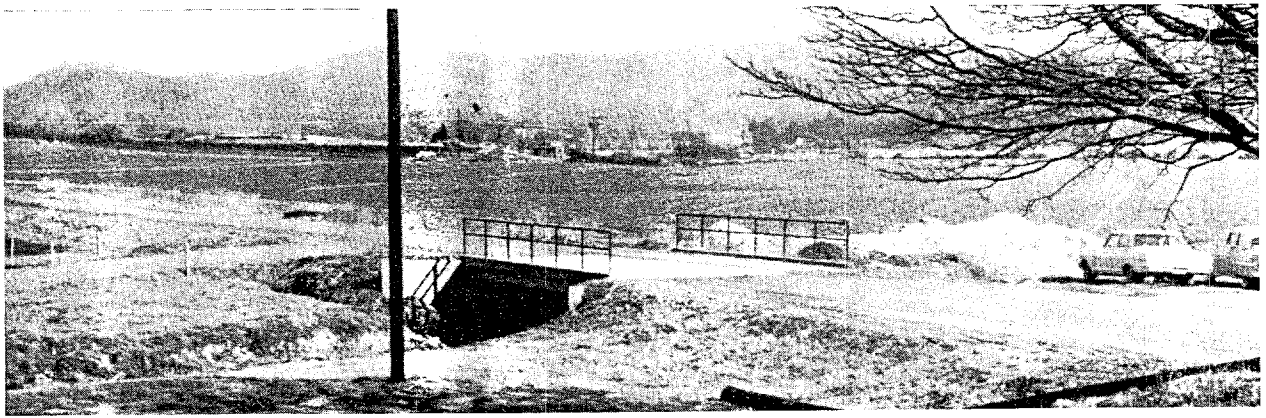
Figure 10. --KING CREEK BRIDGES ON BREVARD COLLEGE CAMPUS

Top view is upstream side of bridge at Mile 1.02. Footbridge at Mile 1.17 in middle view leads to new Physical Education Building on left bank. Bottom view is downstream side of bridge at Mile 1.23 carrying driveway to the same building and to athletic field.

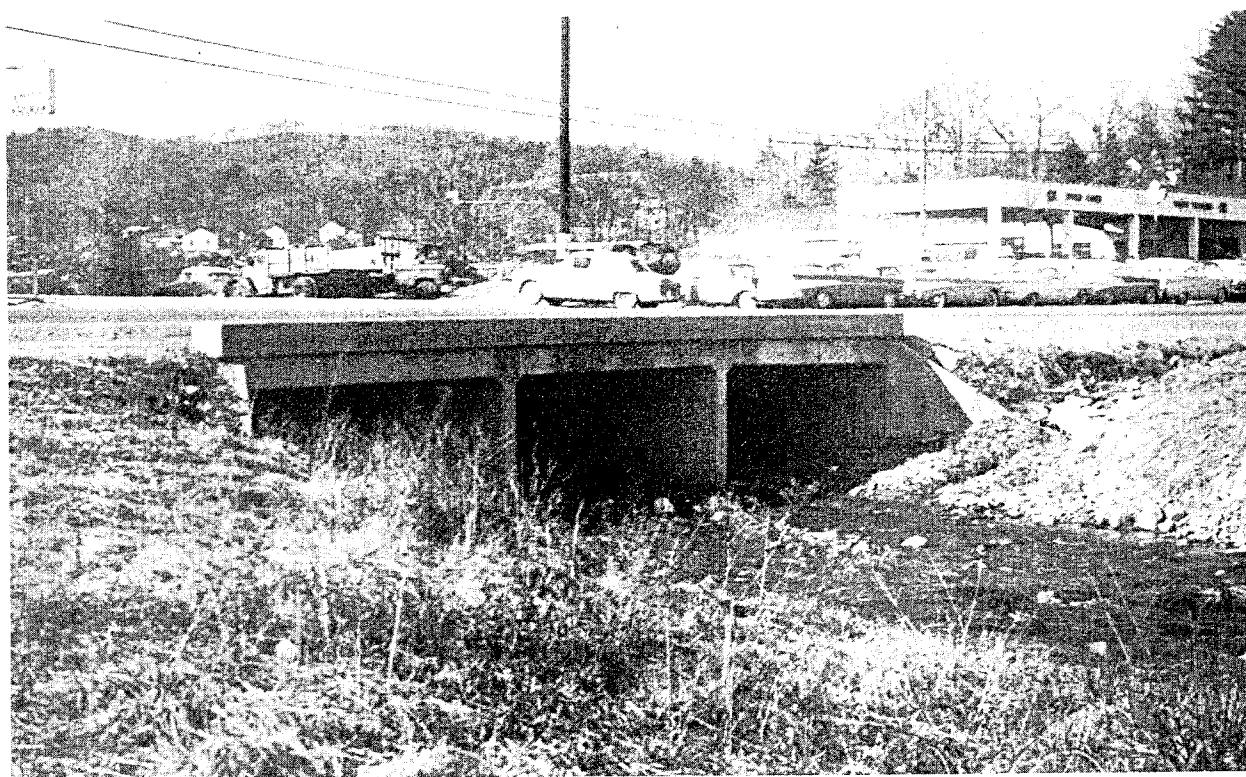
Figure 12.--U. S. HIGHWAYS 64 & 276 CROSSING KING CREEK

This 3-section culvert carries the four-lane highway across King Creek at Mile 1.33. The view shows the downstream side.

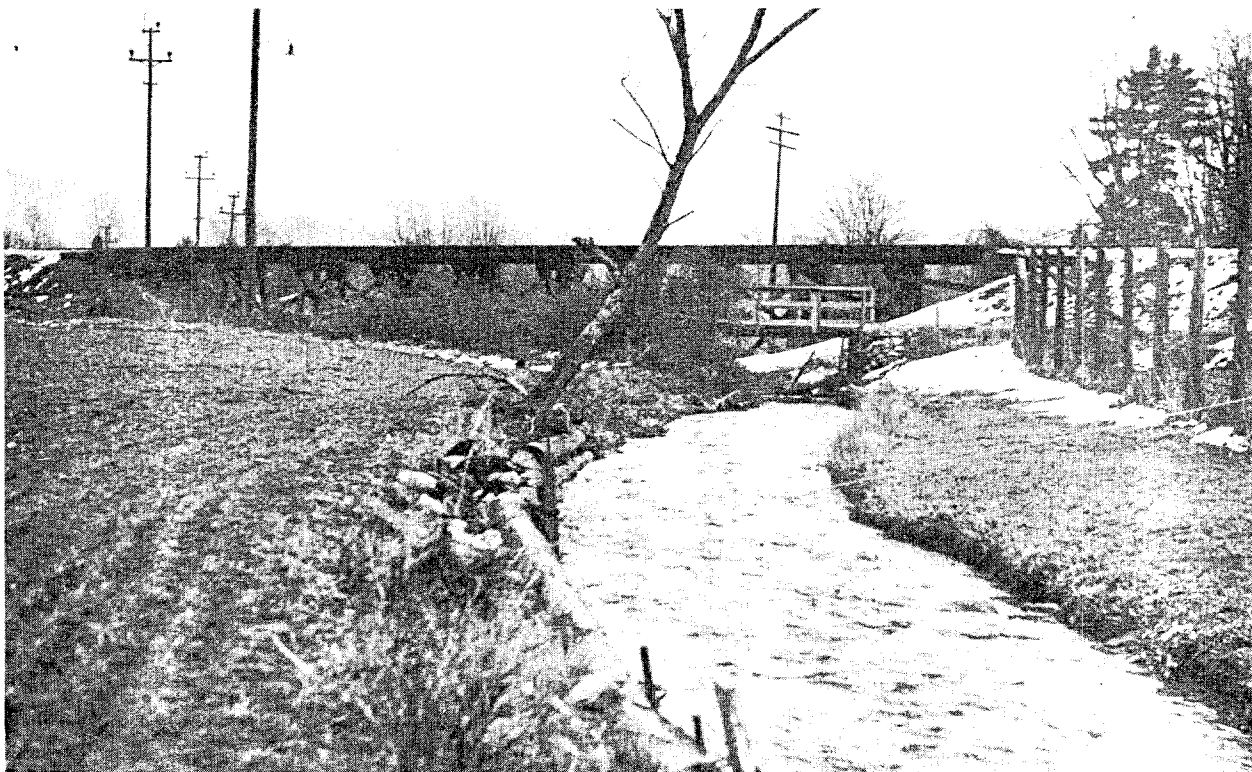
This view is downstream toward the Railroad Avenue bridge, at Mile 1.60, and the Southern Railway trestle at Mile 1.58.

A fill blocks the flood plain where the Southern Railway crosses King Creek. Near the left-bank edge of the flood plain the railroad crosses Tinsley Creek on a low trestle. From Tinsley Creek the fill rises as it approaches King Creek and the right-bank flood plain to bring the tracks to the higher ground at the Brevard railroad station at Whitmire Street. The King Creek crossing is made on a trestle 125 feet long, with an underclearance that is 15 to 17 feet above low water. The height of the fill above the flood plain varies from 4 or 5 feet near Tinsley Creek, which is 600 feet from the King Creek trestle, to 10 feet at King Creek and on the

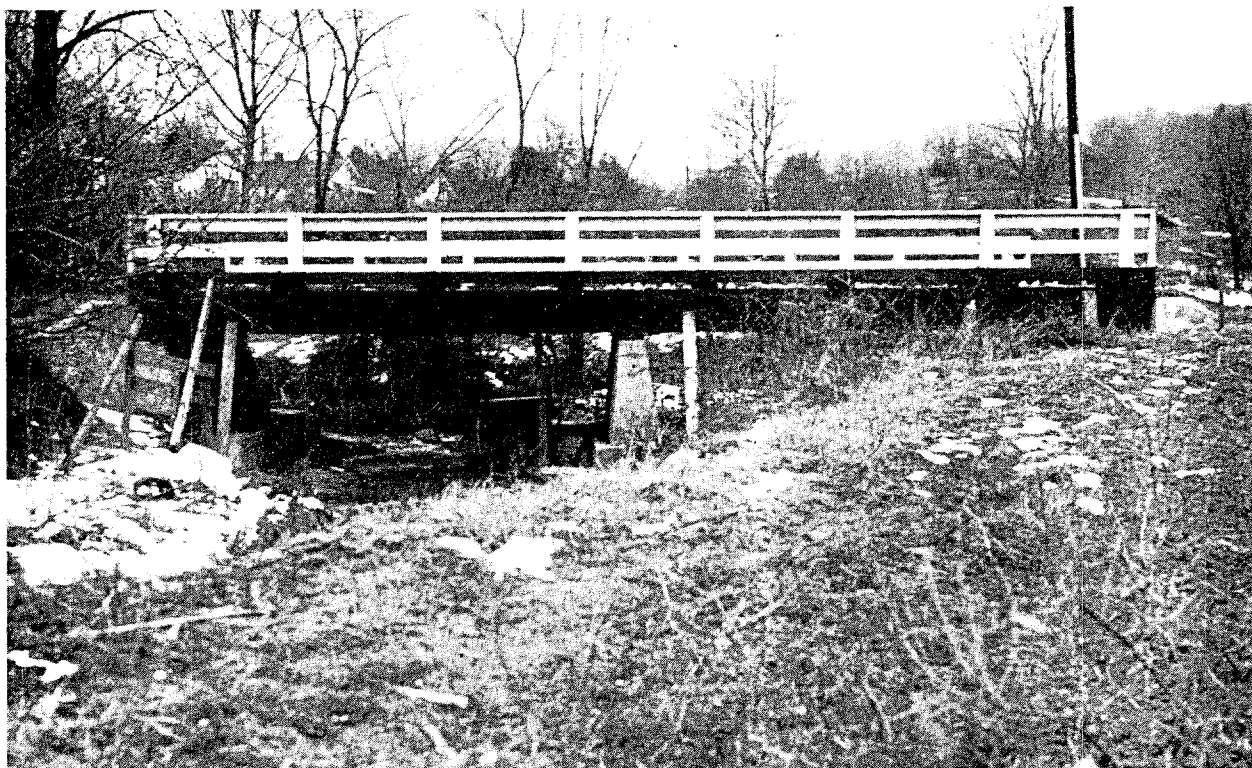
Downstream side of Tinsley Road bridge at Mile 1.79.

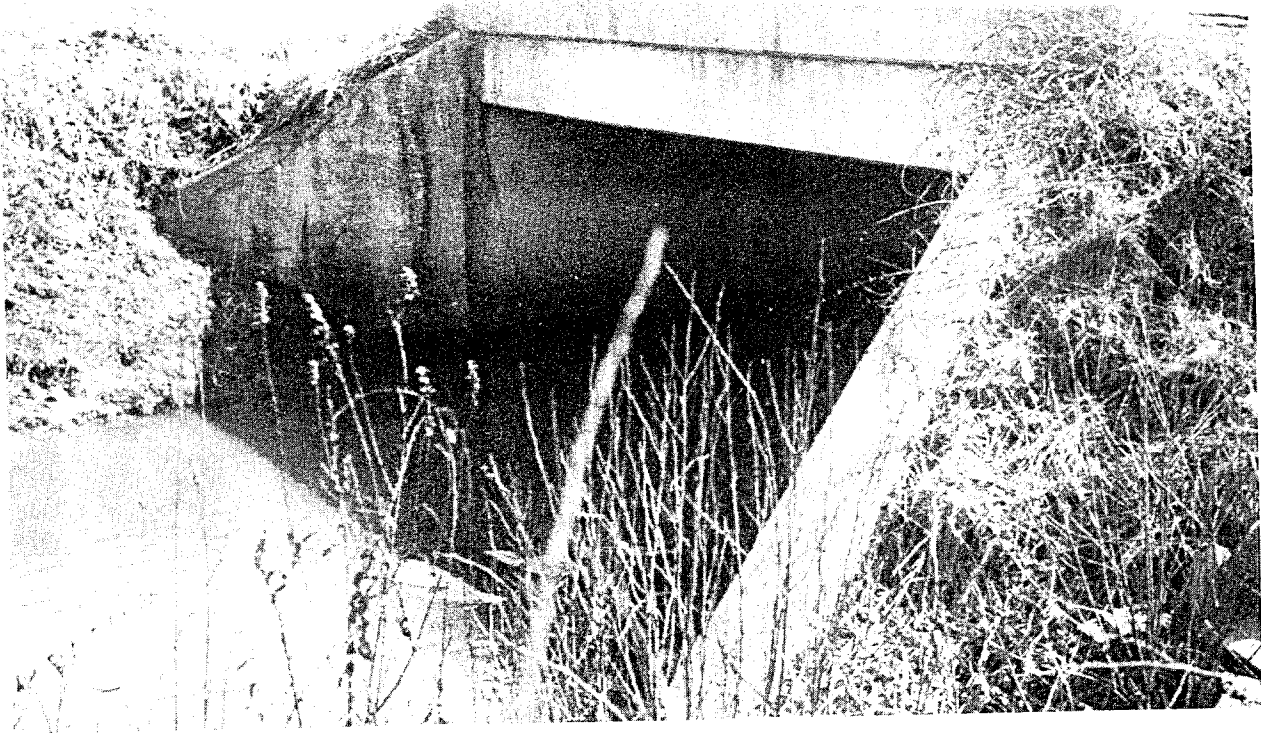
Figure 15. --U. S. HIGHWAY 64 BRIDGE OVER NICHOLSON CREEK

This is the upstream side of box culvert at Mile 1.60 under the main highway to the west.

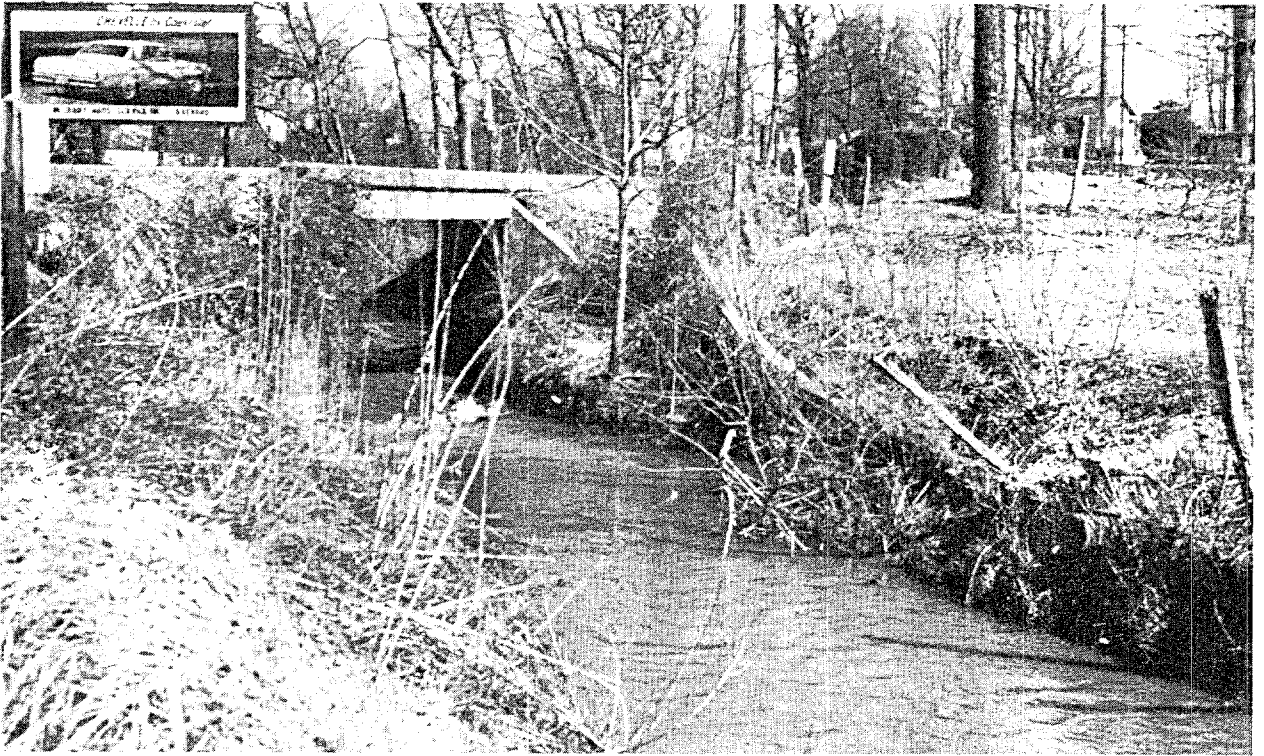
Figure 17. --U. S. HIGHWAY 64 CROSSING TUCKER CREEK

This is the downstream end of box culvert carrying the main highway at Mile 0.33.

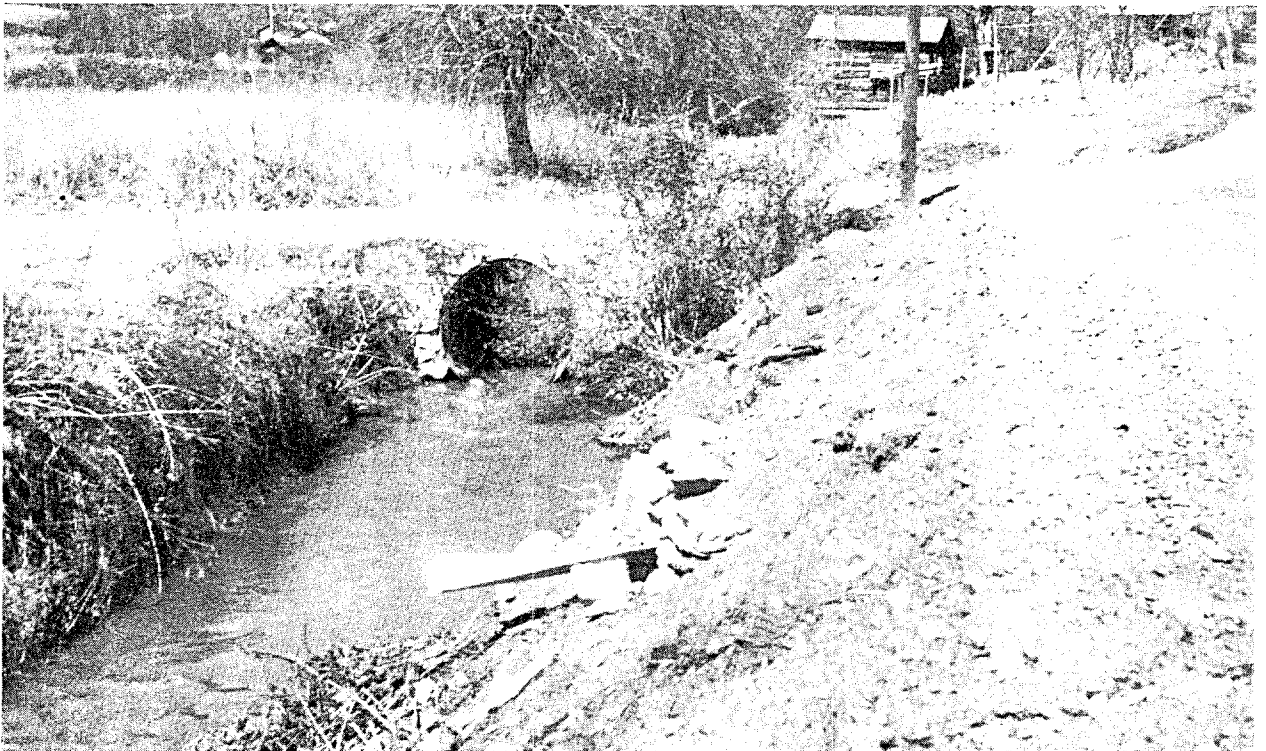
Figure 18. --SILVERSTEEN DRIVE CROSSING TUCKER CREEK

Downstream side of culvert, 72 inches in diameter, at Mile 0.58.

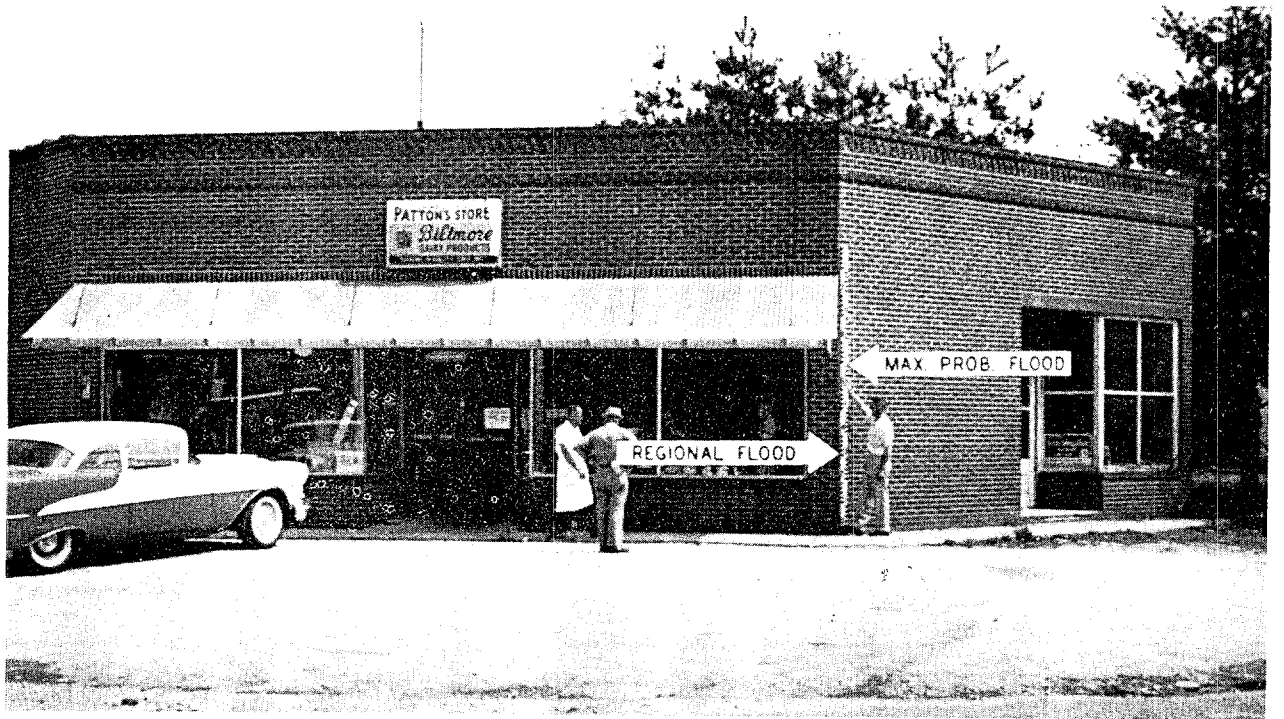
Figure 20. -- FLOOD HEIGHTS ALONG FRENCH BROAD RIVER

Upper view shows the sewage pumping station on New School Road, at Mile 197.7. Lower view shows Patton's Store in Pisgah Forest, in the French Broad River flood plain but 0.4 mile up the Davidson River. Arrows show heights of the Regional and Maximum Probable Floods on the French Broad River. The Maximum Probable Flood on the Davidson River would be substantially the same in the lower view as the Regional Flood on the main stream, and the Regional Flood on the Davidson River would be one-half foot above the floor of the store.

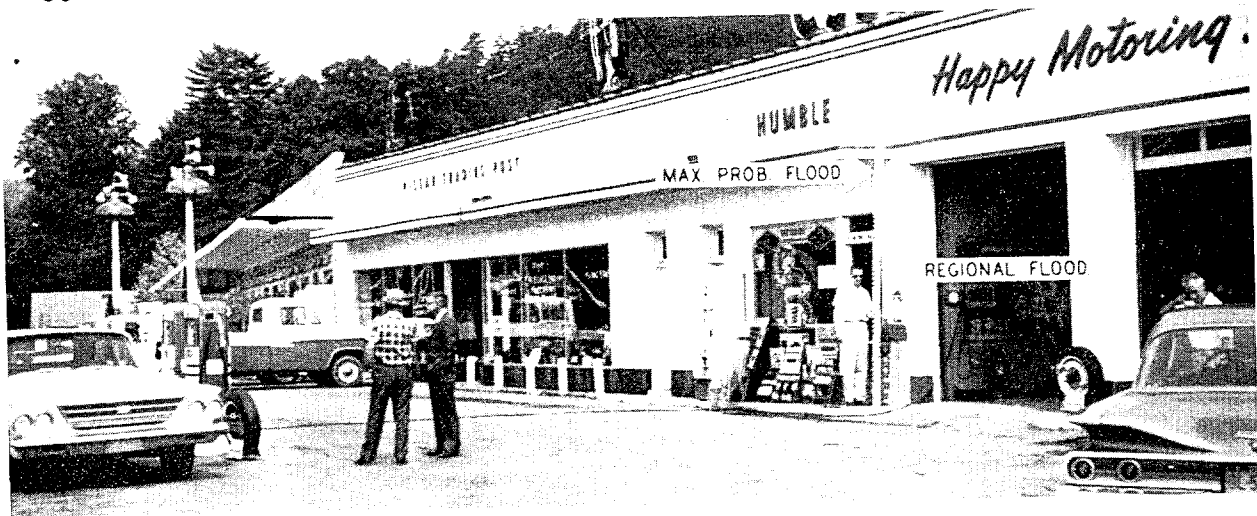
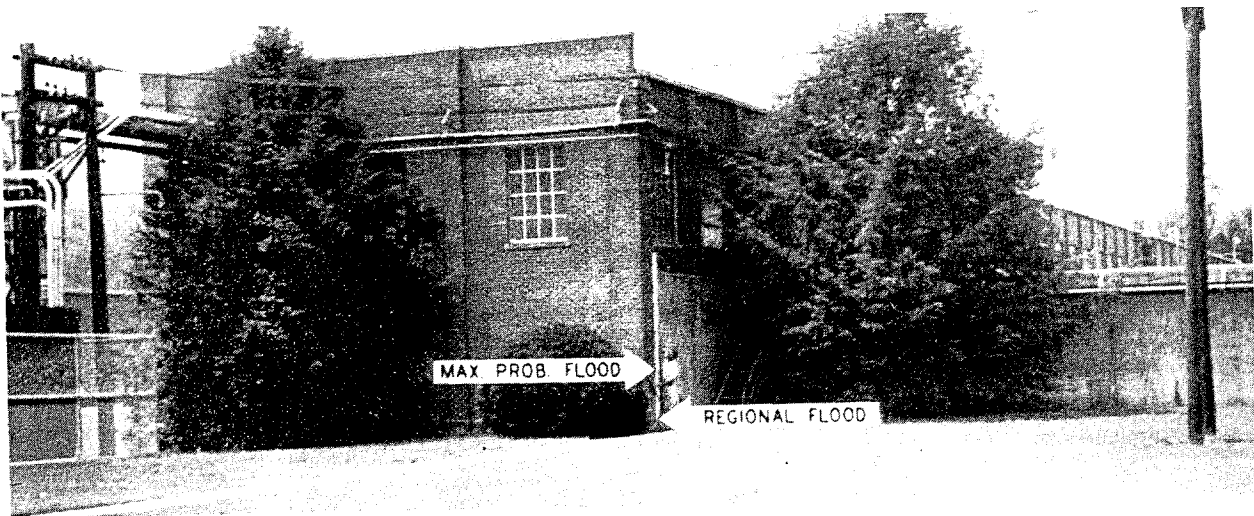
Figure 21. --FLOOD HEIGHTS ALONG DAVIDSON RIVER

Top view is the Pisgah Trading Post at Mile 2.15, on U. S. Highways 64 & 276. Middle view is the filter plant of the Olin Mathieson Chemical Corporation at Mile 1.4. Bottom view is the Duke Power Company substation serving the Olin plant, at Mile 1.29. Arrows show heights of the Regional and Maximum Probable Floods.

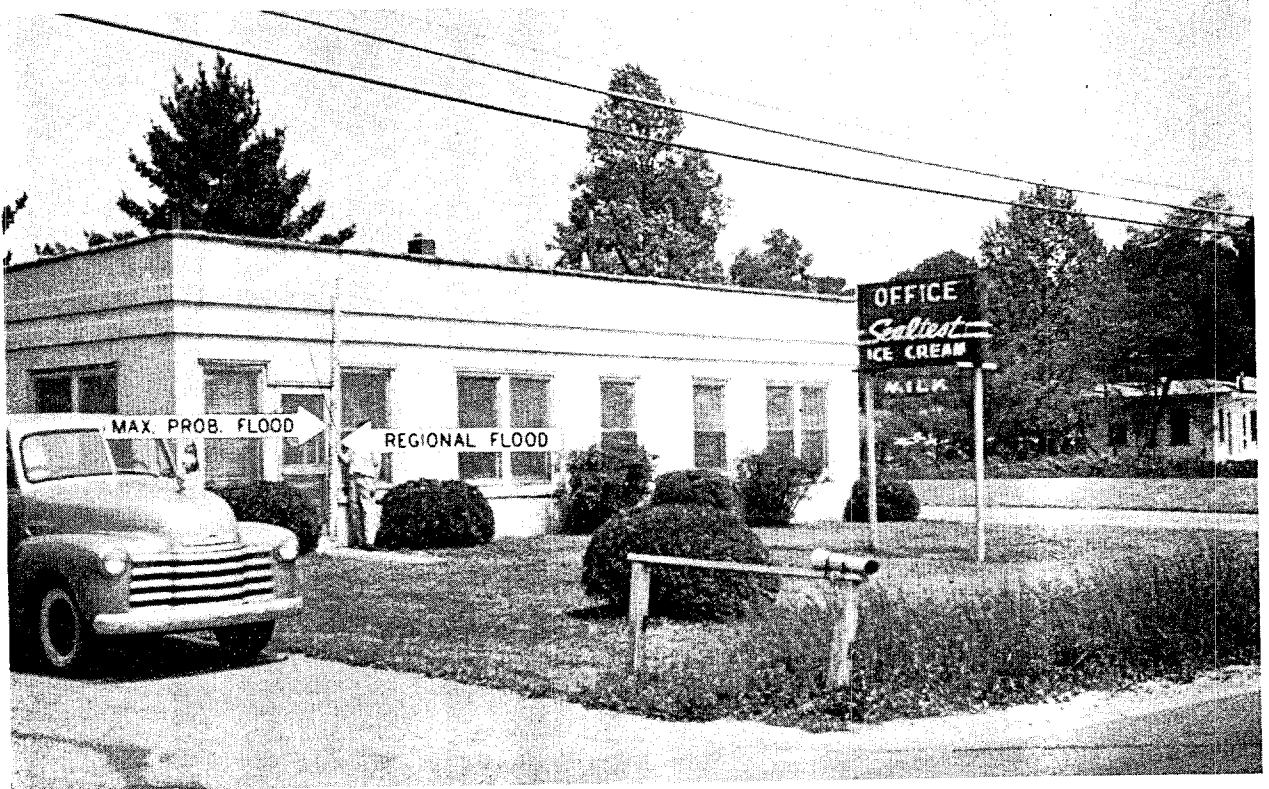
Figure 22. -- FLOOD HEIGHTS ALONG KING CREEK

Upper view is the Sealtest office and salesroom at Mile 1.35, on U. S. Highways 64 & 276. Lower view is the Physical Education Building of Brevard College, at Mile 1.17. Arrows show the Regional and Maximum Probable Flood heights.

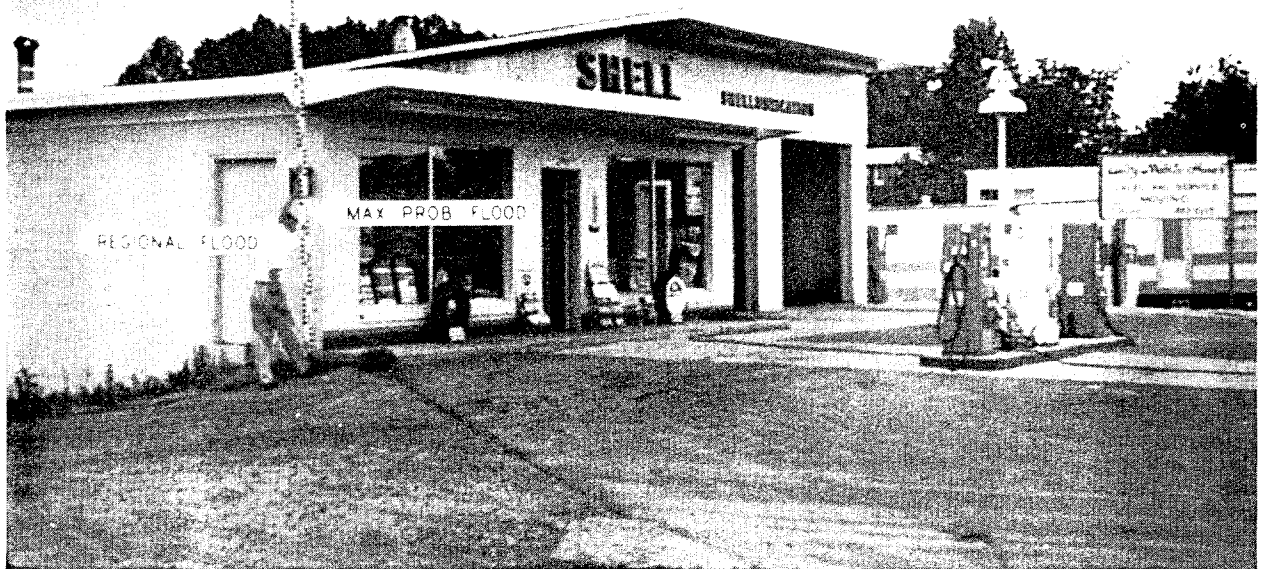
Figure 23. --FLOOD HEIGHTS ALONG NICHOLSON CREEK

This service station is located at Mile 1.61 of the creek, on U. S. Highway 64. Arrows show the heights of the Regional and Maximum Probable Floods.

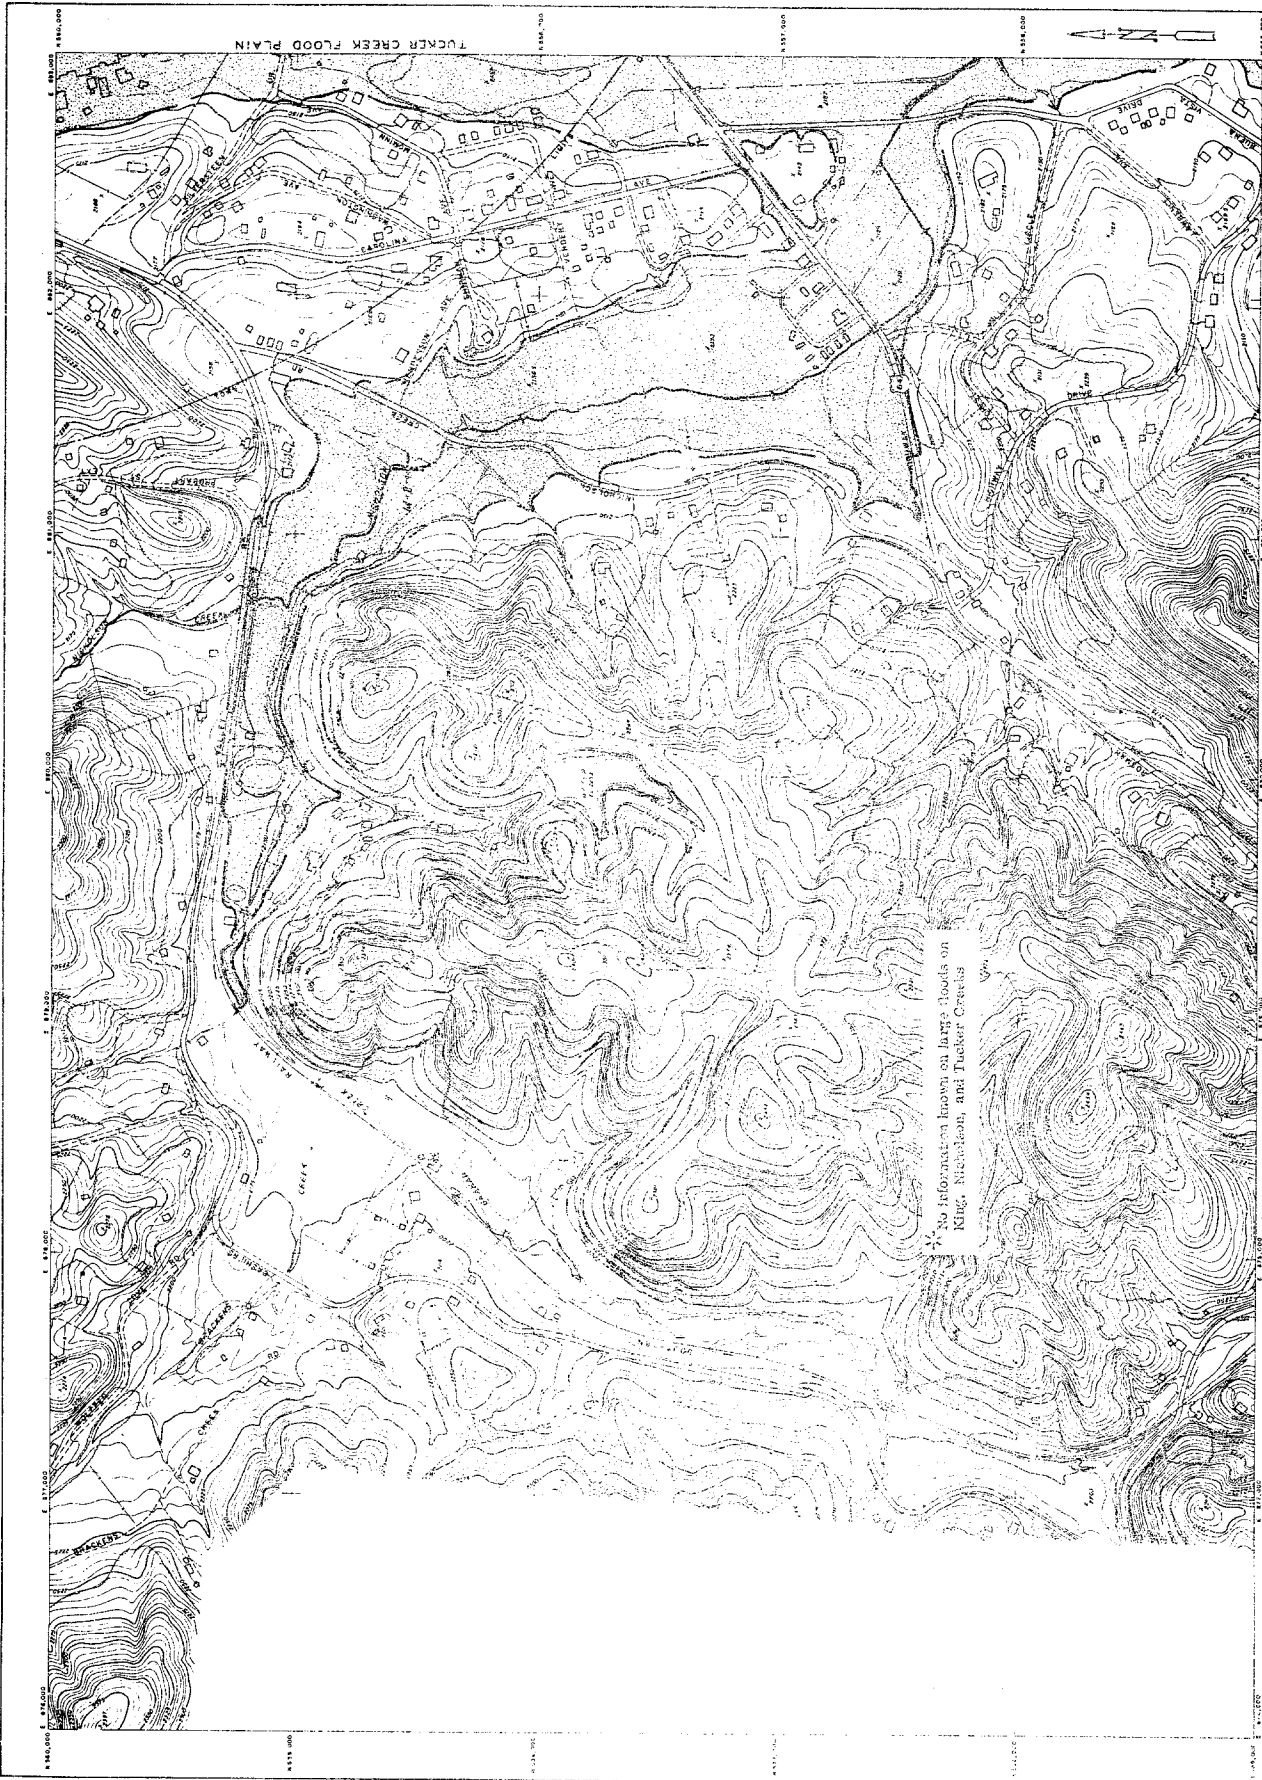
COMPILED BY PHOTOGRAMMETRIC METHOD
SEPTEMBER 1962
By
PIEDMONT AERIAL SURVEYS, INC.
PHOTOGRAMMETRIC ENGINEERS
GREENSBORO, N. C.

FLOODED AREAS
NICHOLSON AND TUCKER CREEKS
BREVARD, N. C.
MAY 1964

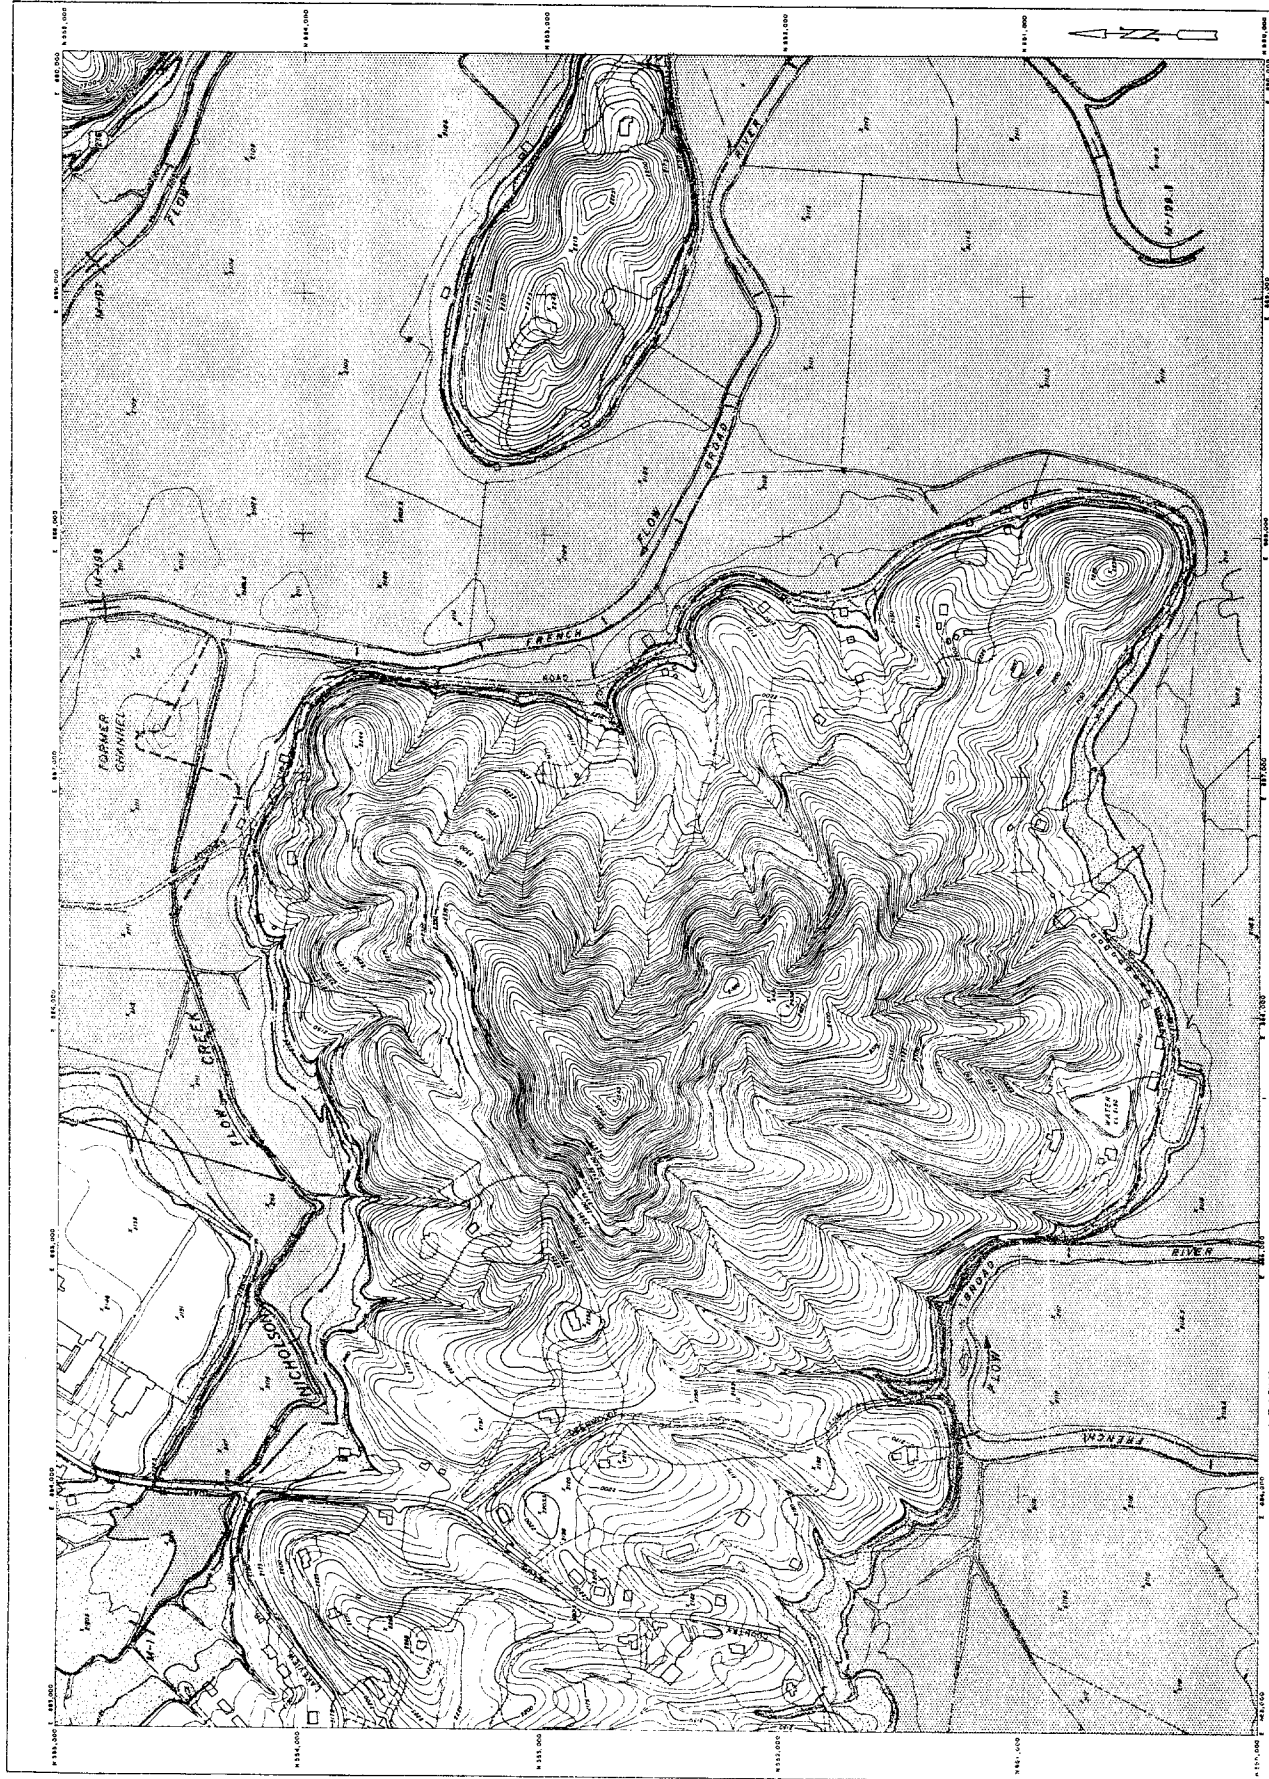
FLOODED AREAS
FRENCH BROAD RIVER
AND NICHOLSON CREEK
BREVARD, N. C.
MAY 1964
